# Fire Incident at Chevron Refinery

# Incident Learning: What happened? (cont.)

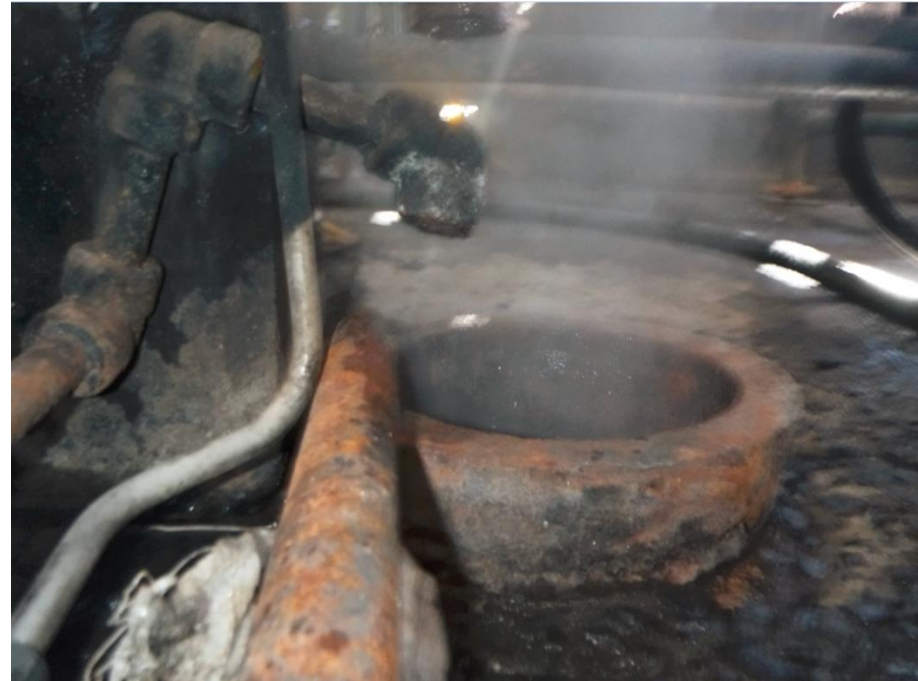
- There were insufficient communication between operations personnel on Z1 and Z2 regarding the simultaneous operations (SIMOPS) in the common area.
- Whilst starting up, vapour lock problems were experienced in Z1 and the system had to be bled/drained at various points.
- Hot work in Z2 was not stopped at any point during the draining on Z1.
- A  $\frac{3}{4}$ " drip ring drain valve in Z1 was discovered in open position. Drain line discharges into the oily water sewer drain in Z2 (the origin of the fire).
- Slag from overhead hot work in Z2 caused ignition. Hot work spark containment standard required "layer of water" to be maintained below work area.
