RIM SEAL FIRE F40115

Date of incident: 1/12/2018

Tank involve: F40115

Product: Crude oil

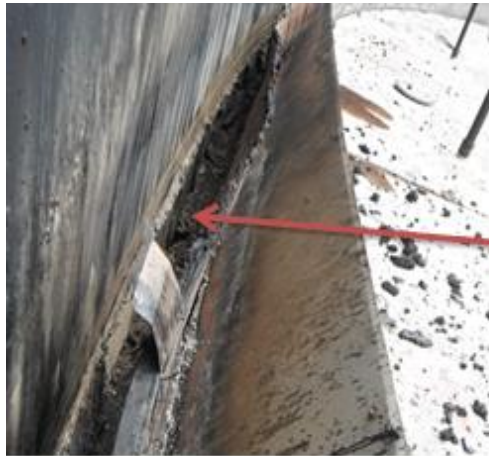
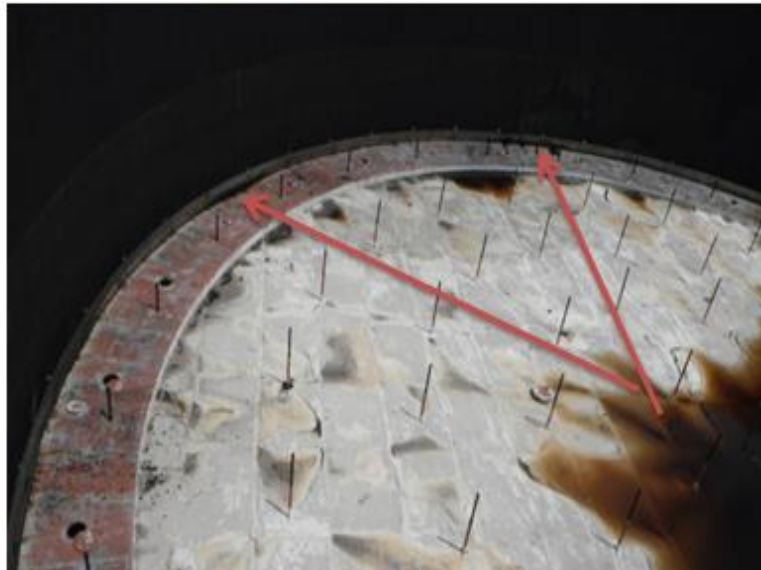
The seals were damaged at two different places.

Damaged seal
