# Natref SHE Learning

| Learning number | | FY20-010 | | | | | | | | | | |
| Key Undesirable Event | | Falling from elevated position | | | | | | | | | | |

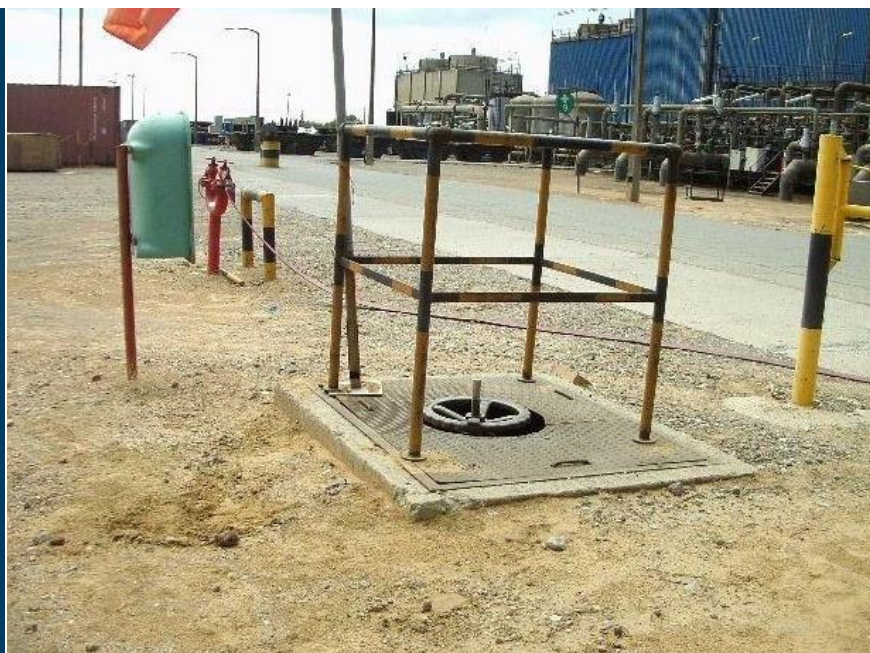
| Description of the incident | | During isolation of the fire water system at FBV/B/2, the plant operator used a valve spanner to close the valve with both feet positioned on the solid cover located on top of the pit. As he was trying to close the valve, the cover started to tilt in and he reacted by placing his left foot onto the ground. In the process, the operator sustained an injury on his right leg. | | | | | | | | | | |

Figure 1. Shows the Fire water pit where the incident took place

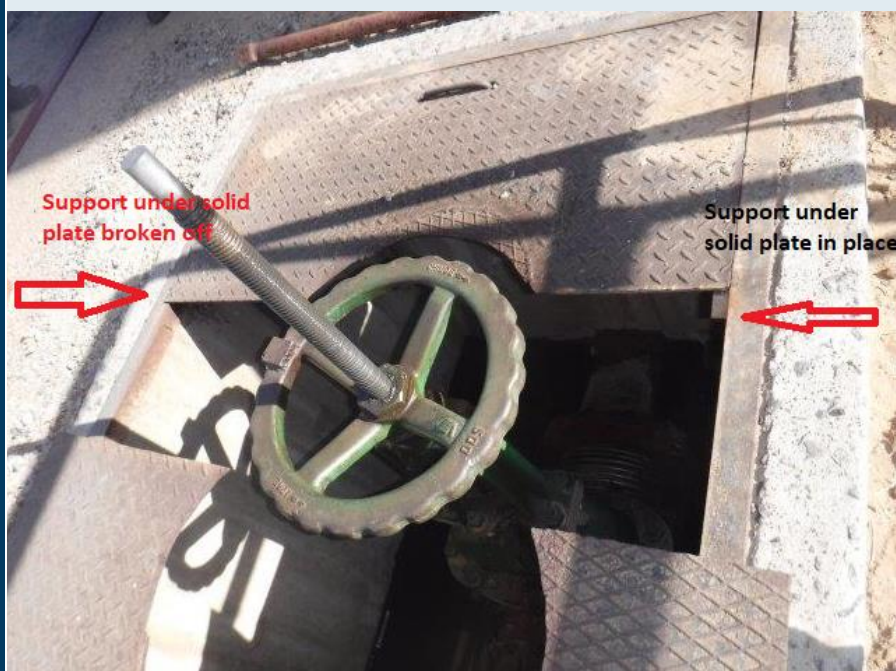
Figure 2.

| Underlying and root causes | | Cause: Broken support underneath the solid cover plate.<br>Underlying cause: No inspection or maintenance strategy on grating / plates which cover pits | | | | | | | | | | |

Indicates that the support under the solid plate was broken off which allow the plate to tilt.

An inspection and maintenance strategy should be developed for all solid cover plates on Fire water and Cooling water pits to confirm their mechanical integrity.
