Natref Durban Operations Tank Floor leak

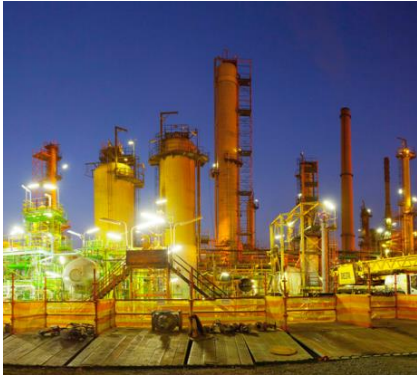
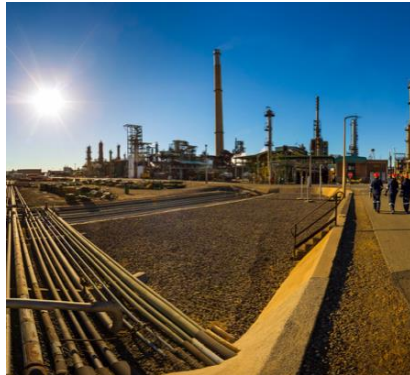
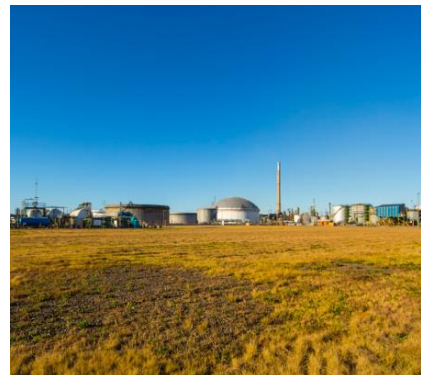
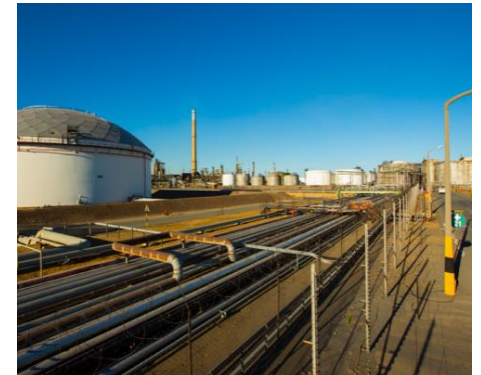
On the the operator reported that the crude oil discharged from the bottom of the tank into the bund area

- ❖ Tank floor and roof was replaced 2 years prior to the incident
- ❖ The tank was commissioned following the correct sequences
- ❖ The tank was in operation for a year when the tank started to leak
- ❖ Welding defect found

- * Spillage into the bund area was contained
- * Water was injected immediately into the bottom of the tank
- * Crude was pumped from the containment area into the sewer system and pumped back into the tank via the separator system
- * The tank was then emptied to do repair work

- ❖ AIA inspector
- ❖ Welding –MPI
- ❖ Vacuum test box
