# Incident Learning: Uncontrolled Combustion in Boiler

- A floor pool fire occurred inside Boiler 2 on Start-up.
  - Located at Steam Generation Unit.
  - Unit comprises of 3 Boilers.
  - Boiler 1 & 2 are Front Walled Furnace systems.
  - Uses LFO, HFO, Flash Gas or Lean Natural Gas.
  - 2 circular oil/gas burners - 2 Oil Guns each.
  - FG and LNG burner pokers located on the periphery.
  - Commissioned in 1991.
  - Supplies superheated steam.

# Incident Description

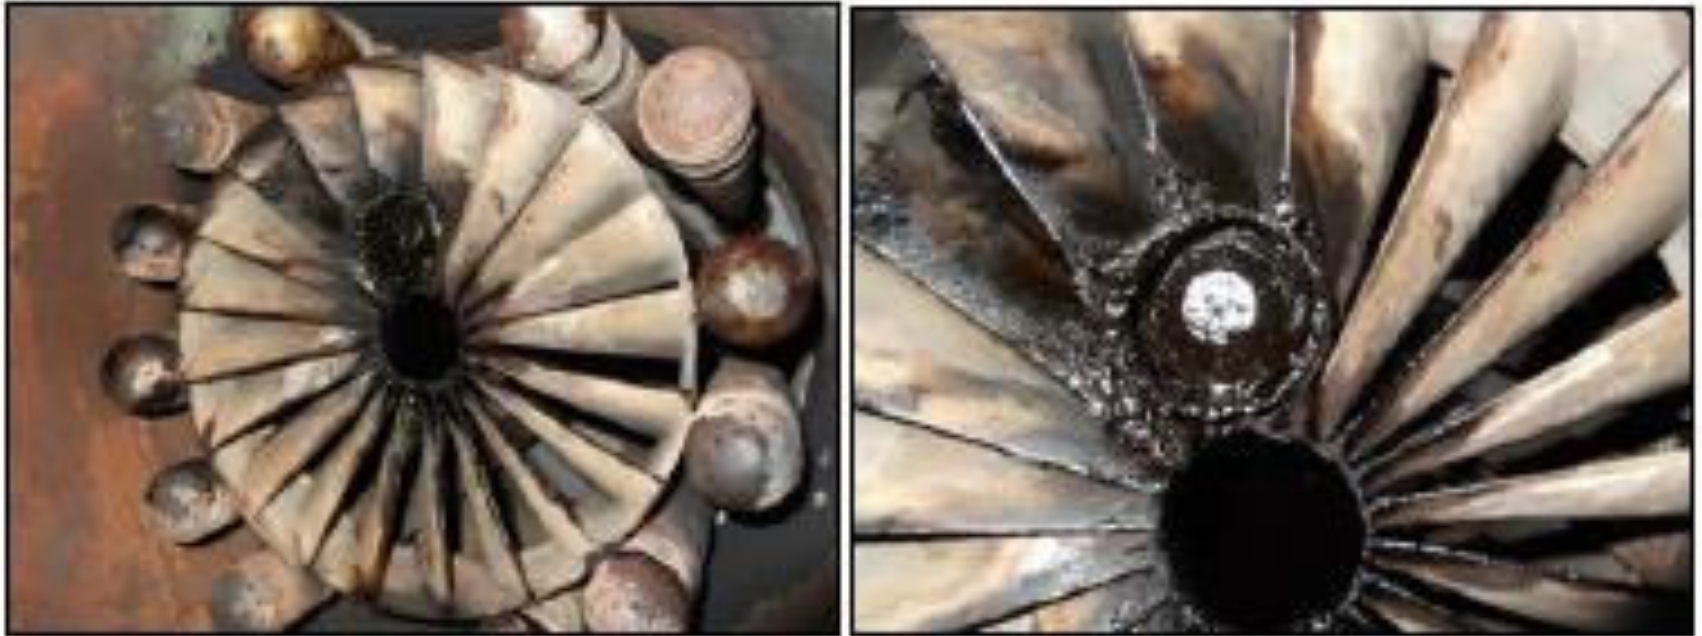
Photos 1 & 2 (Inspection Department photo 25/09/17) – Burner 1

- Burner in auxiliary port does not protrude far enough through port.
- Mechanical damage to swirler, top half bent forward.
- Unburnt fuel around auxiliary burner and primary burner port.

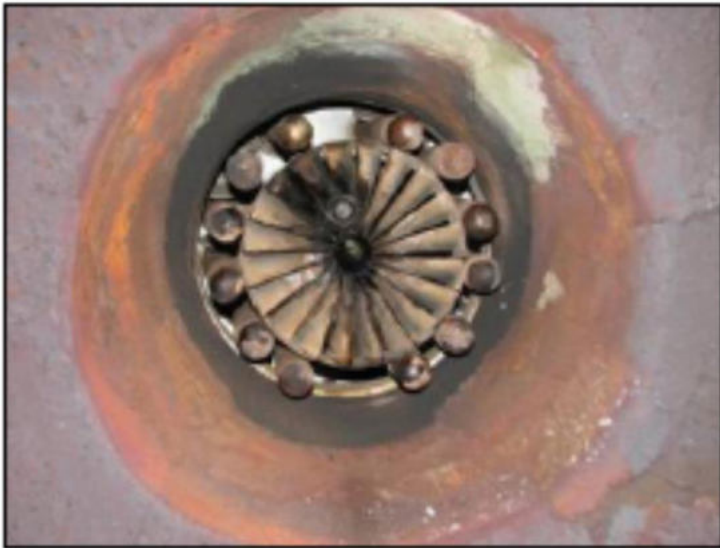
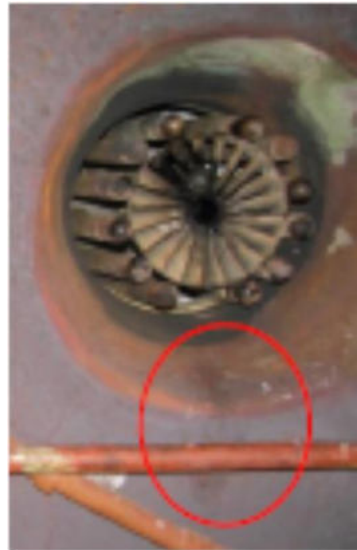
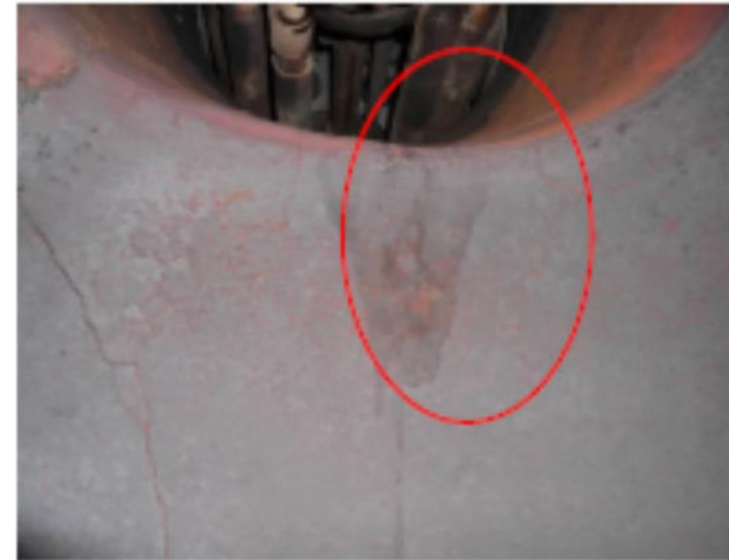
Photo 3 – Minor Refractor Repair

- Minor refractory repair between 01H00 and 02H00 around burner.
- Stains on refractory possibly indicating flow of unburnt fuel.

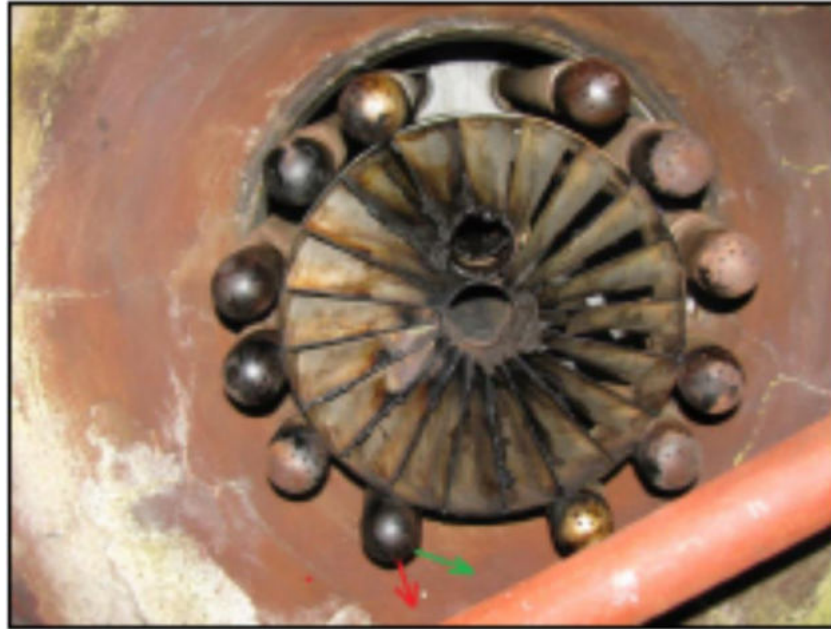
Photo 8 – Burner 2

- Unburnt fuel around auxiliary and primary burner port.
- Incorrect orientation of one gas poker nozzle. Correct orientation as per green arrow.
- Auxiliary burner port off-center to the left.
- Auxiliary burner guide tube misalignment with swirler port.

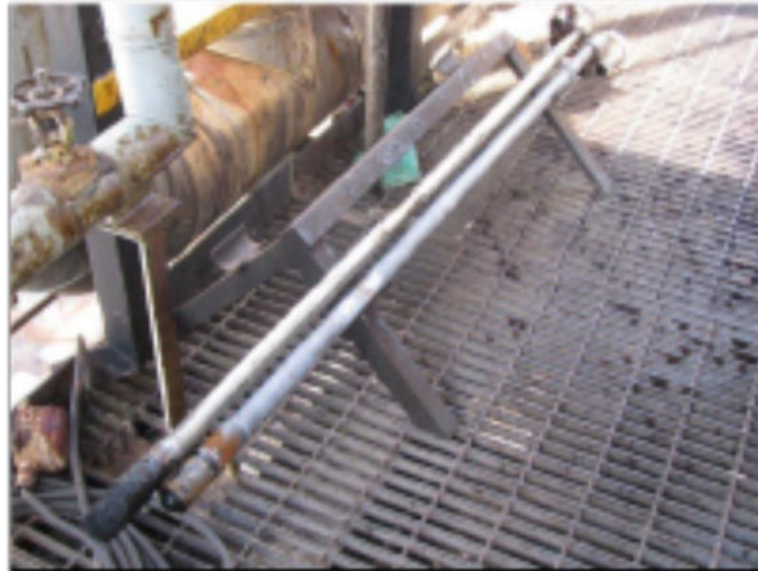
Photo 9 – Burner Gun Length Comparison

- **June 2000:** Boilers 1 and 2 - Incorrect depth of refractory installed during shutdown.
- Burner quarl angle impacted and flame profile exceeding acceptable tolerances.
- Inner set of tubes moved backwards, *Burner guns lengthened* by 100mm.
- Burner 1's coupling block (*new design*) now not interchangeable with Burner 2's.
- Modifications not incorporated fully into all operating and maintenance procedures (MOCA).

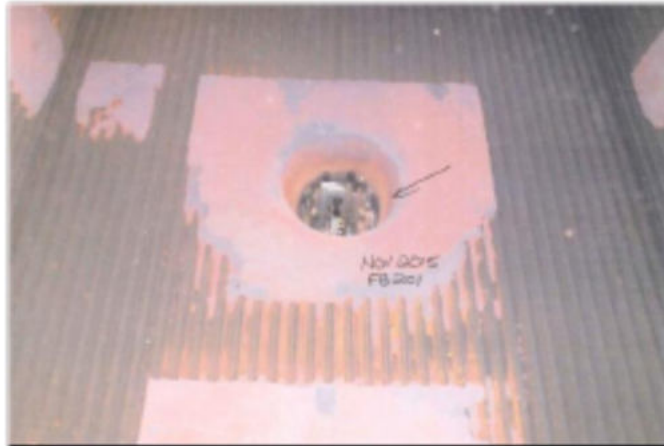
Photo 12: - 43-FB201 Burner 2 with "Missing" Air Swirler

Non-standard OEM air swirlers installed.

- XXX (UK) appointed new agents in SA.
- Swirlers obtained from previous SA agent.
- Change in agent not communicated by Supplier (No MOCA).
- Change in (SA) supplier's agent must submit to MOCA.

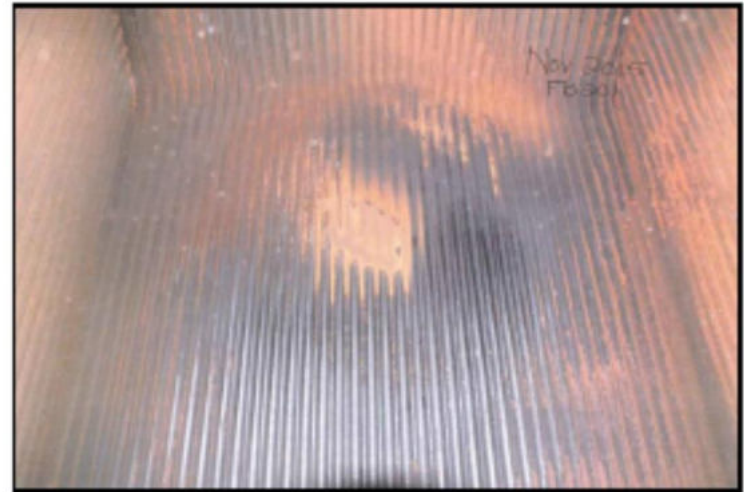
Photo 14: - Burner Flame Impingement opposite Burner 2 with "Missing" Air Swirler

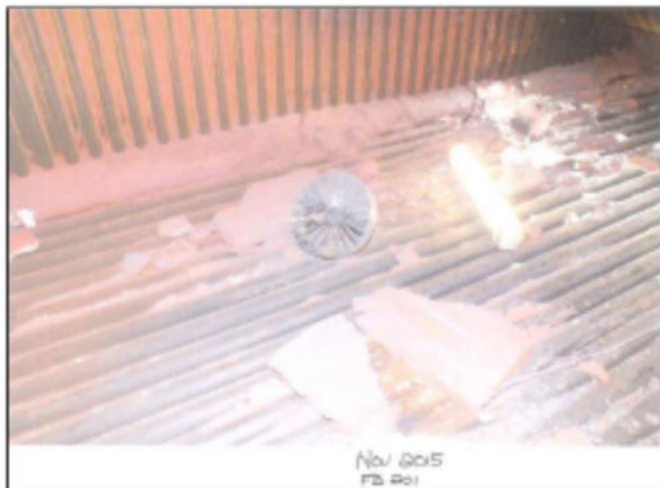
Photo 13: - "Missing" Air Swirler lying on Boiler Floor

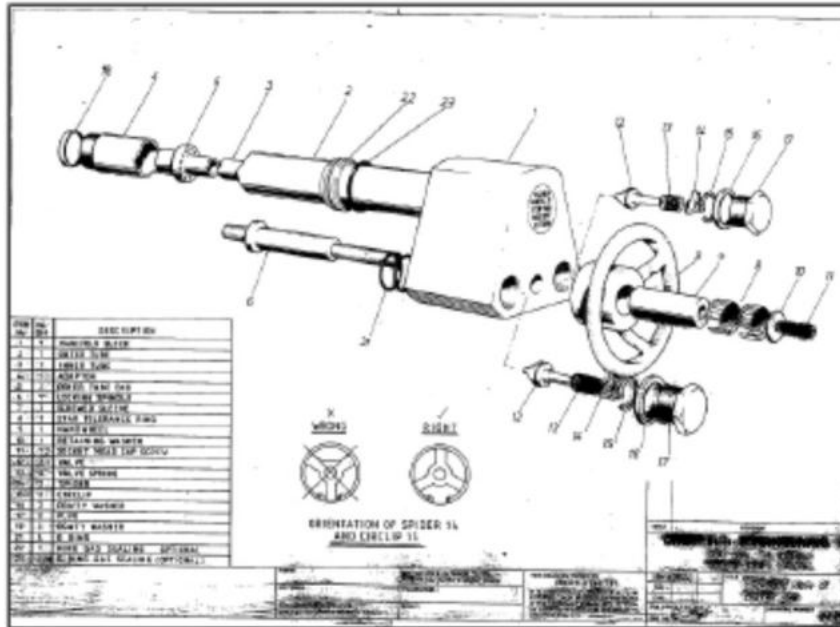
Figure 6: Burner Oil Gun General Assembly

- All 3 boilers have burner equipment designed by XXXX Ltd (UK).
- Atomiser of Boiler 3 (lower duty – smaller holes) was installed in Boiler 2.
- Boiler 3 not designed for HFO.
- HFO firing on Boiler 2 – *thus impossible for start-up & stable operation with HFO.*
