# LFI: **Hydrocarbon Leak** at Condensate Pig Receiver

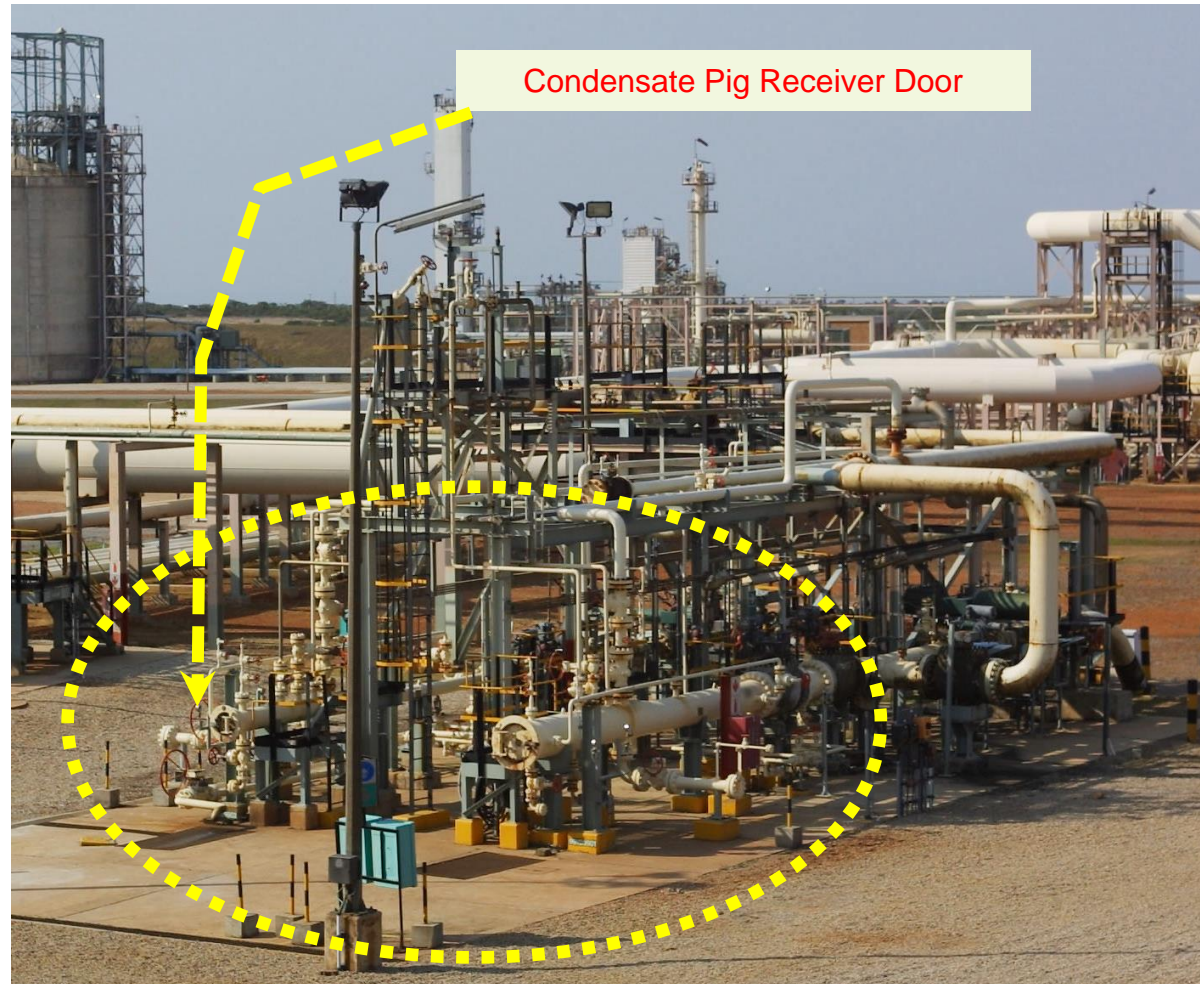
- Liquid Hydrocarbon (light naphtha) leak at Pig Receiver Door.
- *Leak rate = 7 – 9 drops per minute, Tier 3.*
- Both Pig Receiver isolation valves passing.
- *ASU offline and parked – external nitrogen with supply interruptions.*
- Fuelgas supply ex offshore could not be stopped.
- Timeous process to test suitable isolation arrangements whilst maintaining fuel gas supply to flare.
- Incident escalated to Tier 2 as HiPo due to duration. ORA completed - interim mitigations.

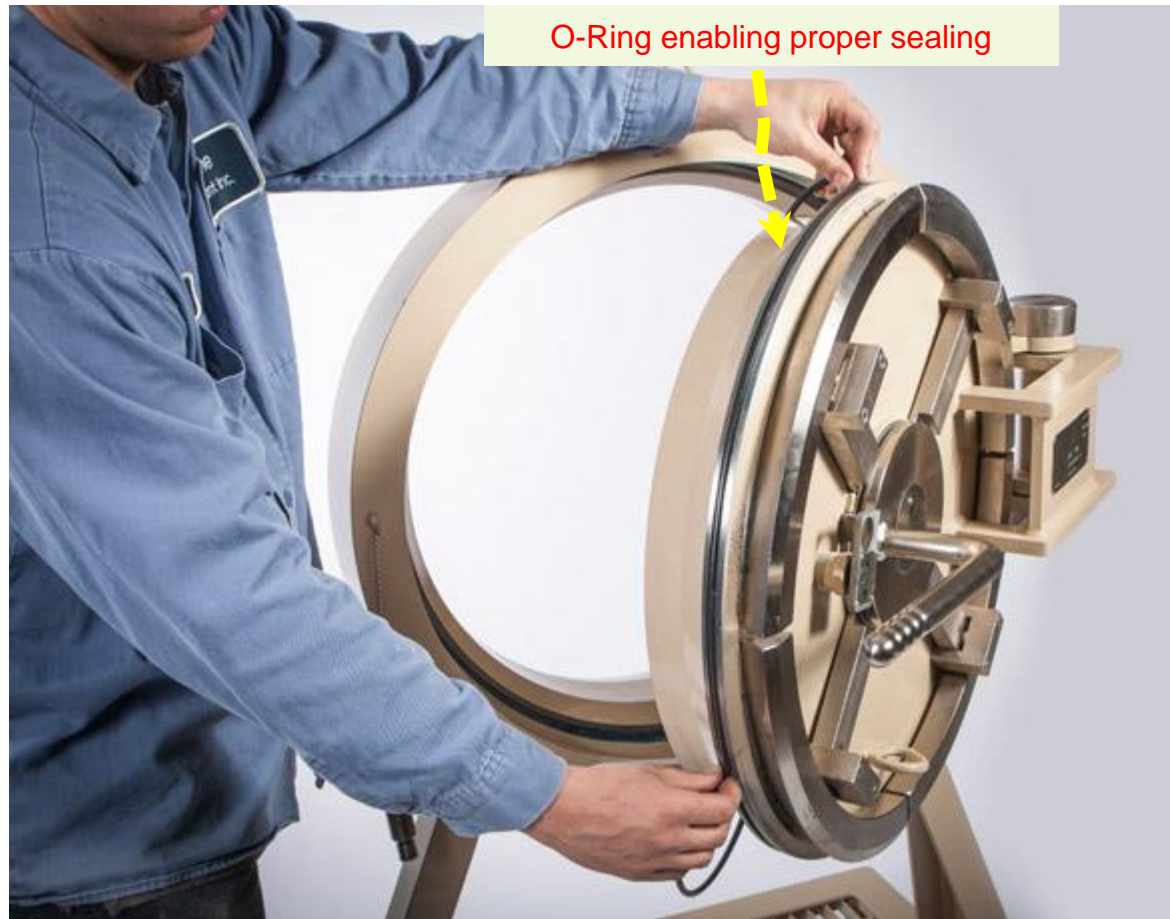
- Quick opening, Clamp ring type closure of the pig receiver door – a 3 piece closure with door, hub, and clamp ring.
- The clamp ring is used to hold the door and hub using an O-Ring pressure seal.
- Likely Cause – swelling of the O-ring after exposure to the atmosphere at last pigging exercise.
- O-ring not replaced after opening pig receiver.
- Pressure fluctuations because of FA Platform trips and draw down of fuelgas on supply line pressure.
- O-ring of Pig Receiver must be replaced after, and isolation checked before pigging operation.
