LFI: Tube failure on an air-cooler on the Naphtha Hydrotreater Unit

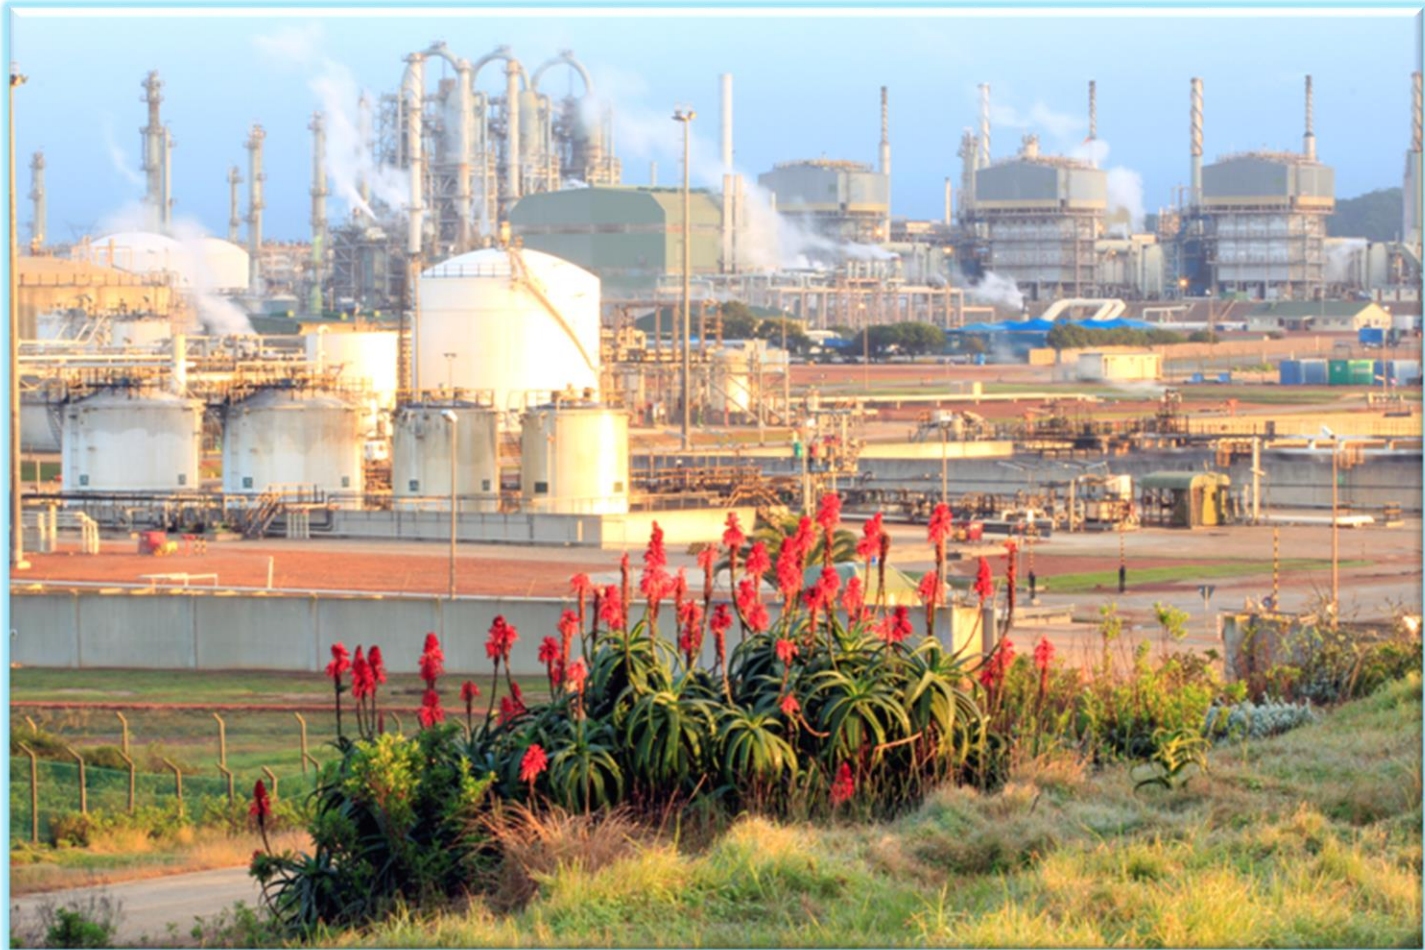
On 17th October 2019 one tube of an air cooler on the Naphtha hydrotreater was observed to be leaking hydrocarbon and recycle hydrogen. In response, the unit was taken offline and depressurized.

1. Operating Naphtha Hydrotreater with circulating wash water in corrosive pH range (<5.5 pH)
2. Operating Naphtha Hydrotreater with inadequate Wash water rate to the air-cooler (<3.5 m³/h)

1. Add the circulating wash water as a scheduled sample on the LIMS schedule and add specifications for pH, soluble iron and chloride.
2. If the circulating wash water pH falls below 5.5 this should prompt immediate operator action to maximise Neutracor dosing rate.

3. Investigate and correct the causes of the current low circulating wash water flow rate.
4. A more reliable online pH reading analyser is required to improve response to low pH incidents.

5. Contact the neutralising amine vendor to determine if they recommend another product for the NHT reactor effluent wash water application.
6. It is recommended to not process Yamal (or other condensates high in organic chloride and low in nitrogen) at Mossel bay GTL&R until either a replacement dosing pump is installed with capacity at least equal to the design required (3.0 litre/h vs current 2.01 litre/h), or a more concentrated Neutralising Amine than Neutracor 2902L is sourced that can provide equivalent neutralisation to 3.0 litre/h of Neutracor 2902L.

- All Naphtha hydrotreater Air cooler bundles will be retubed progressively over the next months. Since the other bundles have been exposed to corrosive conditions similar to the bundle that leaked, it is recommended that the integrity of any bundles going back in service after the regen outage is verified. If application of a tube wall thickness assessment method (e.g. remote field eddy current / Iris / MC Bais) is not feasible, then it is recommended to pressure test (at design pressure) the existing bundles (that are going back in service) in the upcoming regen outage. This precaution is recommended to reduce the risk of further leaks in service. Further leaks in service risk fire (atmospheric release of high pressure hydrogen and naphtha) and the long production outage and start-up incidents.
