# Incident Learning: Fire and smouldering on U7700 HVU

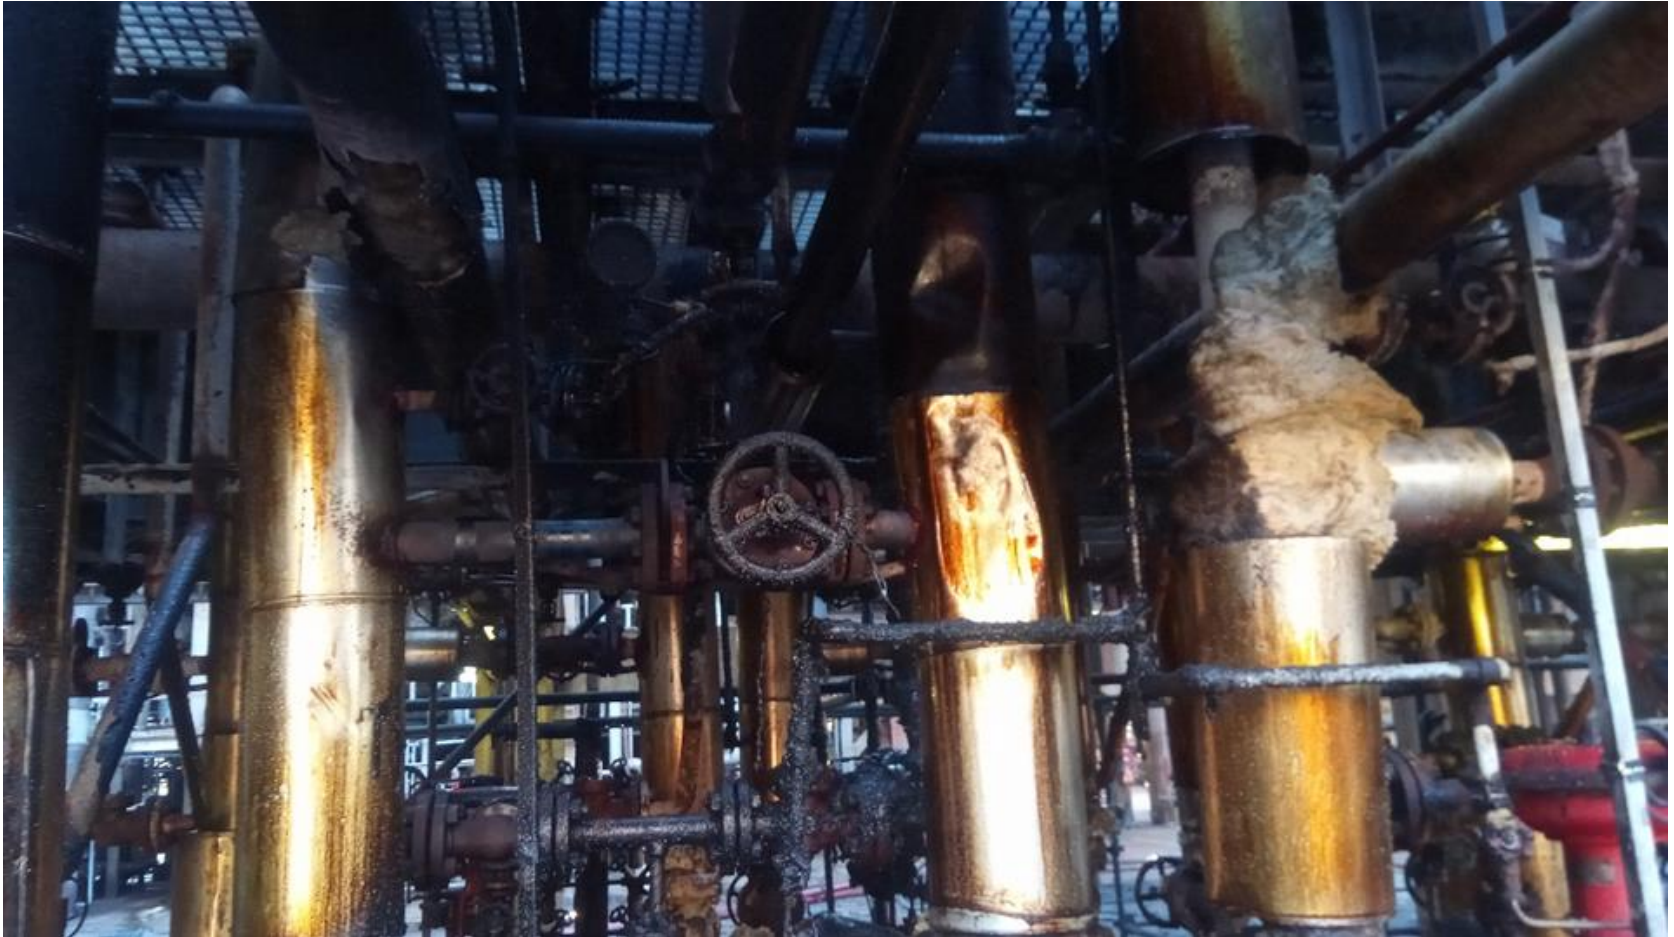
- Mechanical work was being conducted on 77FV15 (control valve) when 77FCA15 coil bypass gland gave-up and started leaking and resulted in a fire. The Mechanical team present which were also members of the Emergency Response Team raised the alarm and activated the fixed fire water monitors.

- The line was isolated and made safe.
- Around 15:30pm while conduction investigations on the scene a **second fire** (insulation) was witnessed by 2 x Electrical department personnel and 2 x Fire Officers who activated the mobile monitors that were on standby and raised the alarm, the fire was extinguished with mobile fire water monitors.

- The insulation was soaked with residue from the previous incident. A team was sent-in to remove the cladding wearing bunker gear with hand lines for protection.

- Although the initial fire was extinguished very quickly , no proper damping down was followed resulting in a subsequent fire
- All hydrocarbon Fire incidents where pipelines with cladding or vessels with cladding is impacted warrants a proper investigation of the status of the insulation before withdrawing from the incident scene
