# Incident Learning: Fire on Gasoil Hydrodesulphurisation unit

## BRIEF DESCRIPTION OF EVENT

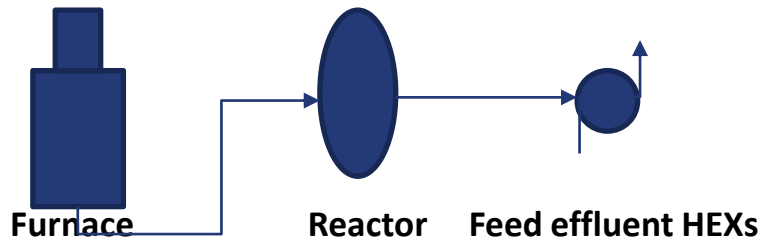
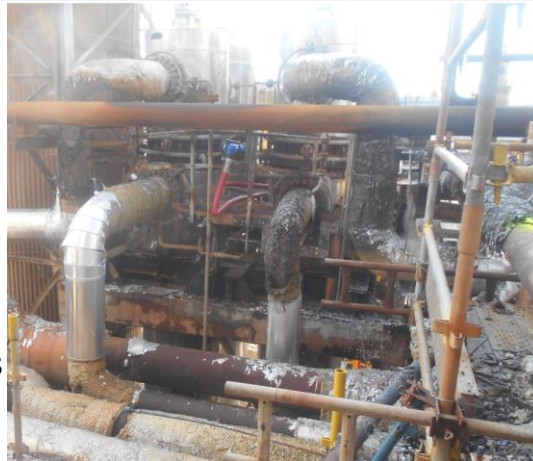
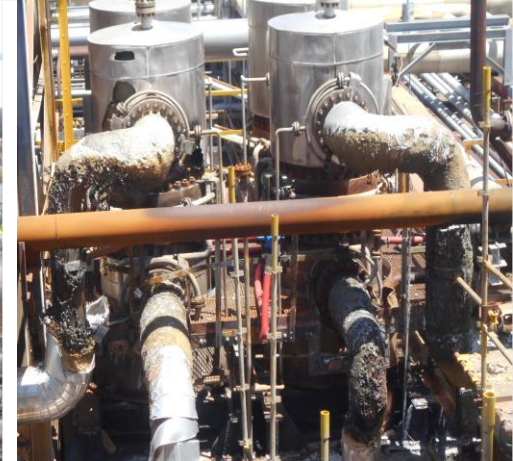
1. The girth flange of the feed/effluent exchanger, experienced a seal failure and a flammable mixture of diesel and Hydrogen was released, which ignited.
2. Piping, insulation and instrumentation systems were damaged.
3. The unit was shut down for approximately 3 weeks for repairs.
4. Incident classified as an API Tier 1 event.

- Fabricator omitted to conduct a finite element analysis, as specified by the Client, in the design of flange. A less stringent level of analysis was done. The Client and appointed Engineering contractor were unaware of this deviation.

- There was misalignment between the gasket manufacturer and exchanger Designer/Fabricator on the acceptable bolt loads for these exchangers resulting in a lower than specified torque being applied on assembly.
- Test gaskets were re-used and utilized in the final assembly of the exchanger.
- The exchanger was not tested to the correct hydro-static pressure by the fabricator, and field test was waived.
- The Client and engineering contractor were unaware of these deviations by the Fabricator.

- The unit experienced several upsets and trips prior to the flange seal failure.
- The upsets resulted in thermal cycling/shocks to the exchanger which exceeded recommended operating windows.

- Design guideline for special application flanged joints is to be developed and rolled out.
- Project Quality control and handover procedures to be enhanced to incorporate additional assurance steps specifically related to gaskets, bolt tension and joint load verification.

- A Client organization structure to strengthen QA/QC oversight over design and fabrication to be put in place.

- Operating procedures and systems be strengthened to ensure operating windows are adhered to during start up for HDS units, and recovery from upset conditions.
