# What happened?

An instrument impulse line of a flow transmitter was repaired and three weeks later the impulse line dislodge from a T-piece in the system releasing a mixture of hydrogen and diesel

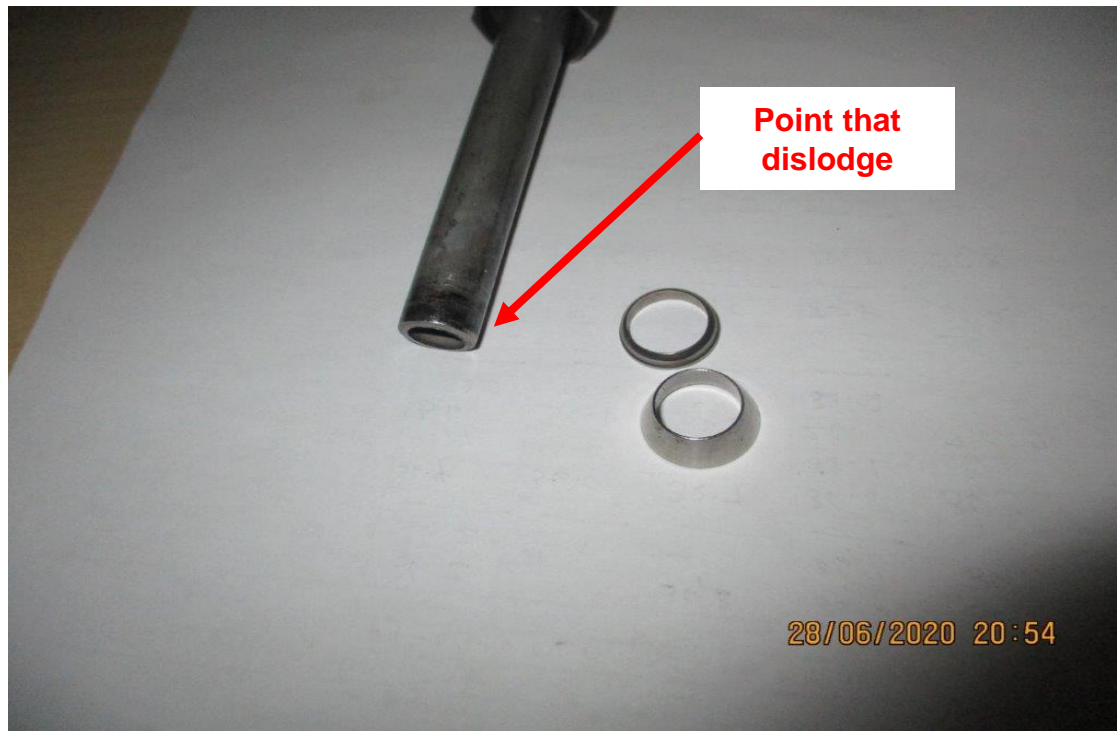
- The flow measurement system was replaced as part of the ESD replacement the previous shutdown.
- Repairs was done  $\pm$  3 weeks prior to the incident.
- No QCP was followed to confirm that the repairs was done properly.
- The impulse line was too short to ensure completeness of box-up

- QCPs to be develop and used for repairs to impulse lines
- Training of artisans regarding impulse lines standard to be of a high quality
- No spot checks done on repair work by supervisor
- All work done by the artisan in the past six months to be rechecked
