# What happened?

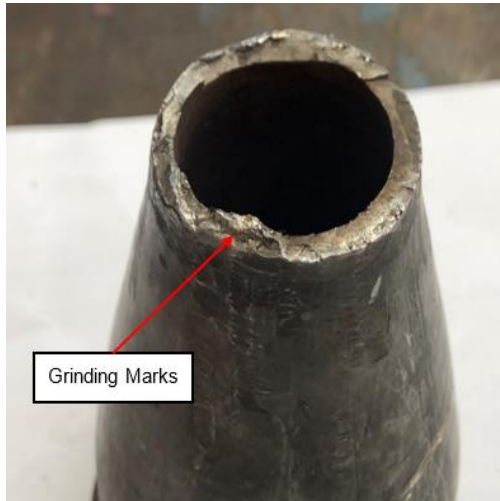
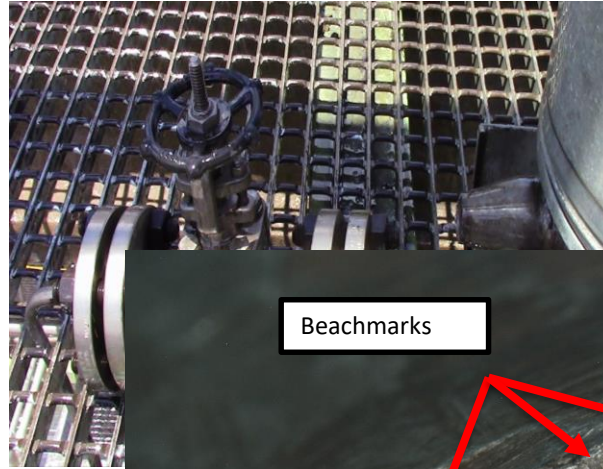
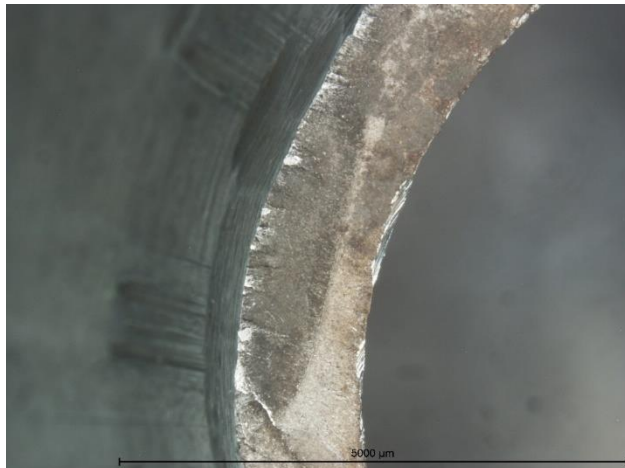
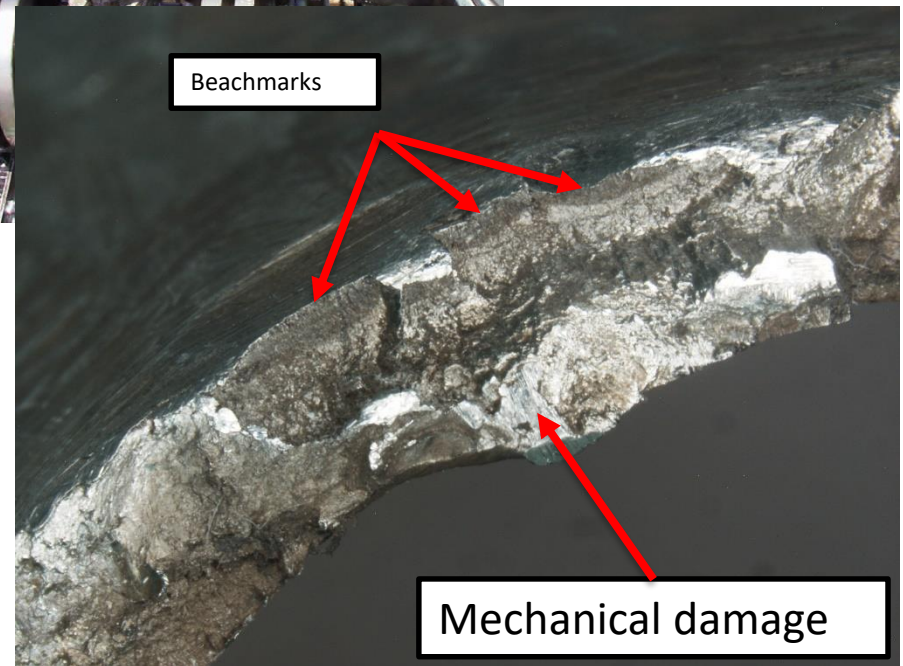
# Photos

- Stabilised Light Oil (SLO) unit lost feed from Tank Farm due to the feed pump that tripped.
- The secondary pump at Tank Farm, was started.
- The feed to the unit was restored, but at a higher pressure and flow relative to normal operations.
- Approximately 20 minutes later SLO was released from the feedline when the 1" stub broke off from the reducer where the pressure transmitter is connected. (15 ton of SLO was released)
- The SLO sprayed into the pipe rack and across the road 5 into another unit.
- Emergency Services responded when the alarm was activated.

- Spec breaks in pipeline not without pressure protection, credit for pressure protection on feed drum
- Inadequate pressure control in unit, control the incoming feed pressure manual with a level control valve
- PSV sizing and installation, gaseous service PSV installed in liquid service, place of installation
- End of job documentation not available after expansion project
- Trips to active at all times, high pressure trip was never commissioned during installation
- Procedure to provide line of sight when feed fall away not available
- Communication channels to long
- Risk studies to be done with upstream & downstream parties involved
