# Incident Learning: What happened?

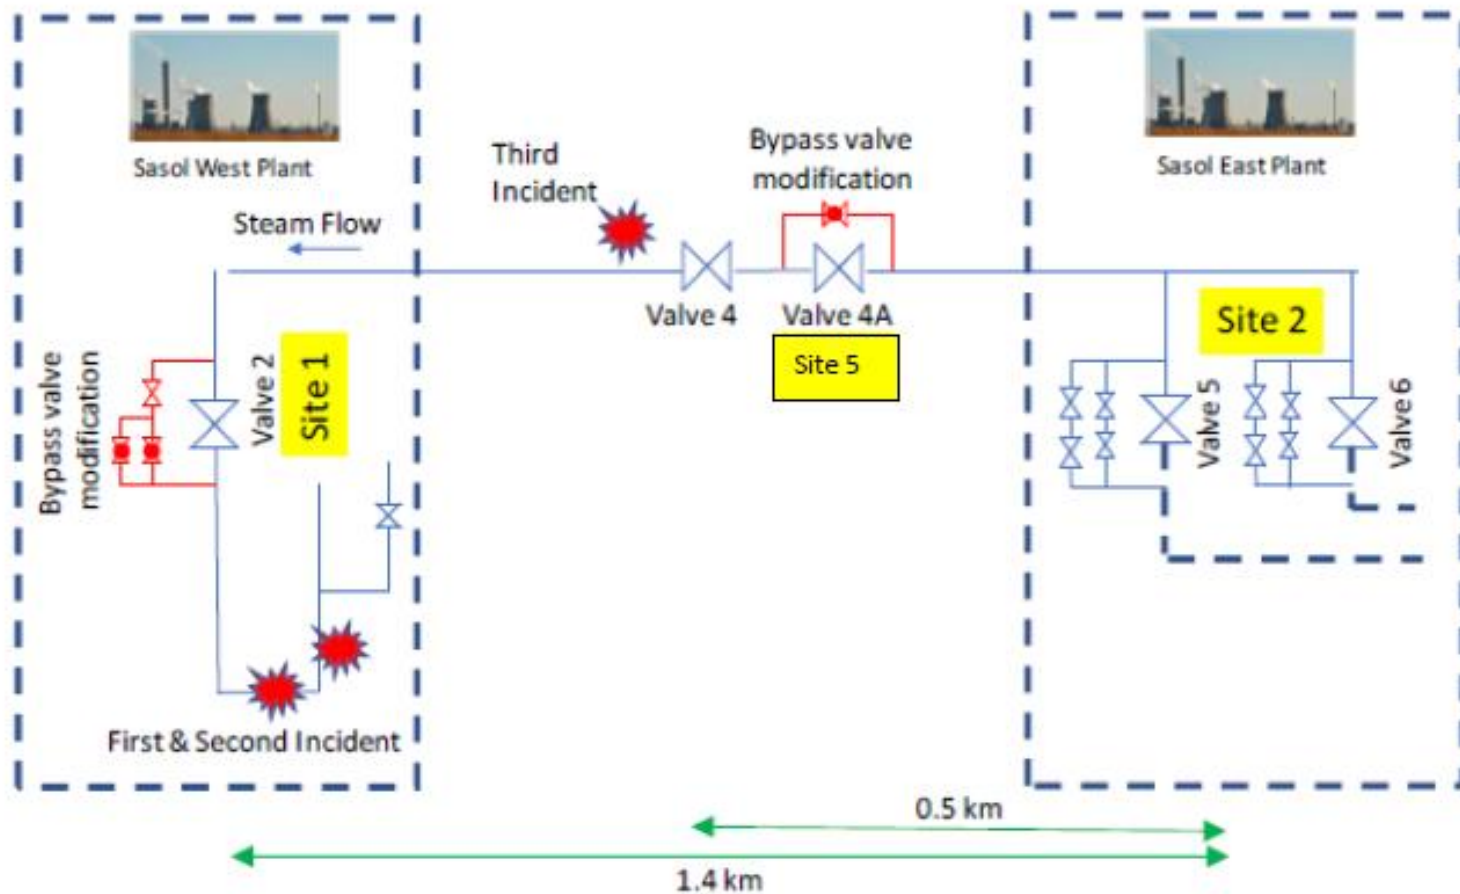
- After installing the new inter-transfer isolation valves on the 40 Bar steam transfer header, the system was started up by using the new warm-up bypasses.
- During this time a number of small bore items broke off resulting in the shutdown of the system.
- After two unsuccessful attempts, it was then decided to warm-up using the existing system at Site 2.
- No vibrations were noted. Even though the header was finally warmed-up and started, these new isolation valves need to be used in future (to allow for isolation of the header for inspection or future tie-ins), therefore it is imperative that a permanent solution is established.

- A lack of experience and awareness of the Acoustic Induced Vibration phenomenon in steam system.
- A lack of experience and awareness on large and complex steam system start-up.

- Gaps in specification it did not specifically identify AIV phenomena, it only talks about vibration in the context of steam collapsing/water hammer.
- The specification only noted a single bypass which is not consistent with existing bypass arrangements.
