# What happened?

## Event:

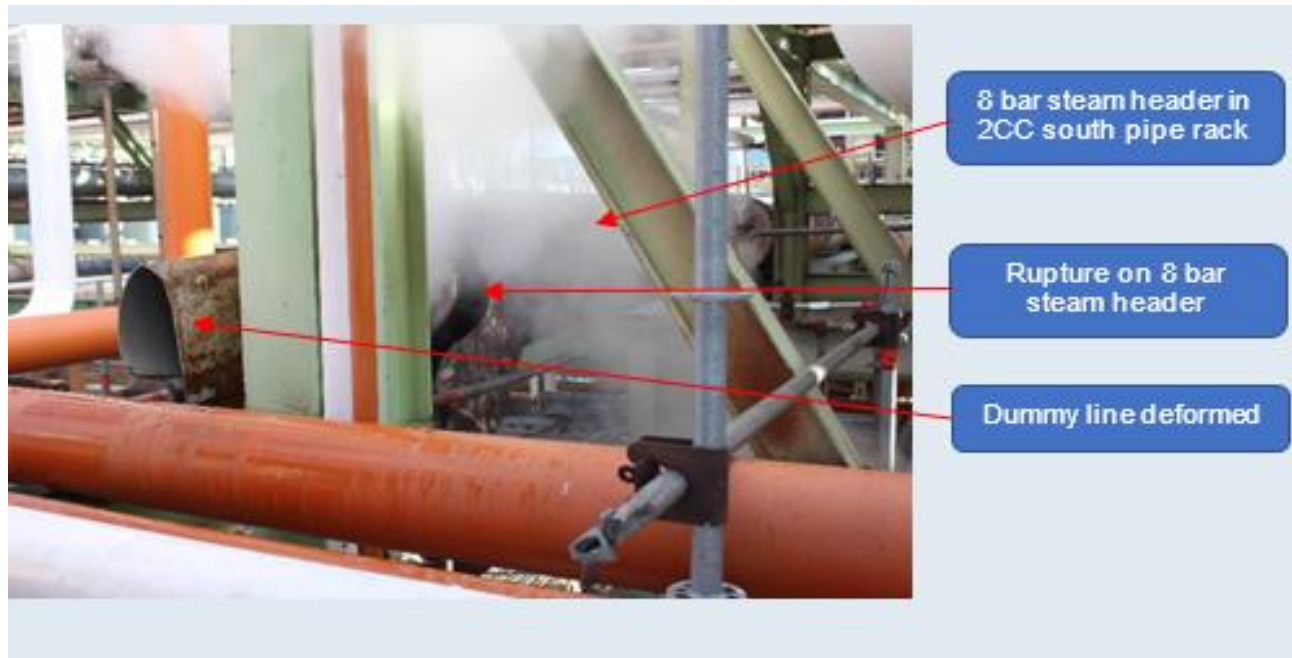
8 bar steam line ruptured due to water hammer due to malfunctioning of the steam trap. Injuries were sustained during evacuation while running away from the incident area.

- Steam trap on the decommissioned phase was not functioning. This created a dead leg.
- The current philosophy on steam traps regarding reporting of defects, maintenance strategy and operating philosophies is inadequate
- There is no management system or philosophy in place to collate information on steam traps from different sources (e.g. trends bad actors, heat maps etc.)

- Ensure that the impact of “dead legs” is well understood and the impact this can have in steam systems during decommissioning is well mitigated
- Understand the importance of steam traps and the subsequent maintenance and inspection regime adopted
- Collation of information from different sources and analysis of this information for trends bad actors, heat maps etc. is critical to ensure that the correct decisions are taken
