# Sasol Secunda Operations

## Learning: Loss of containment of steam

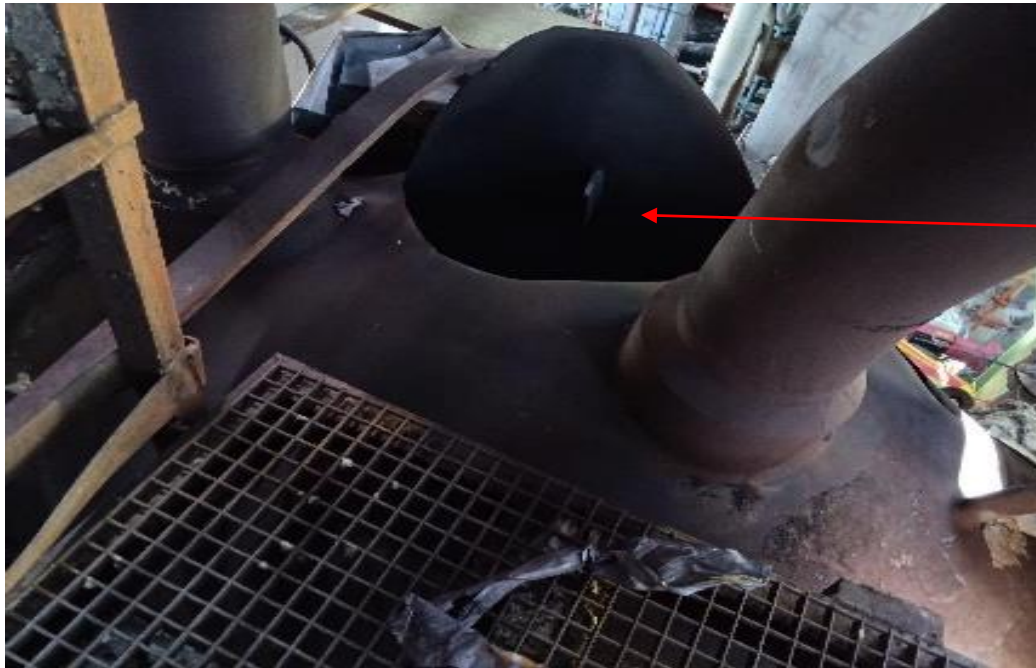
A waste heat boiler shell ruptured (fish mouth) due to high temperature (lack of cooling medium) which resulted in the release of 43bar steam to atmosphere.

Because of no boiler feedwater flow on the waste heat boiler shell side, the temperature of the steam inside the shell increased to above design temperature, weakening the shell, and resulting in the shell to rupture and release steam.

Waste heat boiler shell ruptured due to operating above design.

Level transmitter zero error due to a combination of dilution, liquid loss in all four wet leg AND low trip point (not adequately allowing for measurement error)

- Always ensure that the wet leg are verified frequently to prevent loss of liquid:
  - Process upset have a potential to displace wet leg (medium or filling liquid) and if no action is taken there could be a significant impact on the level transmitter zero error. This could provide false indication to the operators and prevent low level trips to activate.
- The set point for trips and alarms must be set with adequate safety margins to cater for instrument inaccuracy and errors or drift between calibrations.
