# ***TIER 2 INCIDENT***

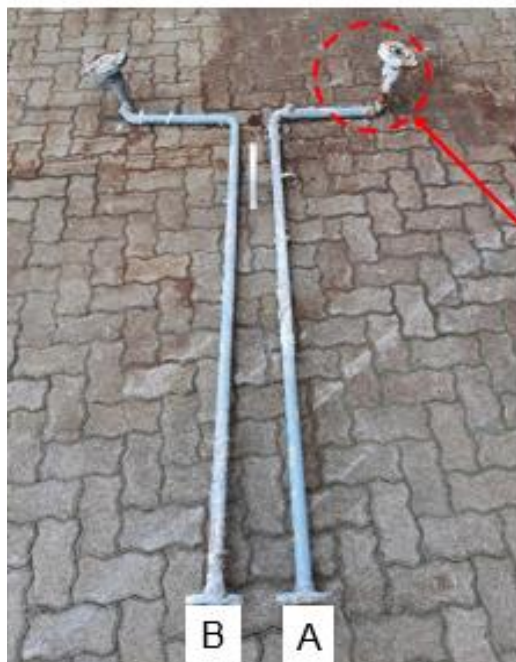
The affected area of suction line A had multiple pinholes and external coating failure.

- **Design incorrect** - The material of construction, size and number of bends not being suitable for the application.
- **Inadequate procedures or methods** - Failure to act on concerns raised in the HAZOP

- **Maintenance System, insufficient troubleshooting, detection, monitoring or inspection** -The maintenance activity on these group of lines were visual inspections and x-rays which were conducted only on the discharge lines and not on the suction lines. Not sufficient to prevent a failure on these lines.

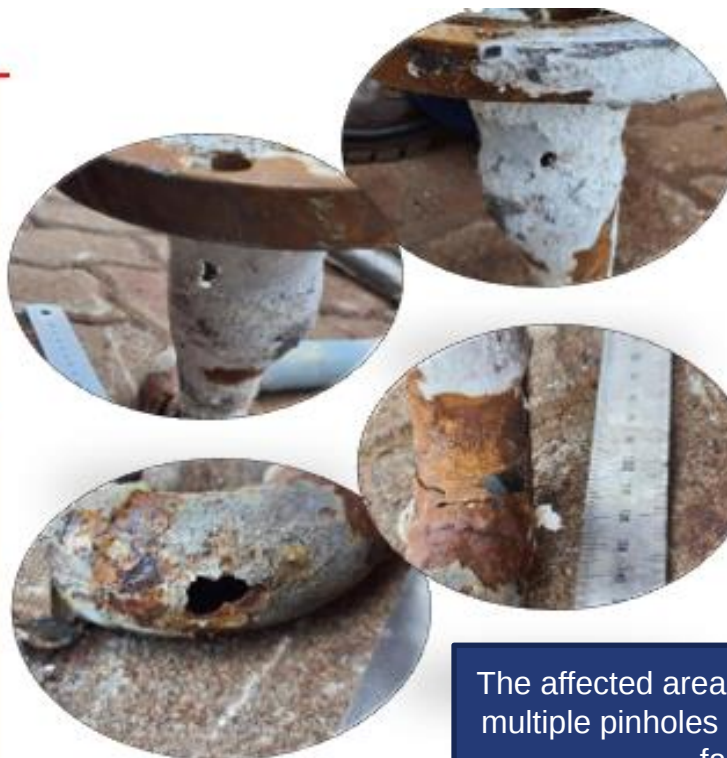
The excessive wall loss on the elbow could be indicative of localized increase in velocity/turbulence leading to accelerated corrosion.
