# LFI: Pinhole Leak on Landed Condensate Line

# PetroSA LFI: Pinhole Leak on Landed Condensate Line

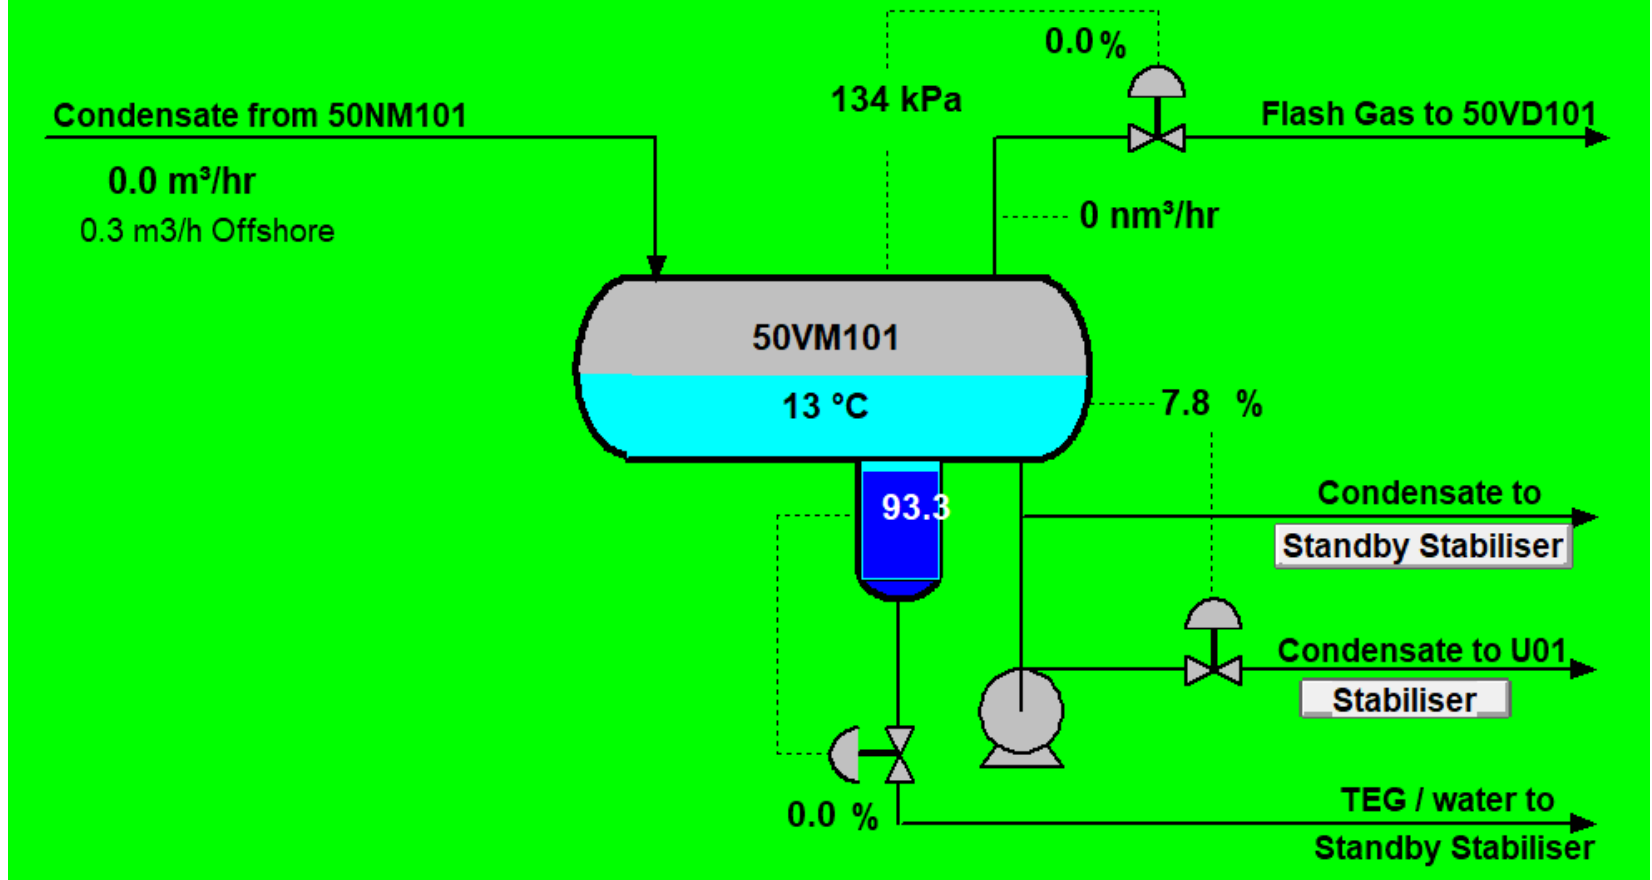
## Three Phase Separator 50 VM101

- The problem at VM101 is the water overflows the drain and goes to deck. Fumes/condensate then trigger the gas detector. The problem is not 50VM101 or the boot, but the flow regime in the condensate line. At times we get water slugs, and other times we get condensate slugs. This disrupts the residence time required to properly separate oil and water, causing water exiting boot to contain hydrocarbons

| | Action | Responsible Task Owner | Due Date |
|---|---|---|---|
| 1 | Initiate a TJR to review the draining from 50VM101 boot to nearby drain instead of deck (review line size). | AGS process engineer | 30/09/2021 |
