Dispenser fire  
incident at bp  
Mabopane  
forecourt on  
07 February  
2022

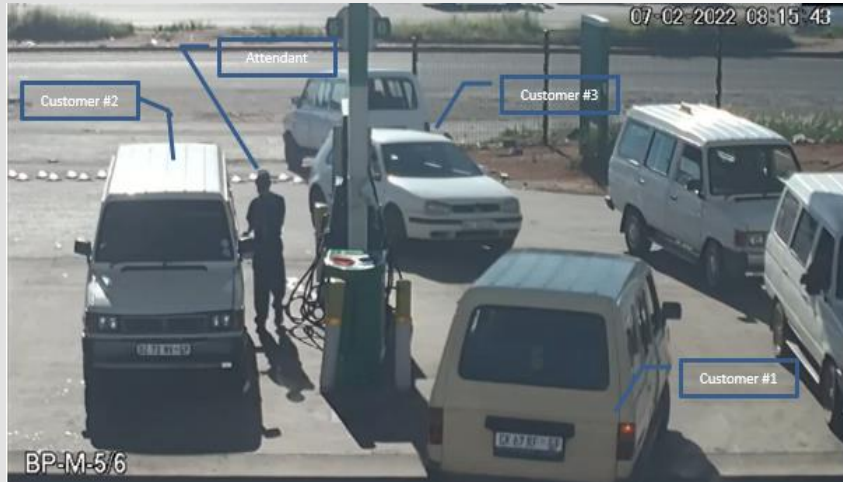
1. Customers #1 and #3 competed to get to the pump first.

2. Customer #1 Maneuvered to the left at an angle and collided with the pump to avoid colliding with customer #3.

3. Customer #1 knocked the dispenser with his vehicle's left side corner light, breaking the ULP 95 hose's safety swivel breakaway coupling and all three product (ULP 93,95 and Diesel 50) shear valves underneath the dispenser riser resulting in LOPC.

4. The spilled product from the hose and nozzle was immediately ignited by customer #1 **vehicle's energized light bulb** which broke off on impact causing electrical short circuit.

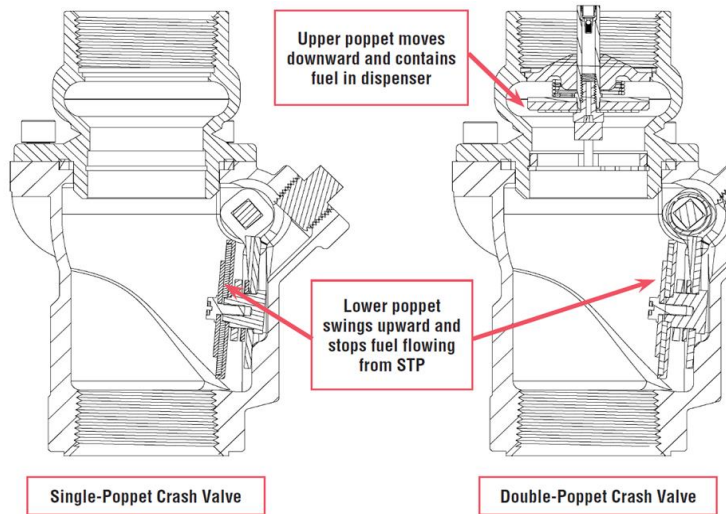
2. Fuel from the dispenser riser and filters spilled into the sump when the single poppet shear valves broke. This resulted in the flash fire which started outside of the dispenser to develop into a pool fire underneath the dispenser sump. That is because a single poppet shear valve does not stop the reverse flow from the dispenser side when it shears off.

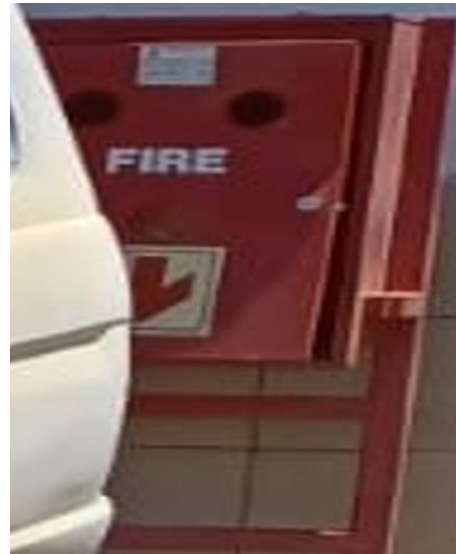
3. Progressing of flash fire to a pool fire was not timely stopped due to first responder's struggle to break the glass to access the keys for the fire extinguisher cabinet. This was because the cabinets doors were damaged providing very little resistance to be able to break the glass

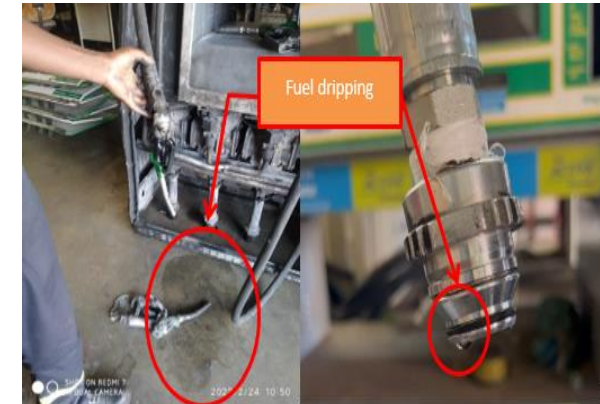
4. There was a continuous drip of fuel from the hose end which kept the flame burning after it was initially ignited during the first flash. This was because the in-line valve of the breakaway coupling did not fully seal off the fuel from the hose when the hose and nozzle separated upon impact. The swivel integral valve was mechanically damaged during the collision.
