**FUELS INDUSTRY**  
Association of South Africa

# LEARNING FROM PUMP SEAL FAILURE INCIDENT

2024

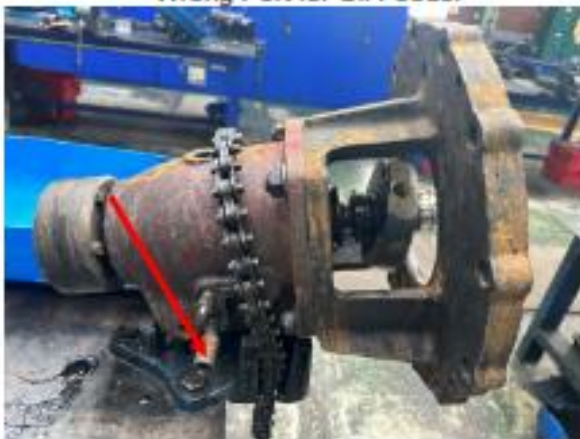
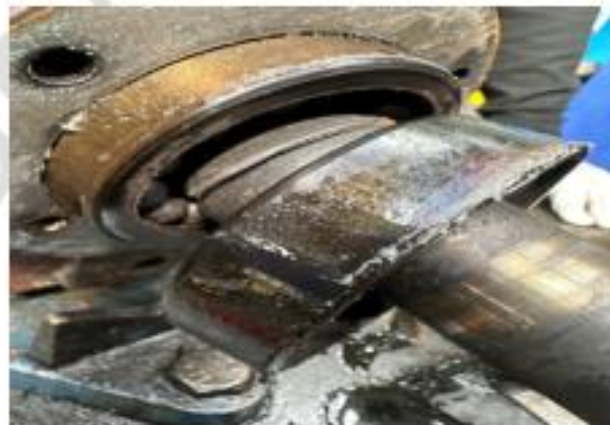
Wrong Port for Oil Feeder

- It was found that bearing failed catastrophically with a severe impeller damage.
- Drain nipple was installed on the top oil supply port whereas the constant oil feeder was installed at the bottom port for drain purpose.
- Then plant maintenance personnel assumed that the nipple was installed correctly.
- This means that the bearing didn't have sufficient oil for lubrication.

- Ensure that QCP is available before assembly and installation of pumps.
- Oil feeder to be verified and installed in correct location.
- No plugging to be done on oil feeder port.
- No swapping of impellers to be occurred on different volute casing.
- All impeller assemblies to be balanced before installation.
- Inadequate rotating equipment skills for some mechanical artisans regarding pump lubricating system on single stage pumps

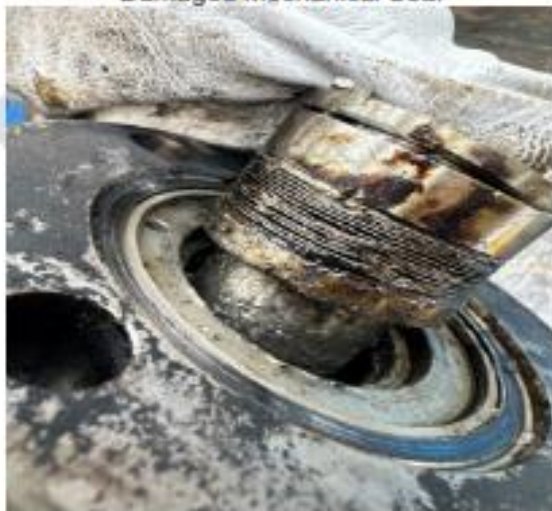
Damaged Mechanical Seal

Inadequate bearing lubrication result in the failure of the bearings with resultant mechanical seal failure.

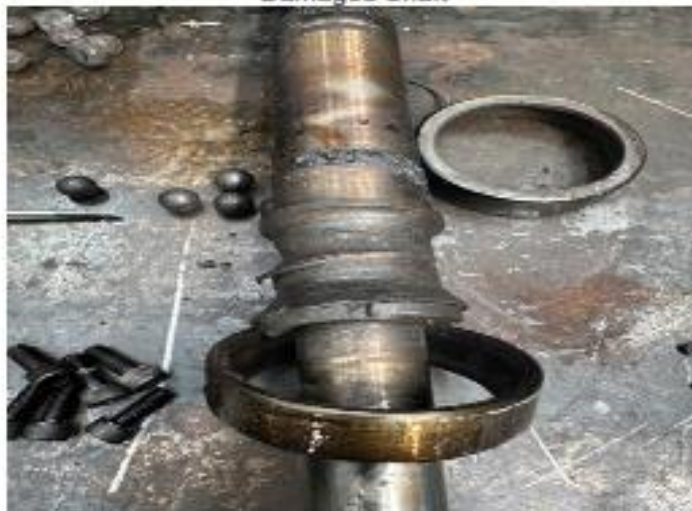
Damaged Shaft
