**FUELS INDUSTRY**  
Association of South Africa

# LEARNING FROM PUMP FIRE INCIDENT

2024

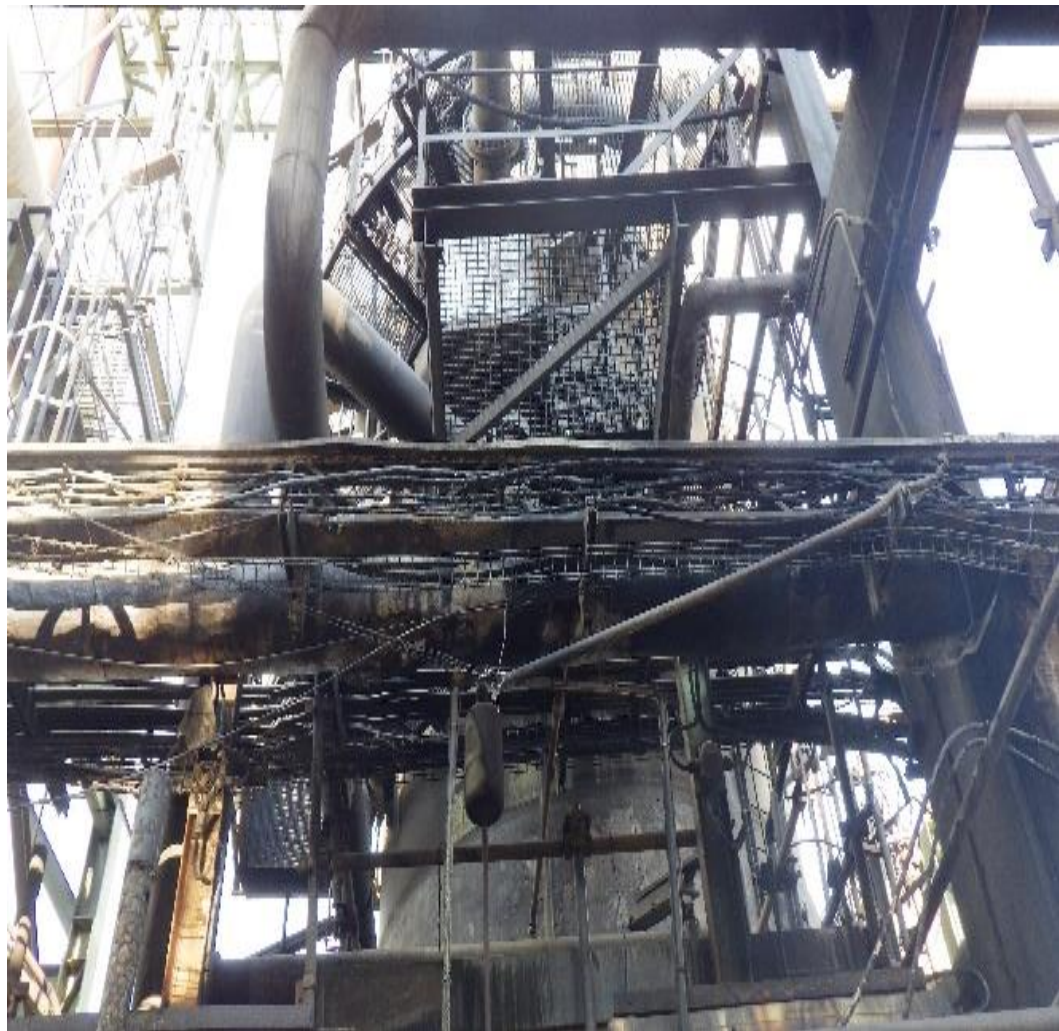
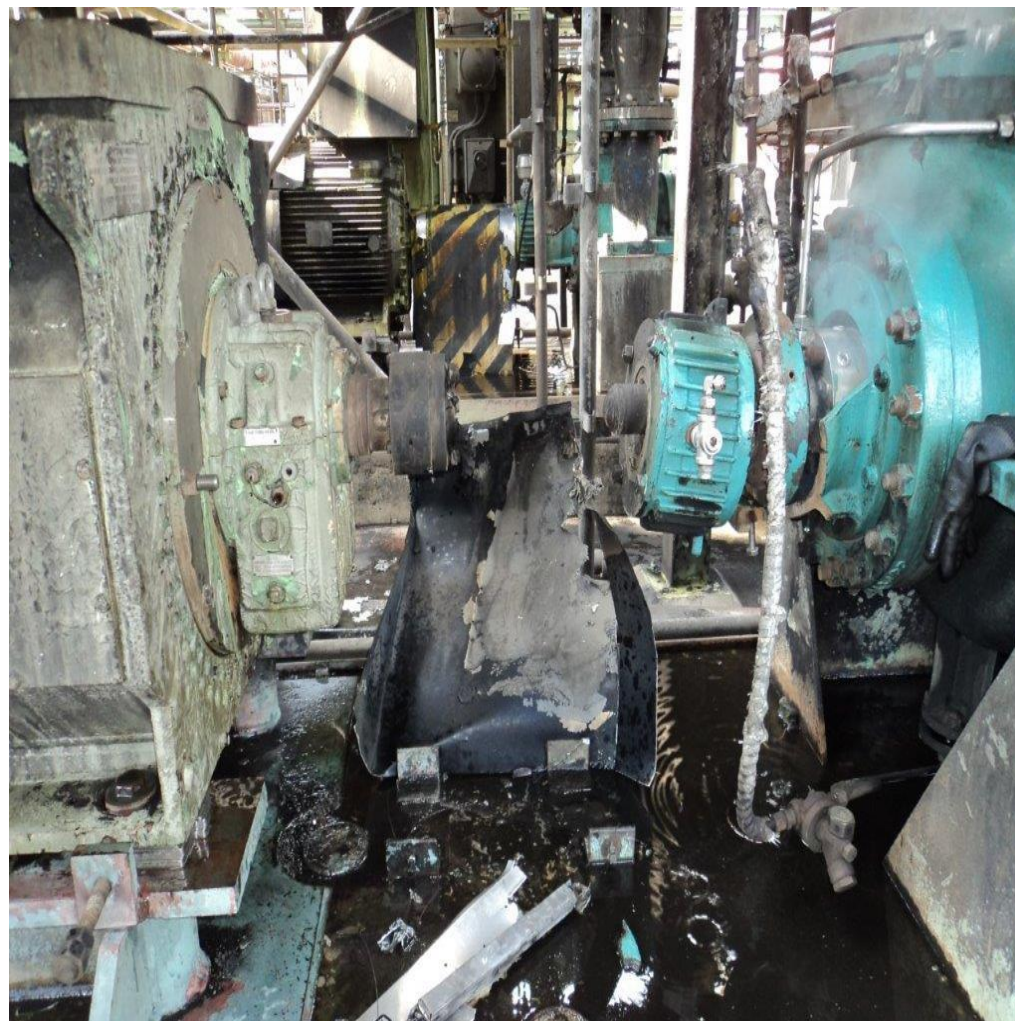
- The shaft failure of a pump resulting in mechanical seal failure and Un-stabilised Light Oil (ULO) to released from the pump mechanical seal and ignited at the recycle pump. Extensive damage resulted due to the incident as the there was scaffolding build over the pump which made it difficult to extinguish the fire. The process alarms was ignored by the process controllers.

- Insufficient tightening of the cap screws to ensure proper tightness of the taper coupling hub (Keyless type hub) to shaft to prevent slippage.

- QCP less than adequate. QCP did not include critical torquing parameters as per coupling hub specification.
- MOC process not followed for changing from OEM to non-OEM hub design

- Ensure that the deluge nozzle spray path remains unobstructed during routine maintenance activities e.g., scaffolding erected for maintenance activities.
- Consider/evaluate undercurrent protection on pump systems where required.
- Always take appropriate action when annunciator alarms are activated.
- Ensure daily inspections (check sheets) are adequately performed by maintenance and production.
- Ensure torquing of coupling hub bolts with torque wrench as per supplier specification and that the requirements are incorporated in the QCP.
