# Incident Findings

## MEK Fire Incident (29 April 2025)

9 May 2025

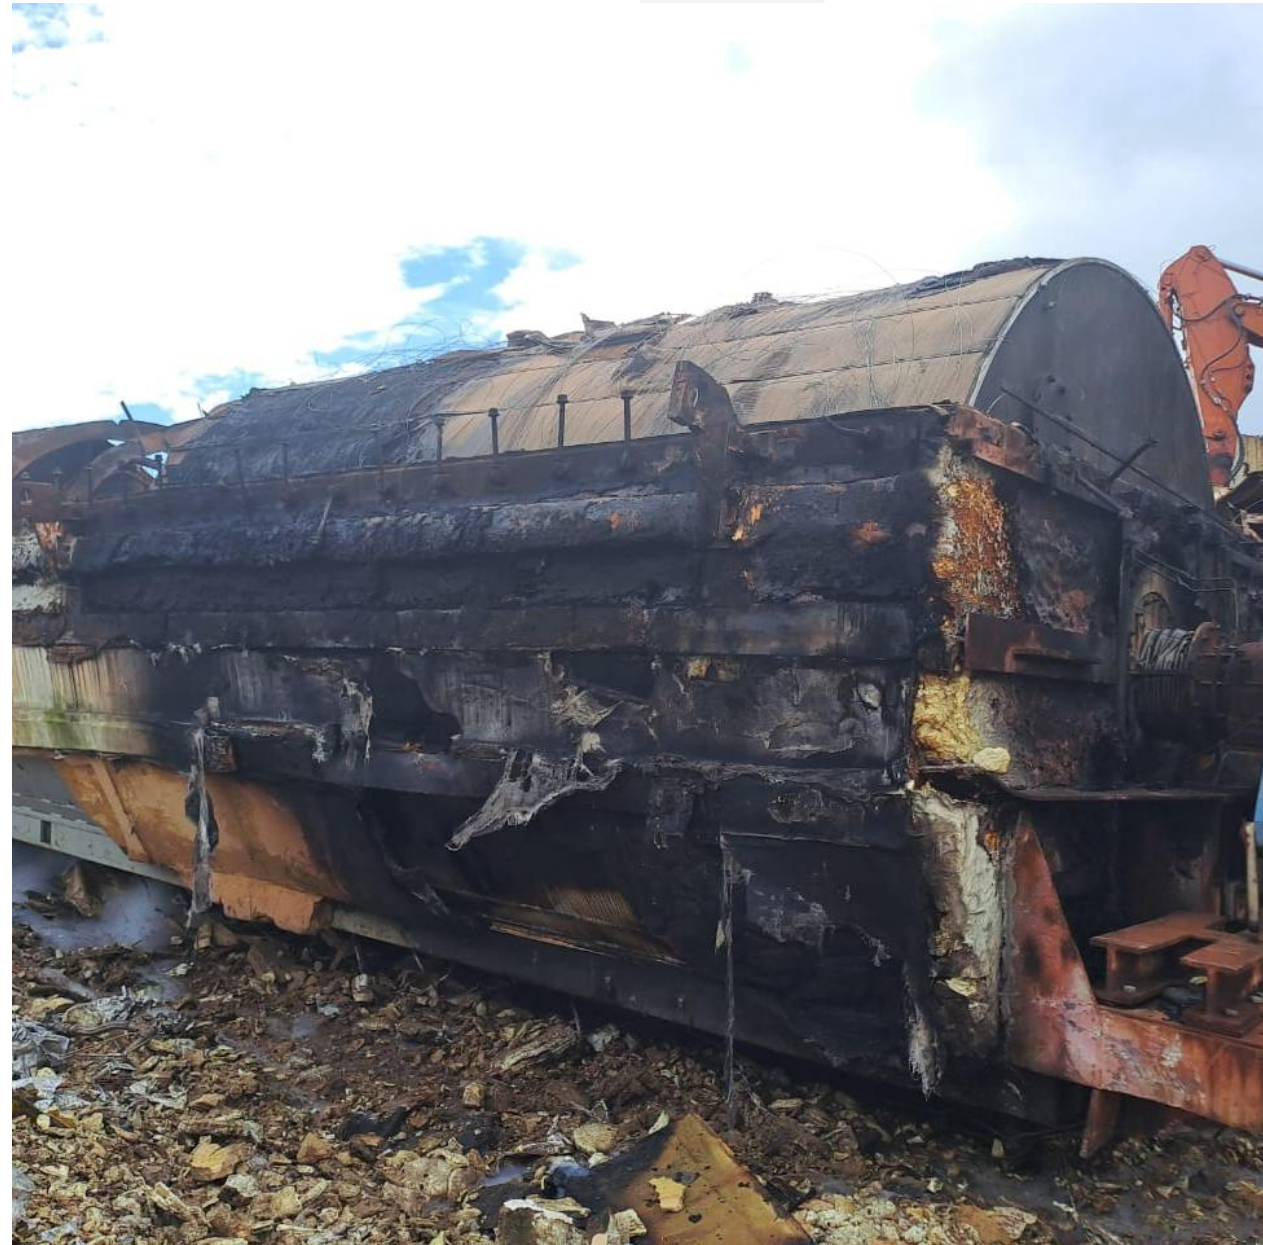
On the 29 April 2025 at 16:05 , during the demolition activities at SAFOR, at the MEK (unit 4) a flash fire occurred while downsizing a drum filter (D40103). The demolition excavator operator was sectioning the drum with a hydraulic shear attachment, when he identified smoke emitted inside the internal drum of the vessel. After lifting the drum with the hydraulic shears for further inspection a flash fire occurred. The Engen Fire Department was notified and extinguished the fire.

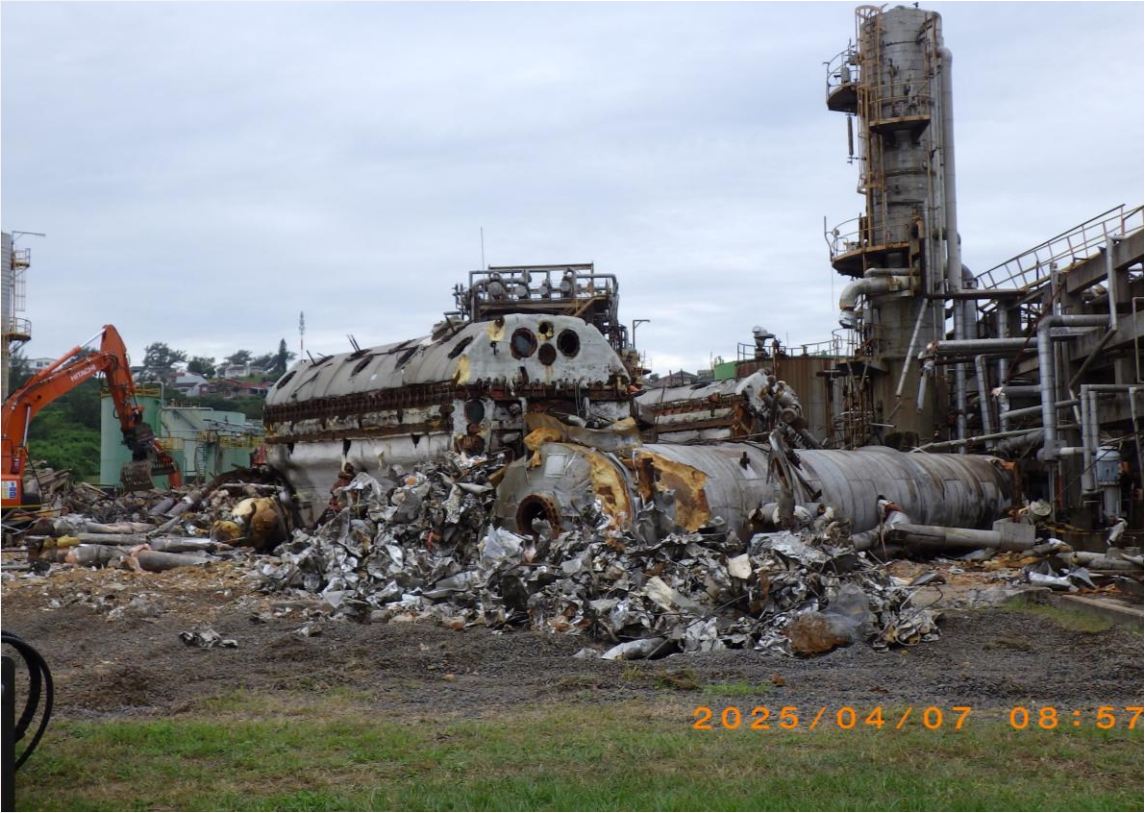
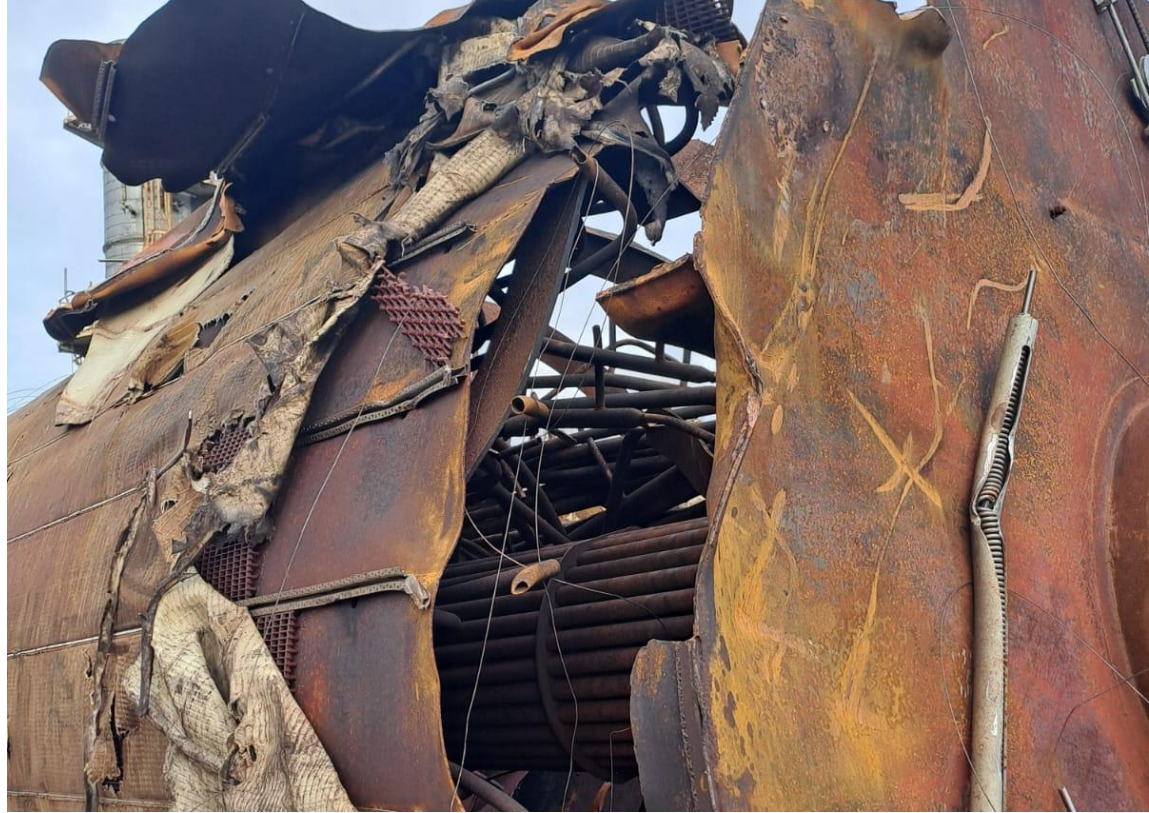
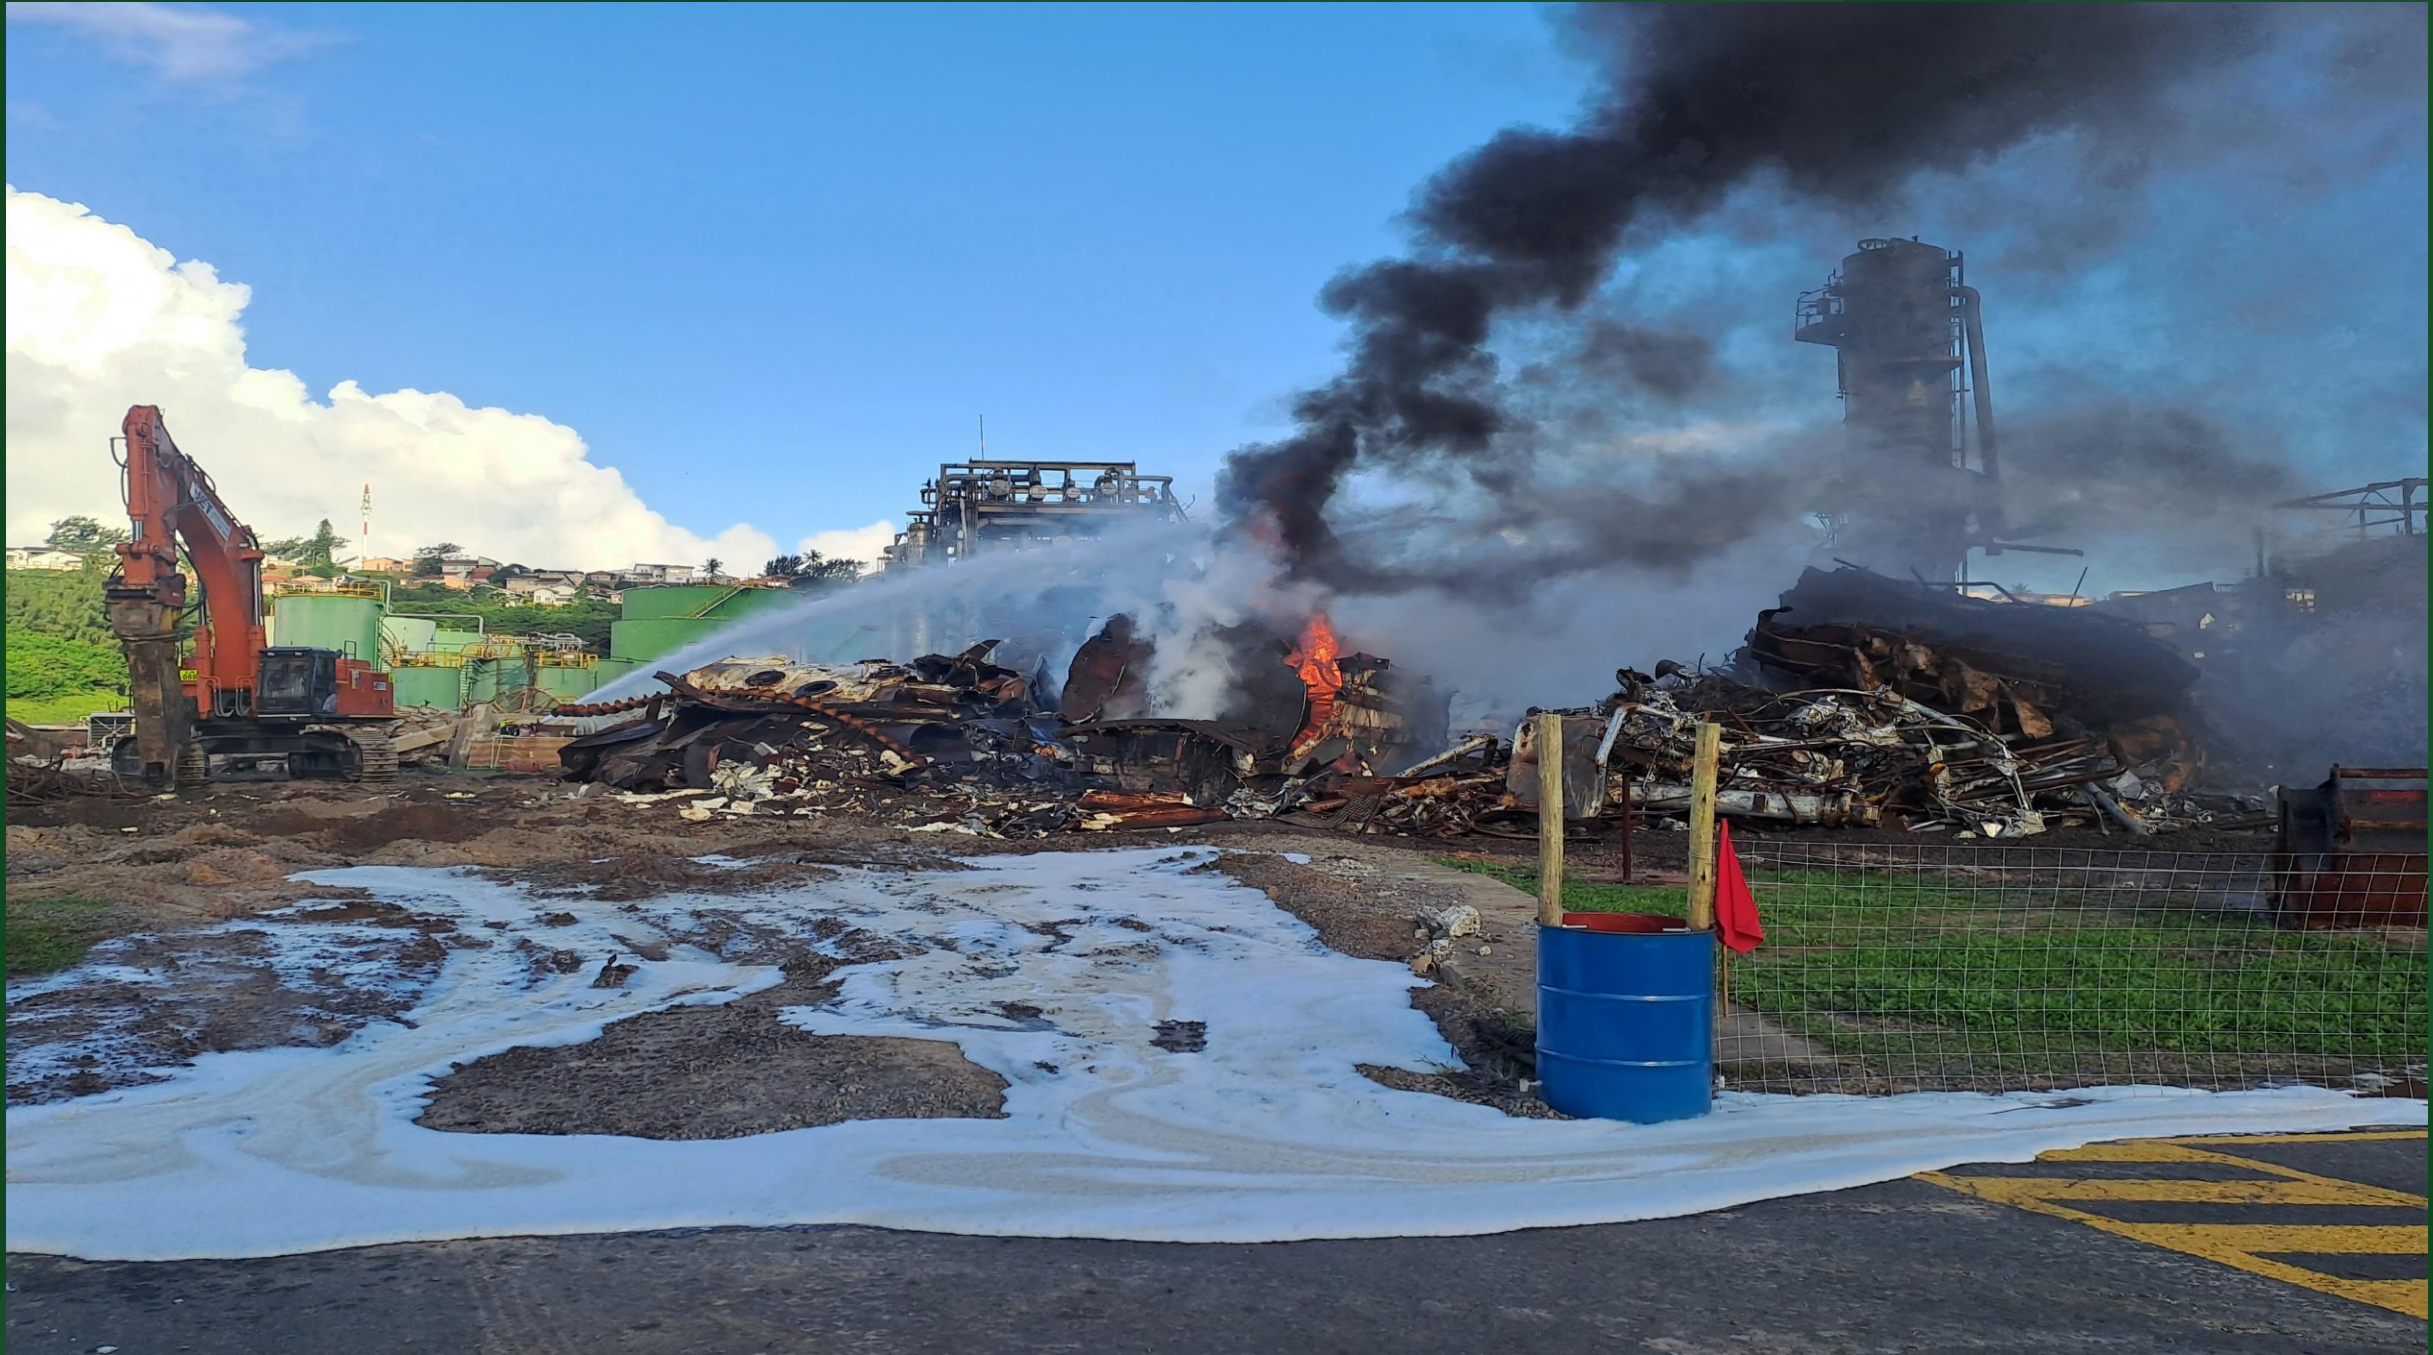
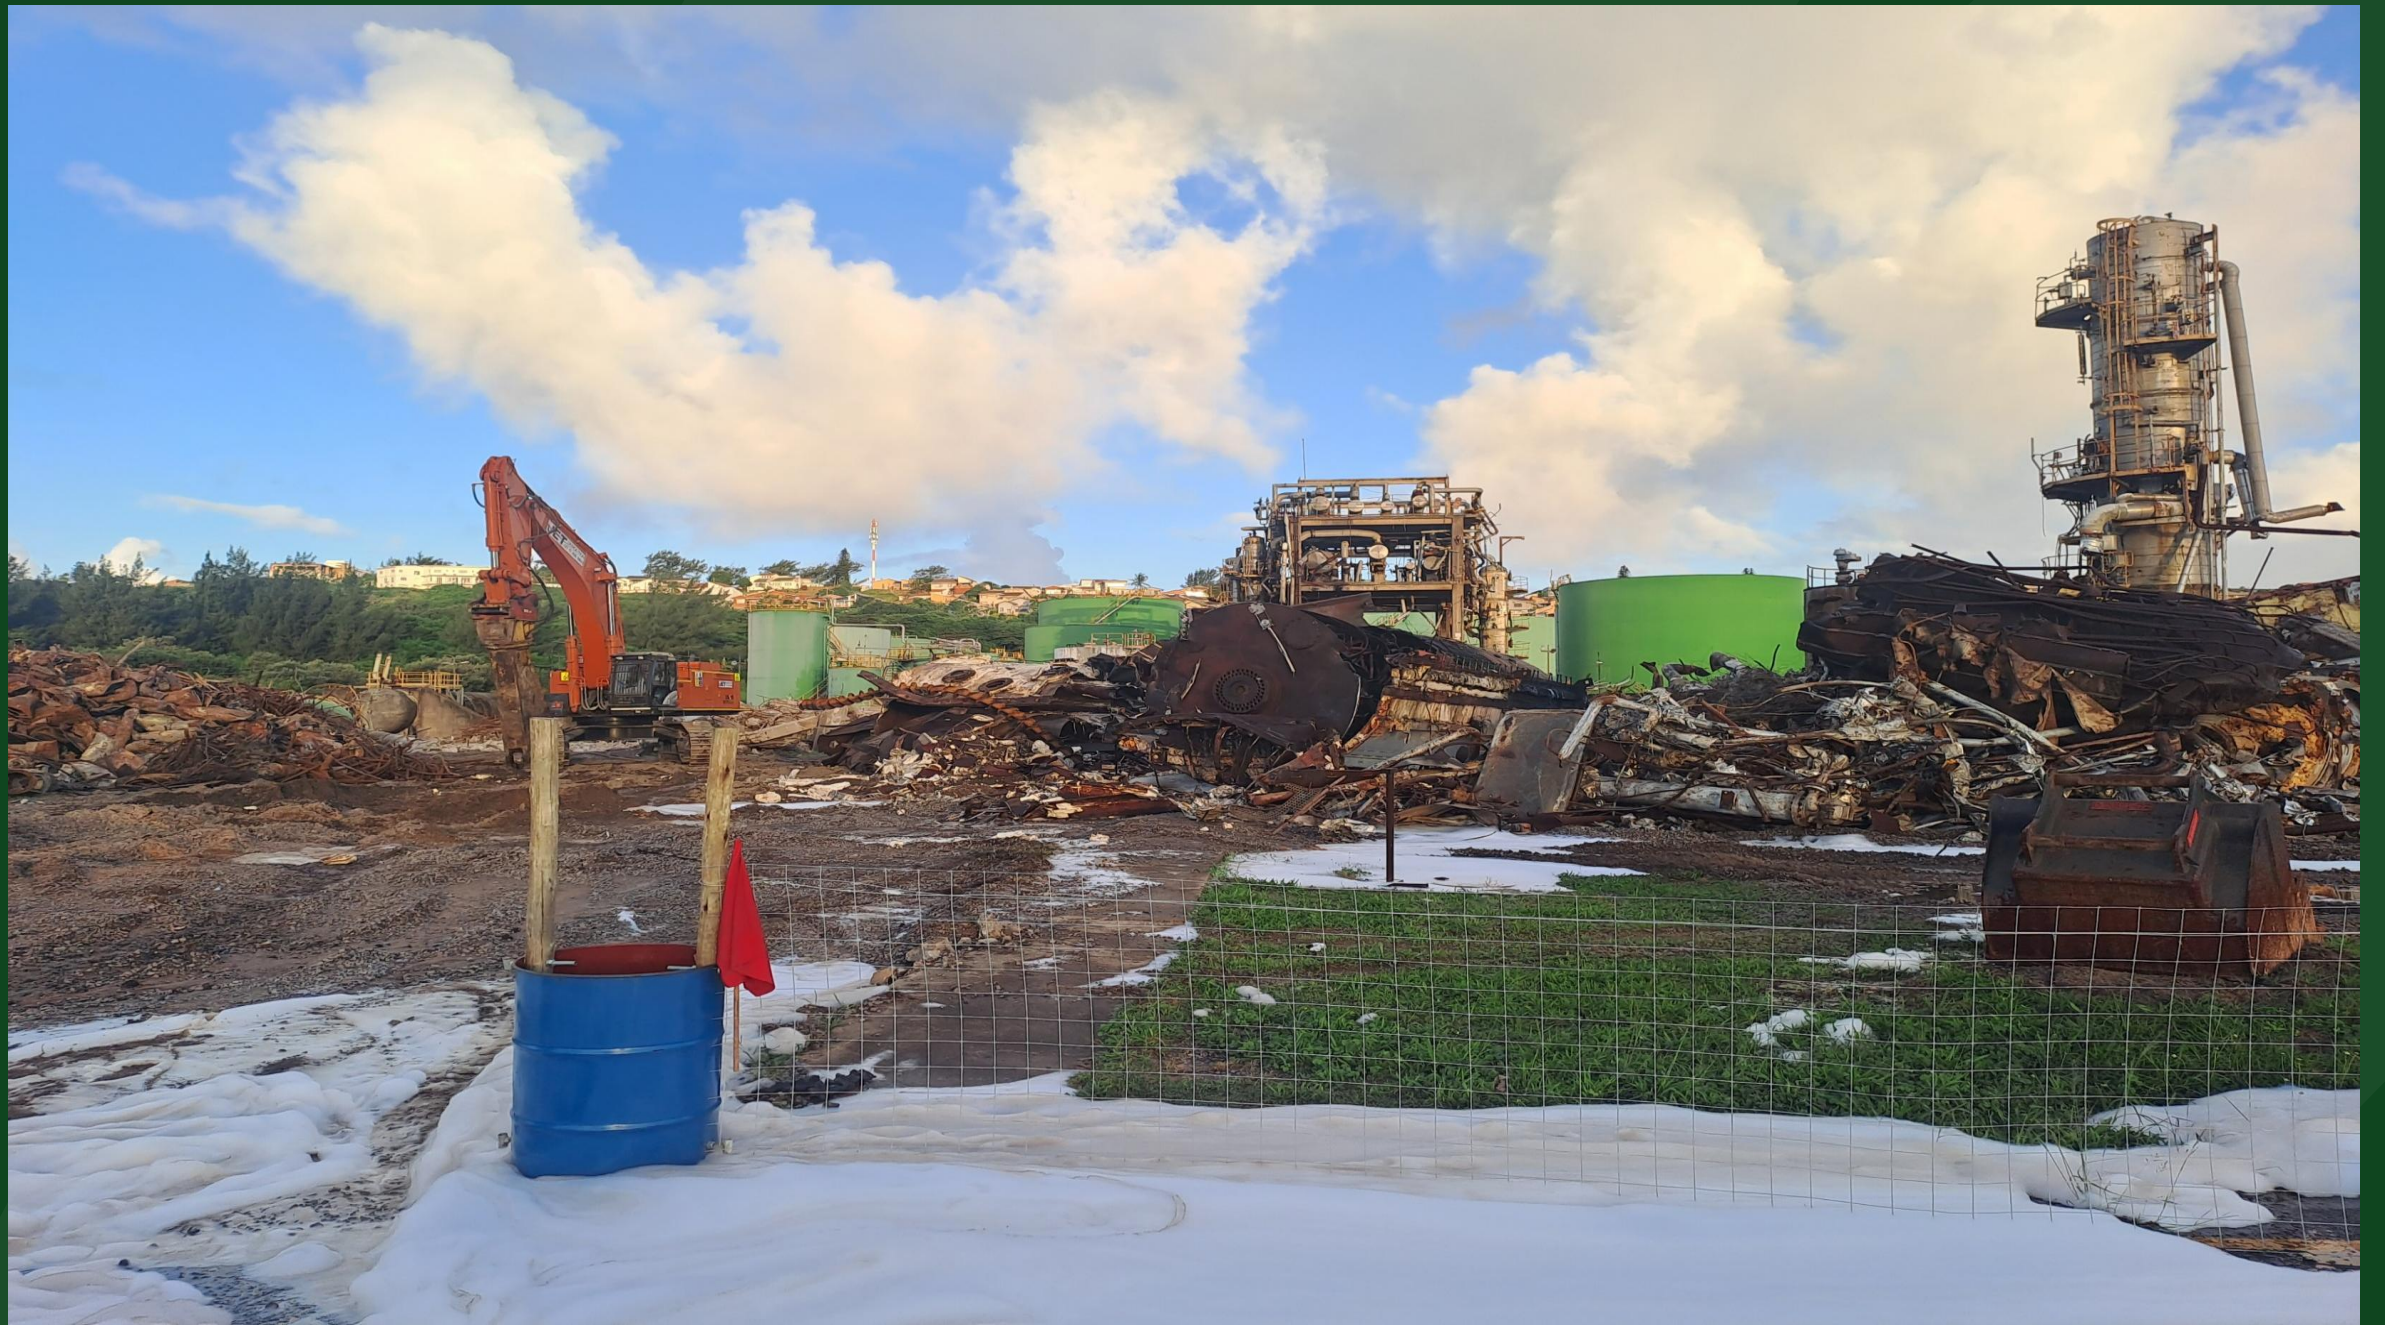
# Drum Vessel Internals & tubes exposed after downsizing the outer vessel

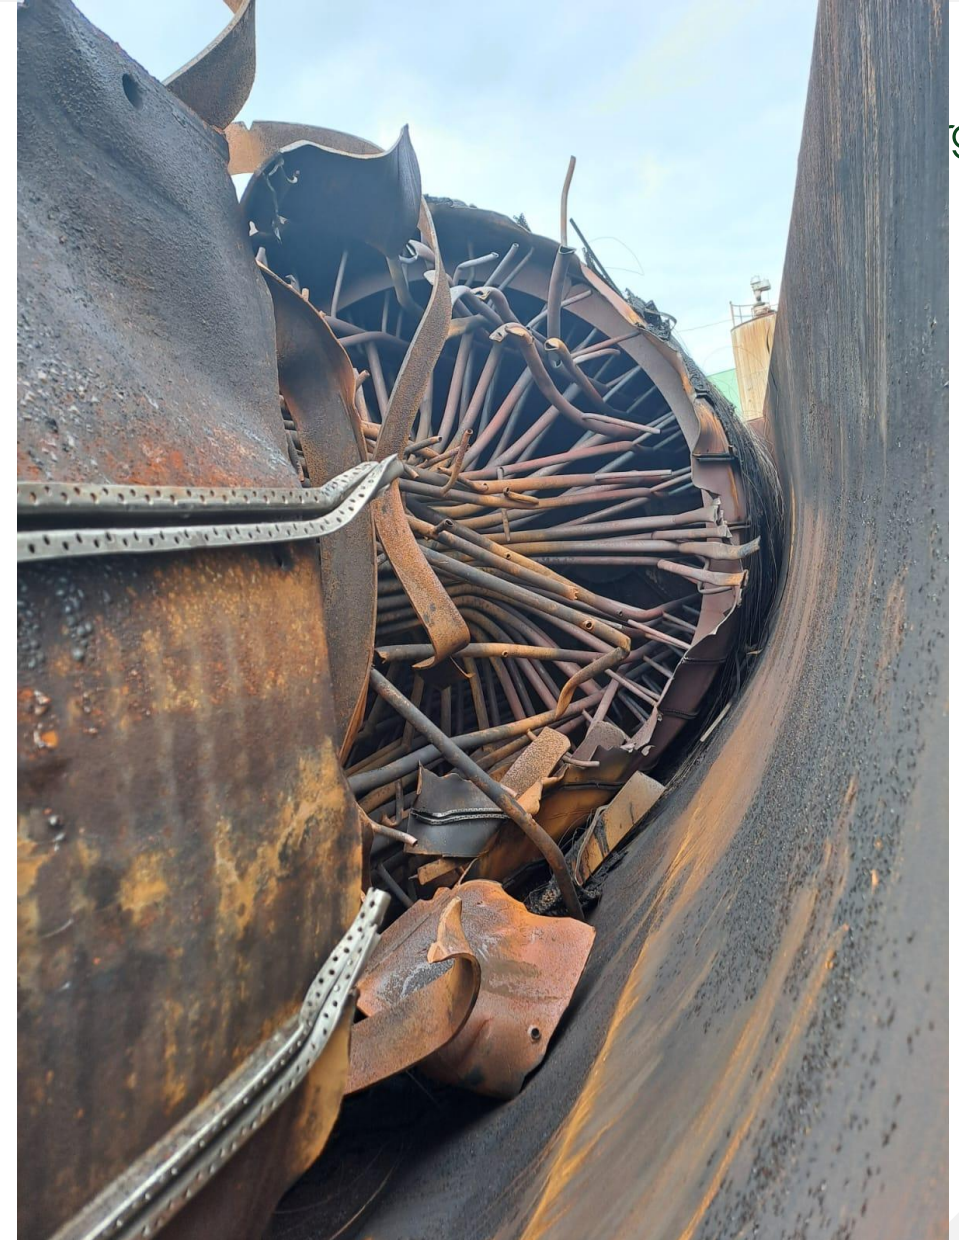
# Presence of solvents in the drum filter

It would not have been possible to completely deinventory and clean this drums (D40-103). The likelihood of solvents in the tubes due to

Not easy to flush and perform an effective steam out(due to configuration of the tubes)

Process upset (ie filter cloth torn, wax ingress)
