# NATREF SHE INCIDENT ROOT CAUSE ANALYSIS REPORT

21 March 2025

**EMERGENCY  
SERVICES**

LOC Burst Battery

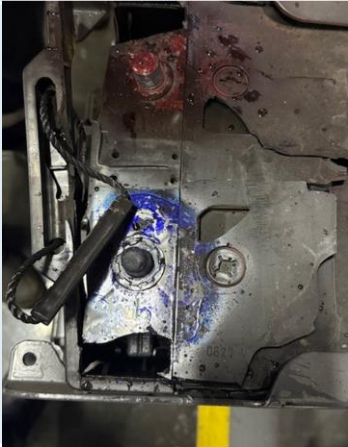
| Description | Battery on Sides Fire tender burst during shift hand over while vehicle was been started. |
| Consequences | Damage to battery and battery cover |

Battery cover to be replaced

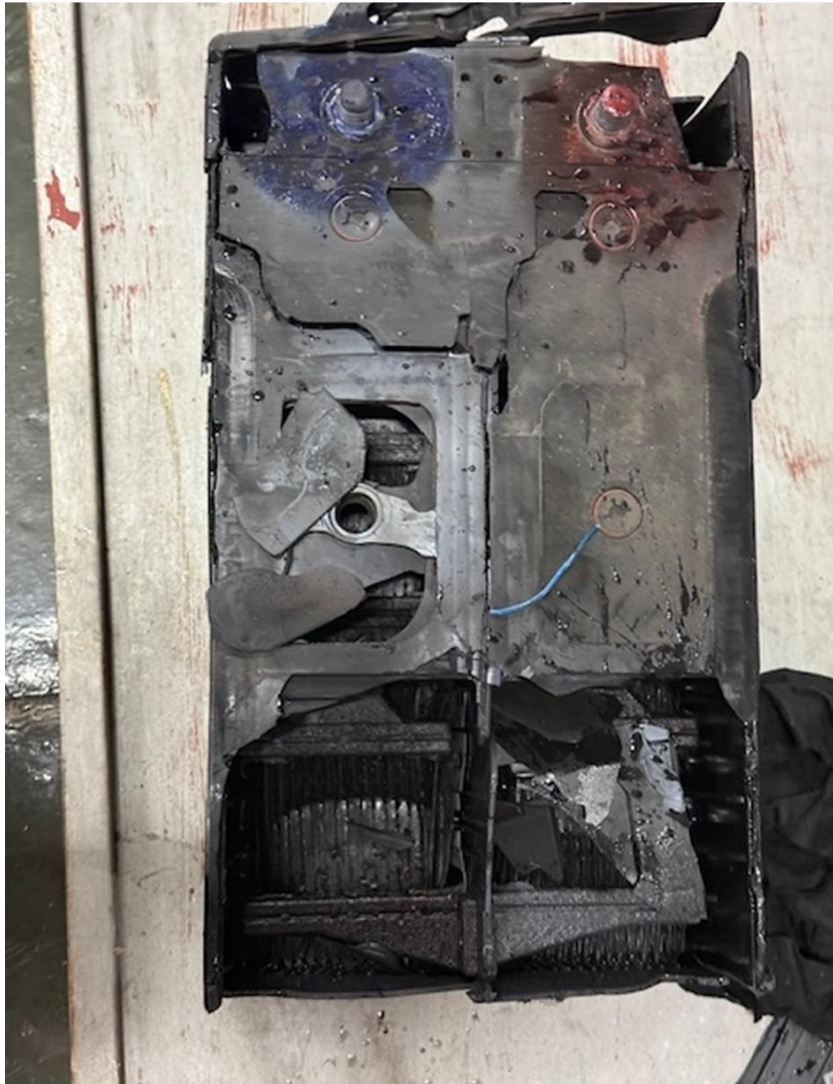
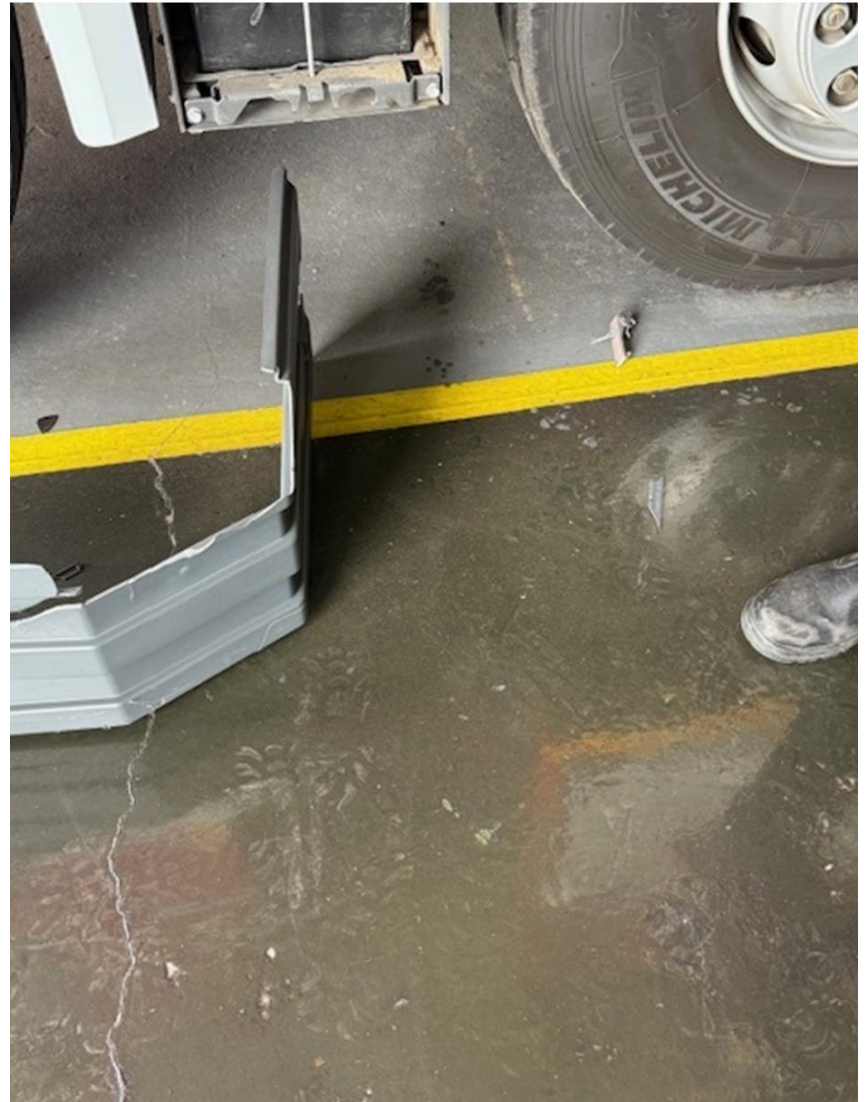
## Additional pics

- Battery cover in pieces
- Top part of battery burst open
- Battery acid in plus minus 1 litre spread over the other battery and chassis area
- 2<sup>nd</sup> battery of the 2 x 12 V batteries was found to be faulty.
- Batteries on vehicle have been manufactured in 06/2020
- External Charging System and Alternator was tested and found to be in order.
- Due to being an Emergency vehicle and lead time, immediately 2 new batteries were ordered, pending completion of investigation.

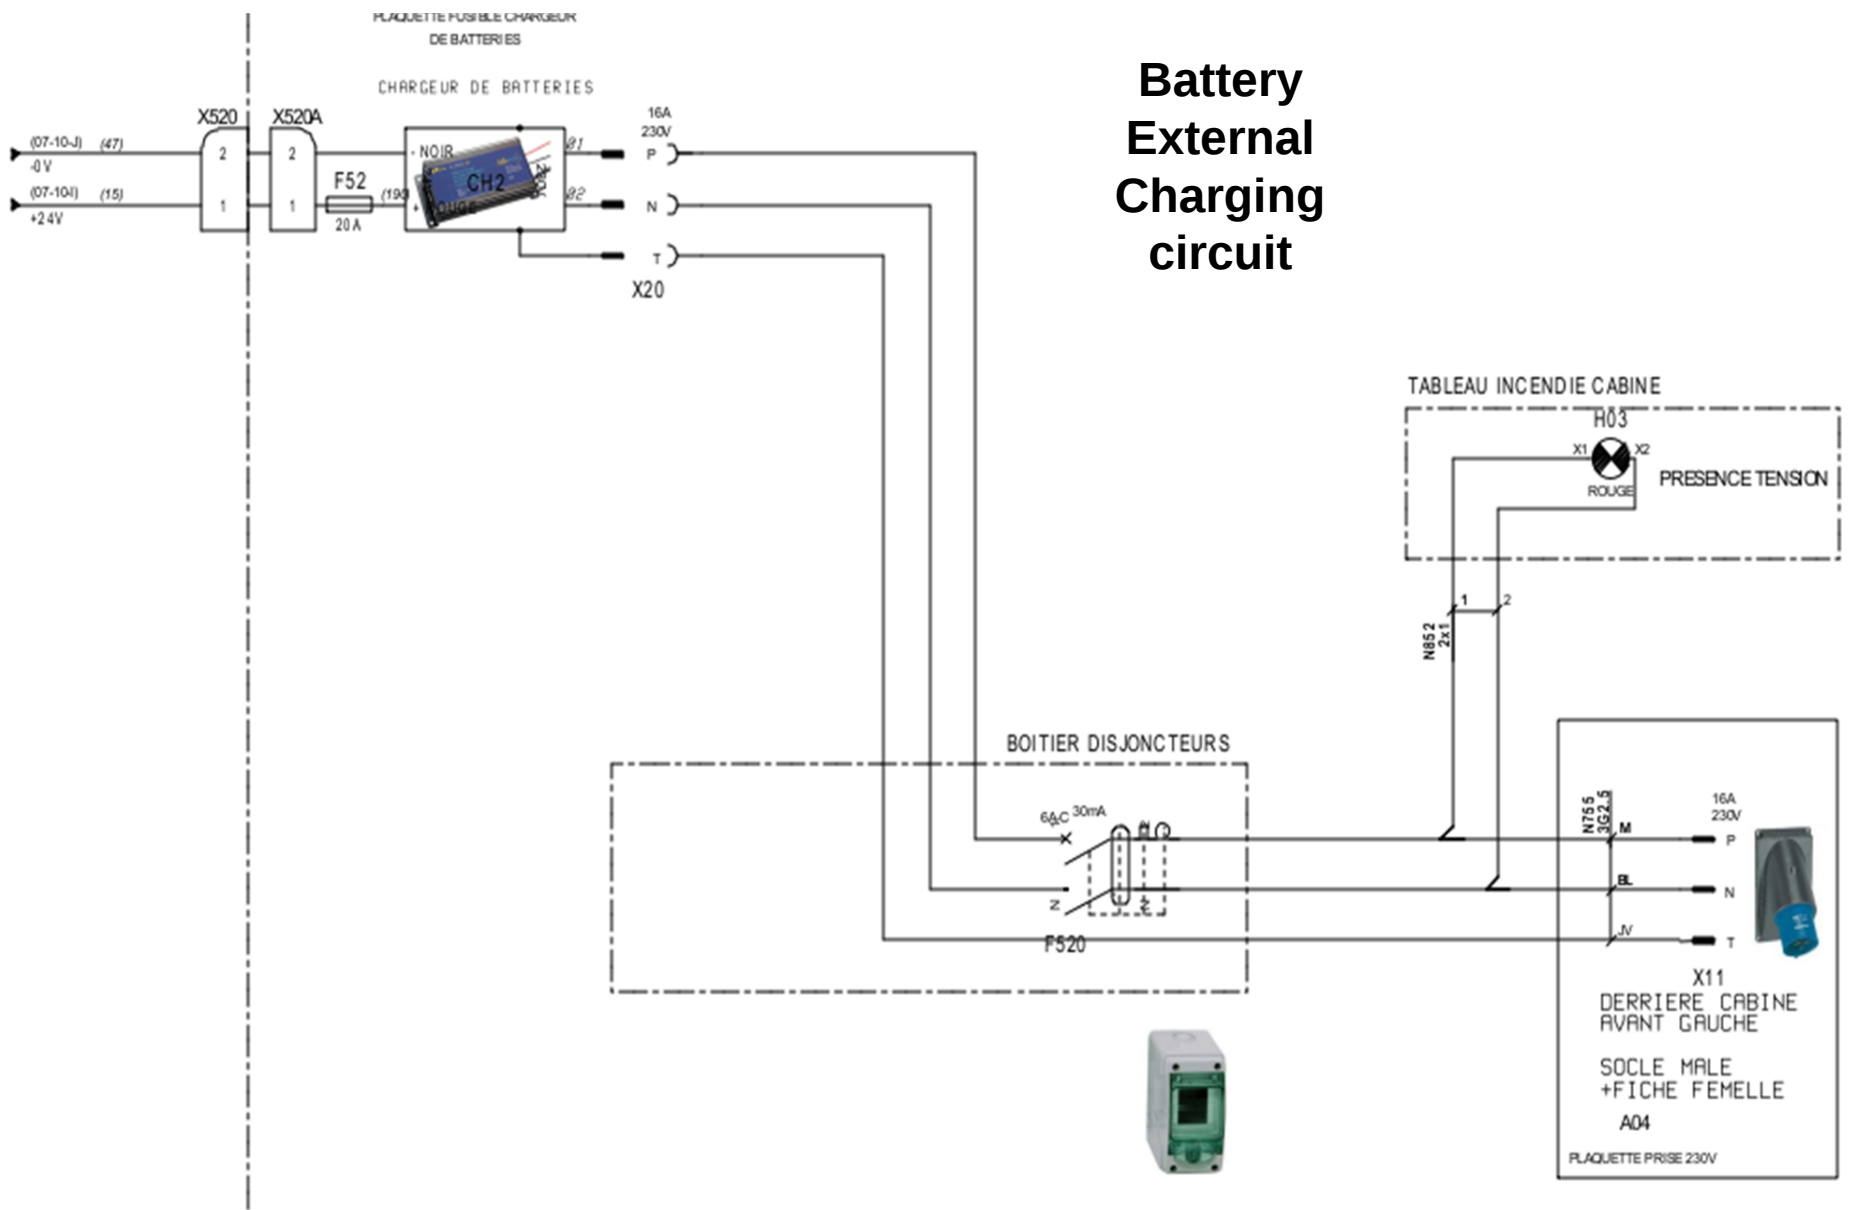
# Battery External Charging circuit

## **Battery Charger from external supply does not trickle charge**

Vehicle regular on external charge and charger found not to be a trickle charger

Trickle Charger to be purchased and replace present charger which will prevent over charging when one battery is faulty.
