# **LEARNING FROM INCIDENT (LFI)**

## **Sparking from Electrical Wiring**

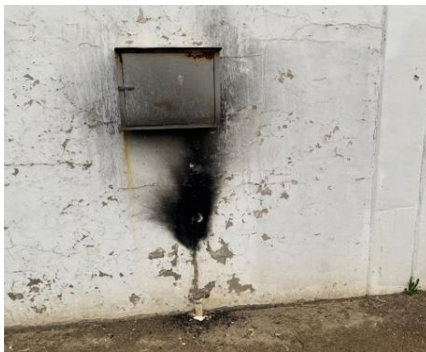
- A neighbour walking along the fire pump house, located outside the terminal fence line, identified an electrical spark at the electrical distribution box mounted on the pump house building.
- Investigations identified that the wiring leading into the fire house had been isolated and de-energised but the wiring coming into the redundant distribution box from the municipal supply was still energised.
- Over time, the insulation of the wiring had weathered away, exposing the cables, resulting in the electrical sparking as the wires made contact.

This had the potential to cause harm to someone who touched it assuming it to be de-energised, a potential ignition source if there was a large vapour cloud that moved in the direction of the live exposed cables.

This building is outside the terminal

- When the distribution box was made redundant on the terminal side, the follow through to test the municipal isolation was omitted.
- The Operator rounds did not identify the exposed cabling or sparking from the municipal distribution box.
- The Proactive maintenance inspections and checks did not include this element of the facility in the R&I plans
- This section of the fire house does not form part of the staff/contractor normal routes of travel

- 3<sup>rd</sup> party assets and installations pose a risk to business installations.
- Redundant equipment of the organisation and other parties should be considered in the site risk assessments.
- Operator rounds to be more specific on conducting 360deg checks around assets and installations.
- Review the current process for validation of Electrical Isolation across the power supply as per the Lock Out Tag Out requirements and guidance

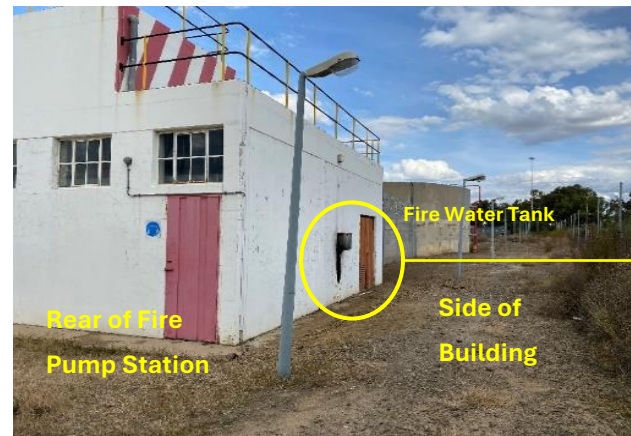
Point where the Sparks occurred
