# Incident Learning: Mogas Line Leak after Decommissioning

## 1. BRIEF DESCRIPTION OF EVENTS

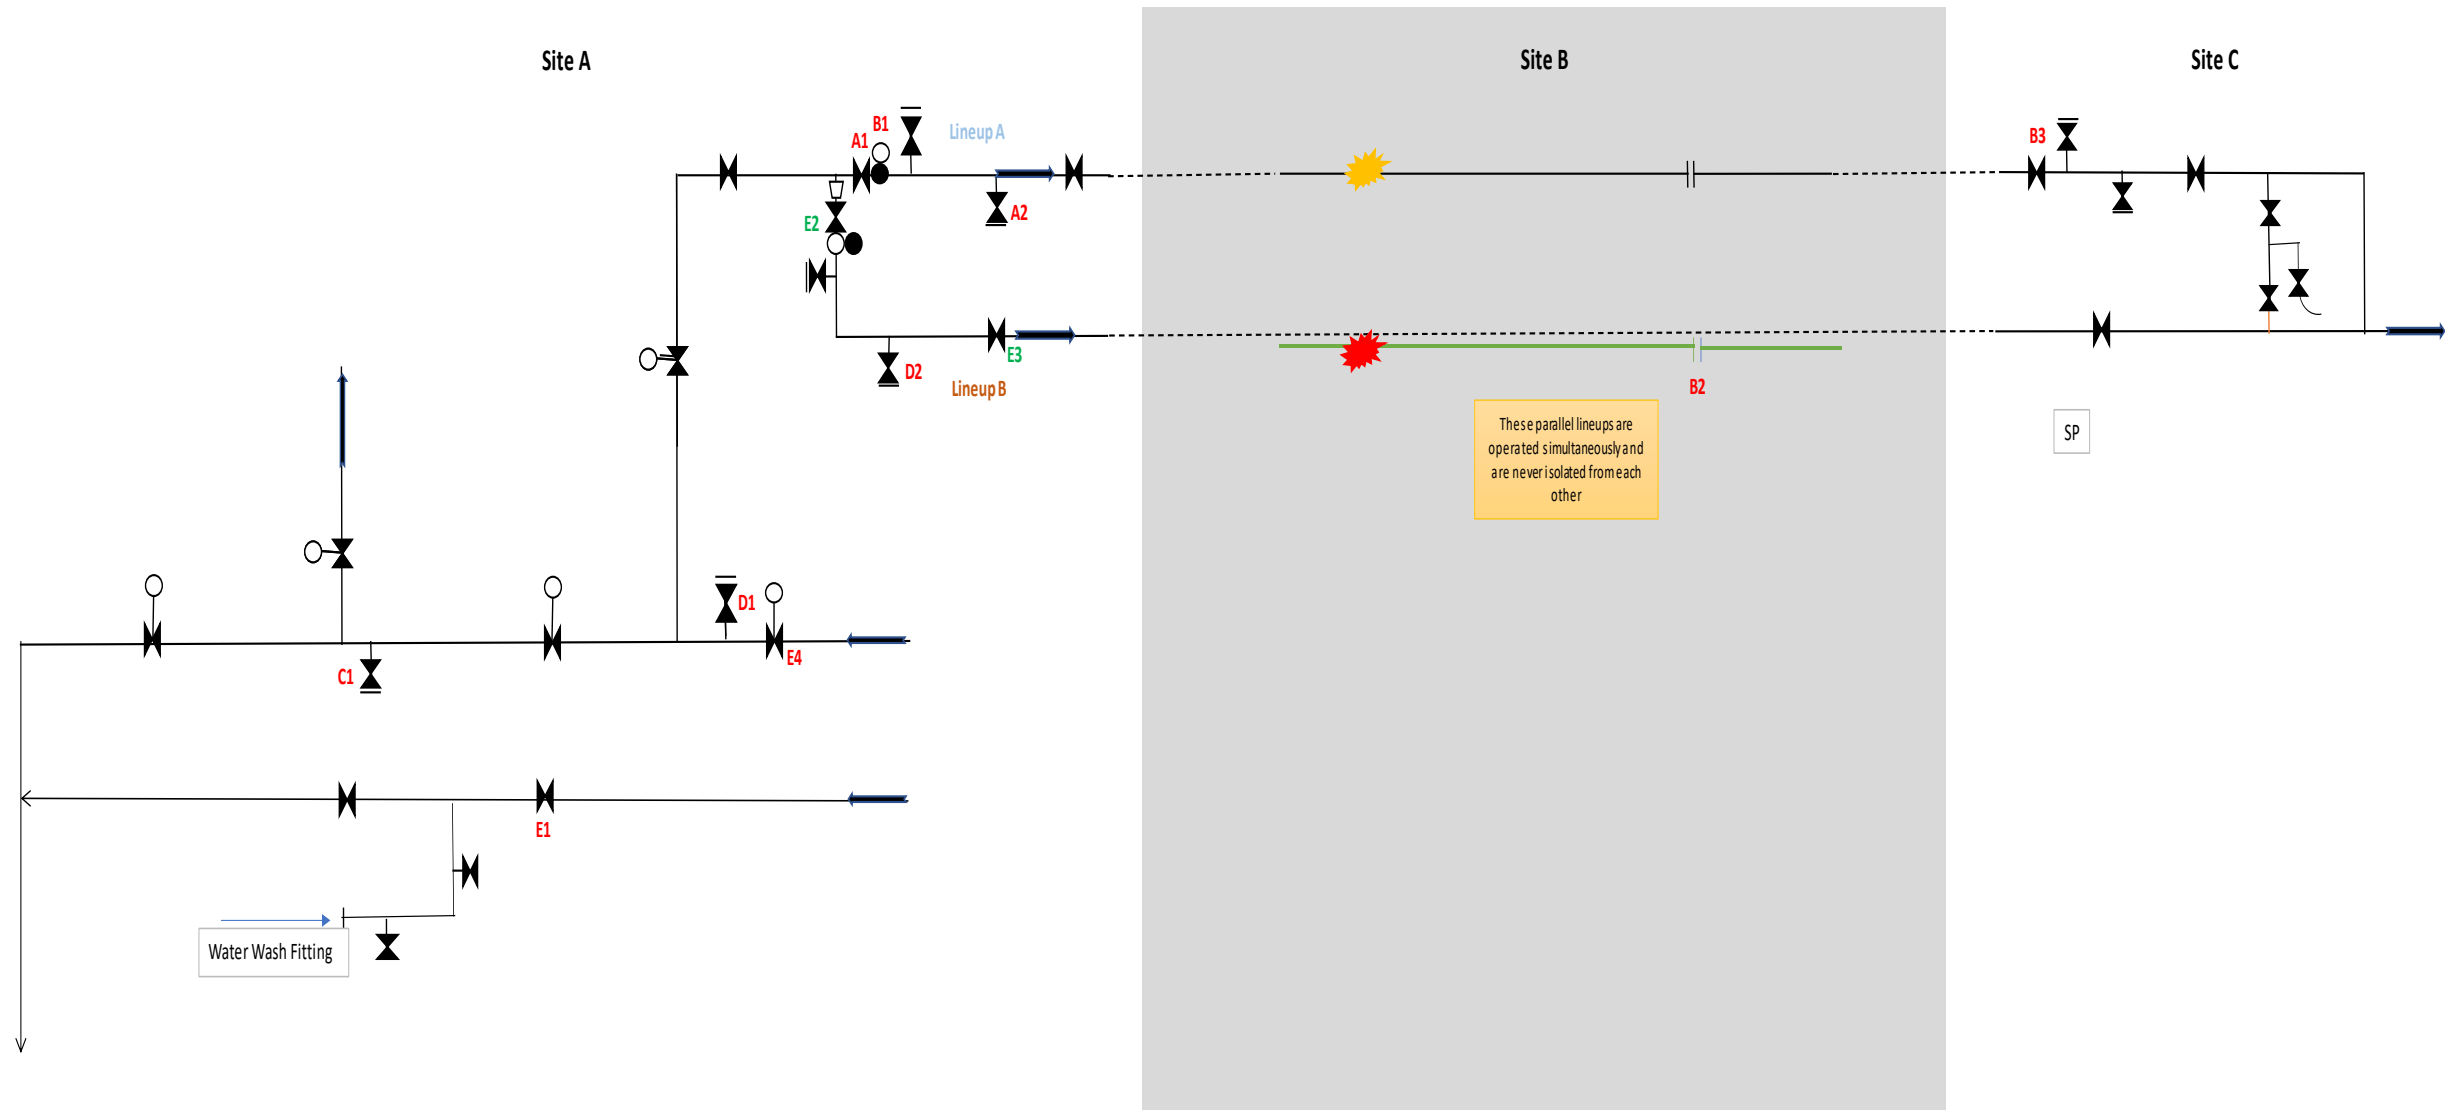
Incident 1 - Approximately 162kg of Mogas was released from a Mogas line (Lineup B) when the cold cut of the line progressed through wall on the bottom half. The Mogas, which continued to be released for 30-45 minutes, was contained in a drip tray and cleared using the gulley sucker. The leak was arrested with the installation of a clamp. This was classified as an API Tier 2 incident

Incident 2 – 1332kg Mogas was released when the line was pressurized with fire water in an attempt to push the Mogas from the upstream piping to Site C via Lineup B. The line split at the cold cut area releasing the contents of the 6” 100m pipe. This was classified as an API Tier 1 incident.

The Mogas rundown line at Site B (Lineup B) developed a leak due to external corrosion. Due to the belief that Lineup A was the line with the leak, this line was decontaminated and water washed in preparation to remediate the corrosion.
