# Successful Soil & Groundwater Remediation Technique

Yoliswa Makhoba

April 2025

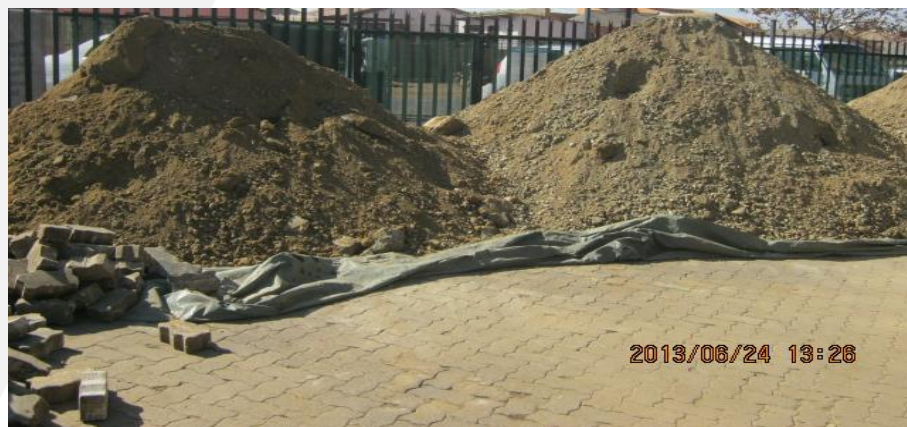
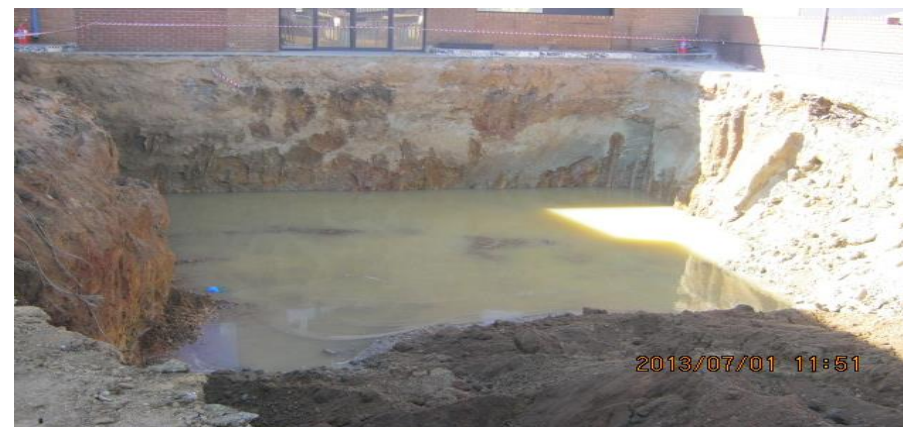
### “DIG & DUMP REMEDIATION DURING UST REMOVAL”

- 3 x 23 000 ℓ and 1 x 46 000 ℓ USTs were decommissioned.
- Contaminated soil (from UST and canopy areas) with a volume of ~930tons was disposed of safely.
- **Additional 580tons of soil was excavated at the canopy footprint area for safe disposal.**
- To enhance attenuation, the solid product (*infested with Bacterial, Fungal and Yeast isolates*) was blended with import soil material during backfilling of the UST excavation.
- For future monitoring, Pit Observation Wells (POW) were installed in the former excavation during the backfilling process.
- Seepage was detected at 1.6mbgl and the average depth to GW was measured at 1.955mbgl.
- Besides hydrocarbon sheen, no measurable LNAPL was found within the excavation.

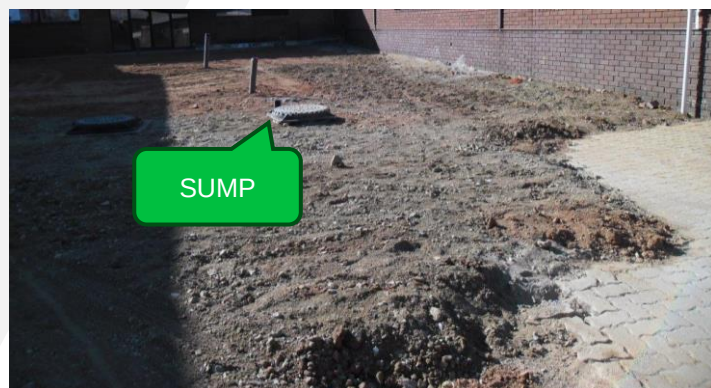
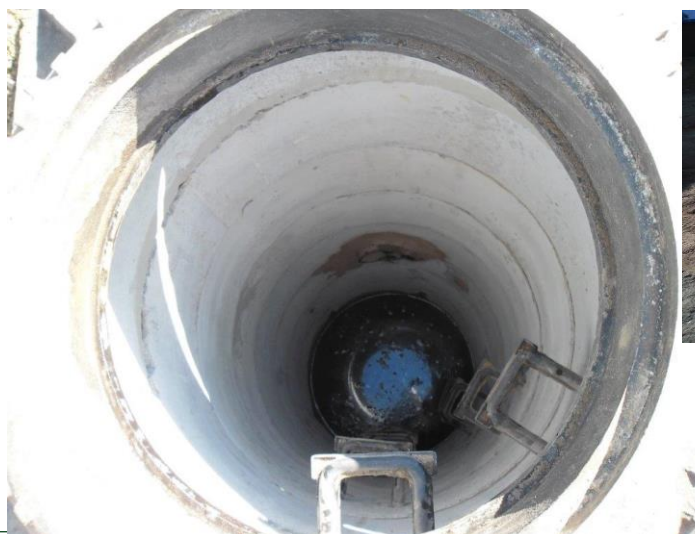
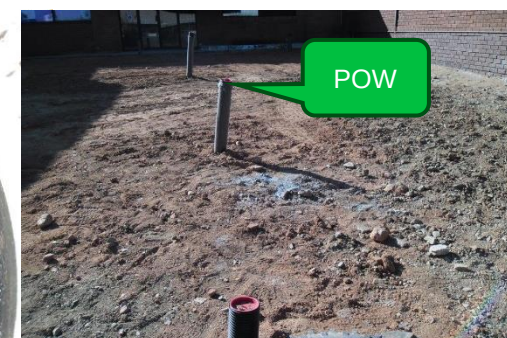
## “PUMP AND TREAT SYSTEM “(LINKED TO CUT-OFF TRENCH)

A cut-off trench was installed on the down-gradient end of the UST excavation.

A sump (equipped with a pump) was linked with the cut-off trench to drain the trench.

The contaminated GW from the trench channelled via the aboveground separator and treated using the air-stripper prior to its disposal into the local sewer system.

No LNAPL was found within the sump.

GW samples were taken from the sump and/or separator and from the outlet of the separator to verify treatment efficiency prior to disposal.

Based on the GW samples taken prior to and post treatment, the *airstripper* was effective in terms of treating/lessening the dissolved phase hydrocarbons.
