“Condensate Spill @ Voorbaai Tank Farm”

Process Safety Incident

Voorbaai Tank Farm

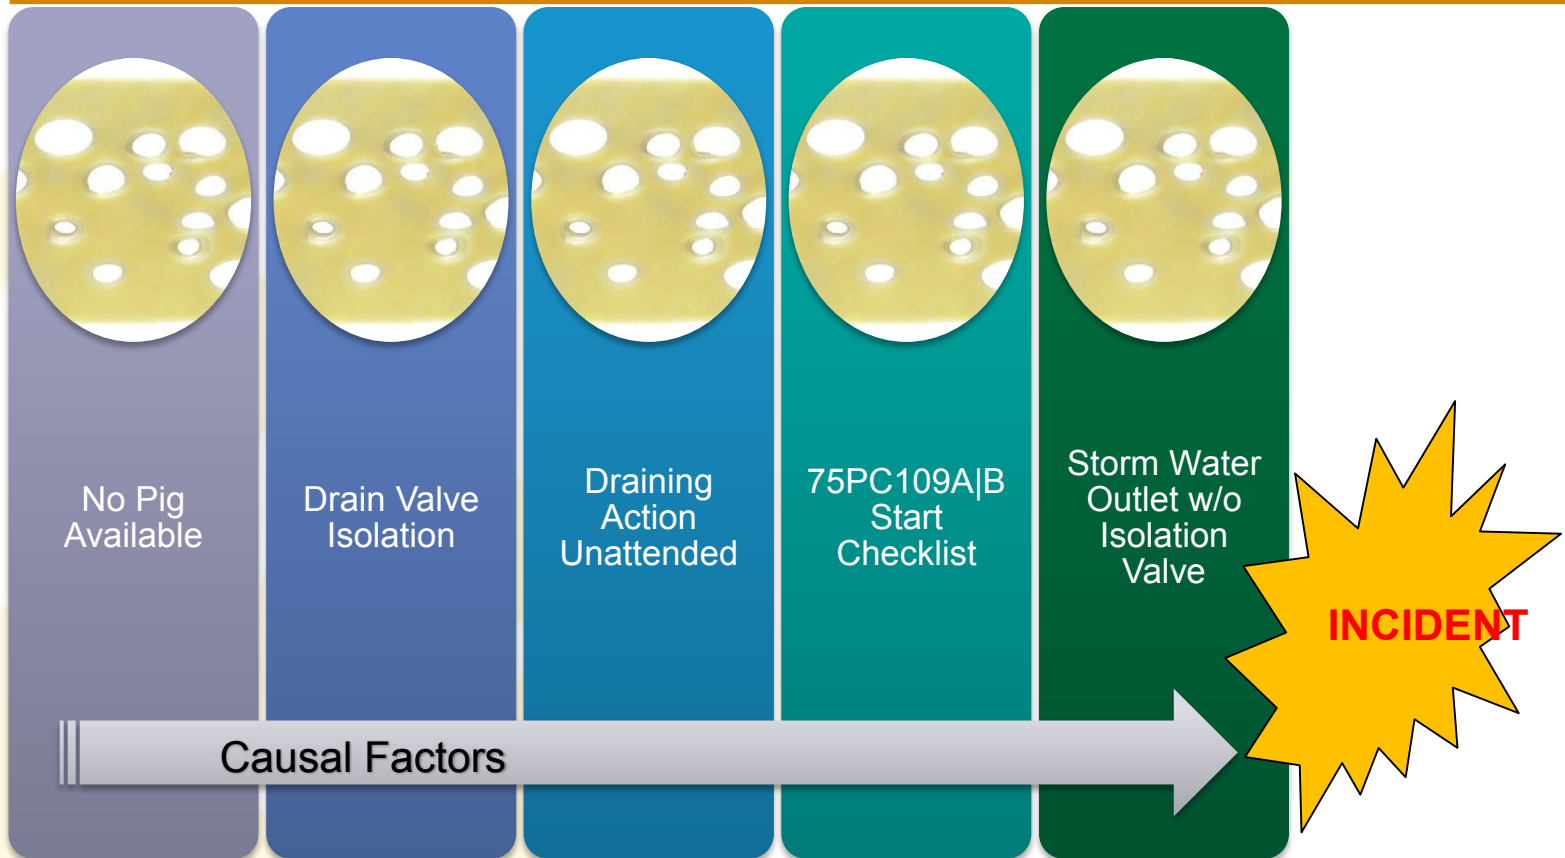
Swiss Cheese Barrier Failure

- A pig was not available at the launching area prior to preparation of the pig launching activity, the only pig available was stuck in the pig receiving chamber at GTL Refinery Tank Farm.
- The isolation of the valves for draining the pig launcher was not followed according to pigging procedure. Pump side isolation of the pig launcher not done.

The procedure needs to be updated to include all relevant steps in the preparation of the pig launching system which should include the following

- *Pig to be available at launching area before preparation of the system*
- *Continuous monitoring of the draining of the pig launcher*

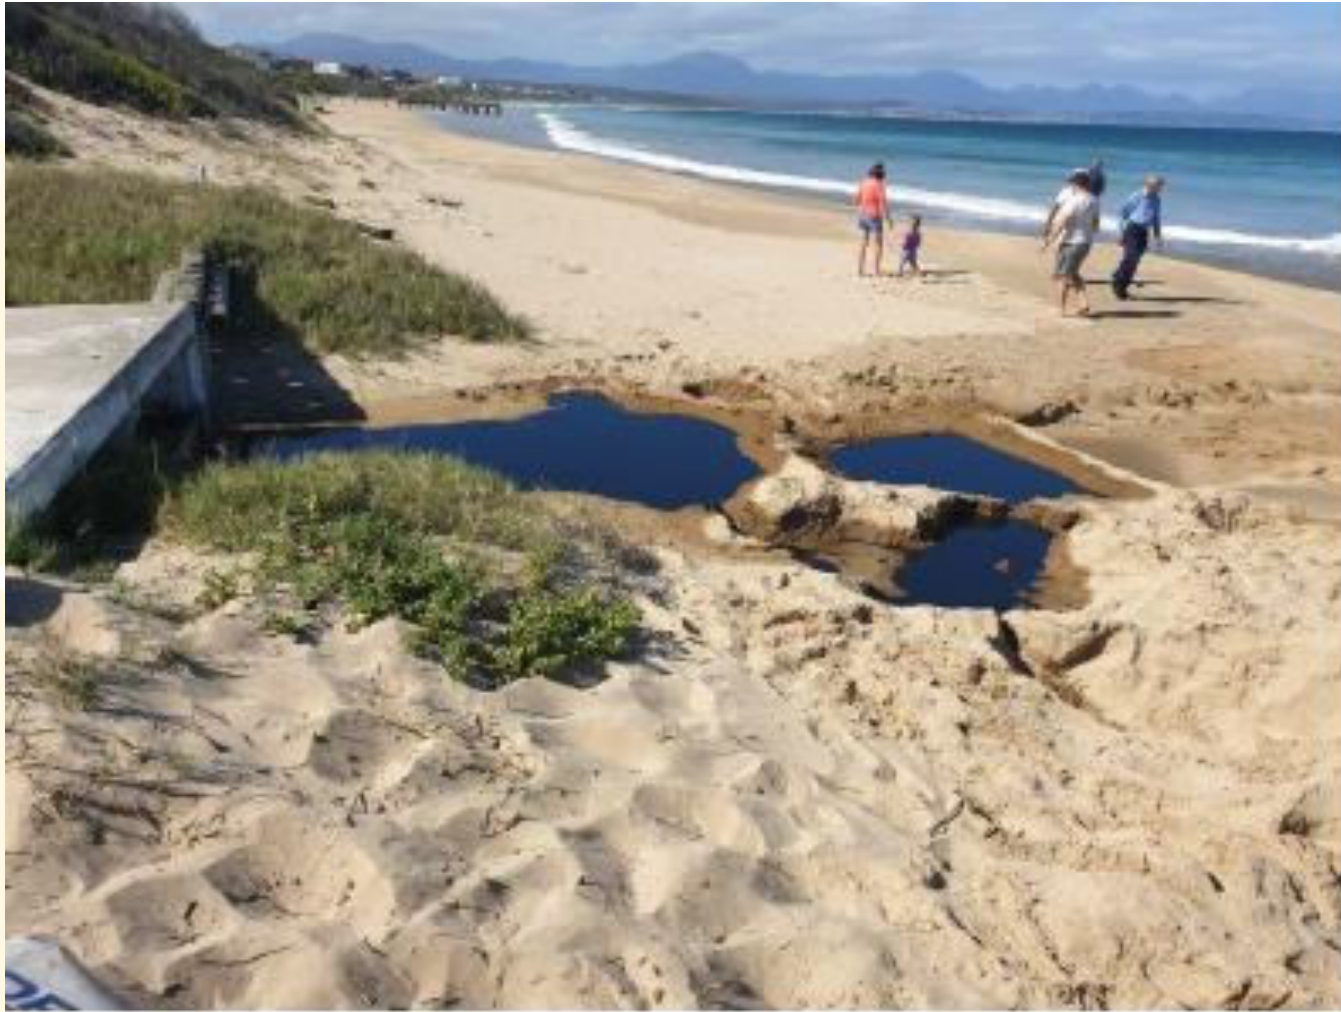
Photograph 1: Condensate spill at beach

Condensate Spill Itself...(approx. 20m³)
