# LFI: Petrol Spillage during Tanker Loading

- Petrol Splash onto Body of SPC -

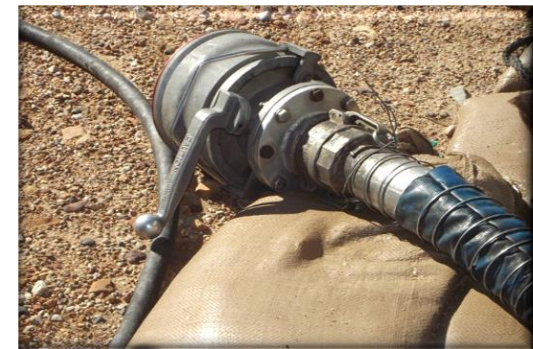
Truck side installation - coupler  
*location of safety pin*
