# **SASOLBURG**

## **Exposure to Cyanide**

Area: Cyanide plant on Midland site

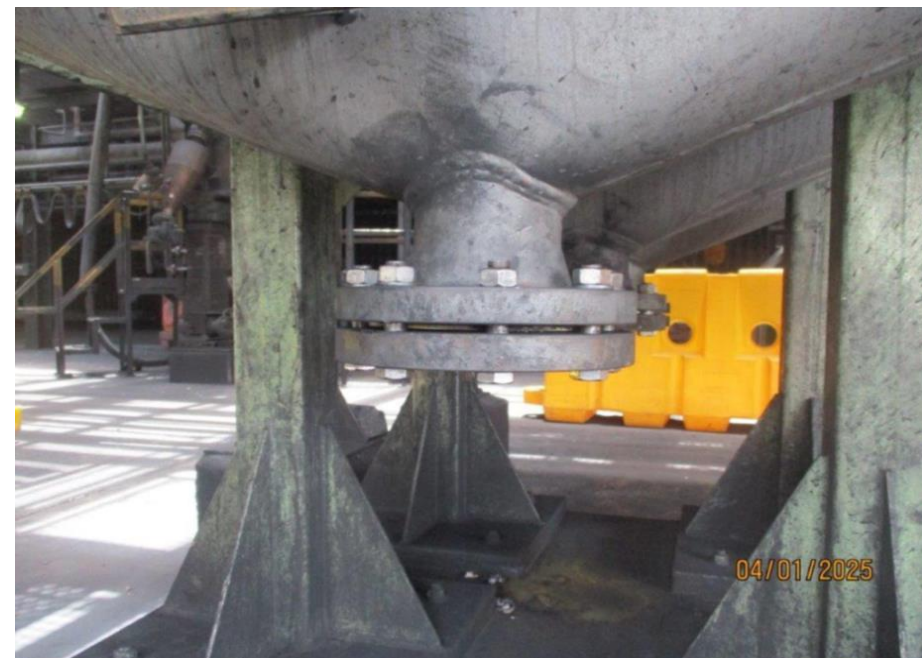
At the time of the incident, the gas cooler G (EA1301G) operating pressure was 16 kPa(g).

- DCS trends indicate that EA1301G started to lose operating pressure at 9:53 and was switched off at 10:01
- Permit was issued for EA1301F, fitter stripped EA1301G.
- Permit to work and PTRA was issued for the task.
- Correct equipment was identified, tagged and made safe

Leak source: It was found that 5 of 8 bolts were removed, resulting in the release of HCN.

- Incorrect equipment was identified by the employee.
- Always double check to ensure correct equipment is worked on.
