# Incident Learning: What happened?

While a service provider employee (the IP) was cutting grass in the Synthetic Fuel Farm (SFF) area using a lawnmower, a metal signage plate (the projectile) that was attached to an underground electrical cable indicator concrete block struck the IP on the right leg (shin).

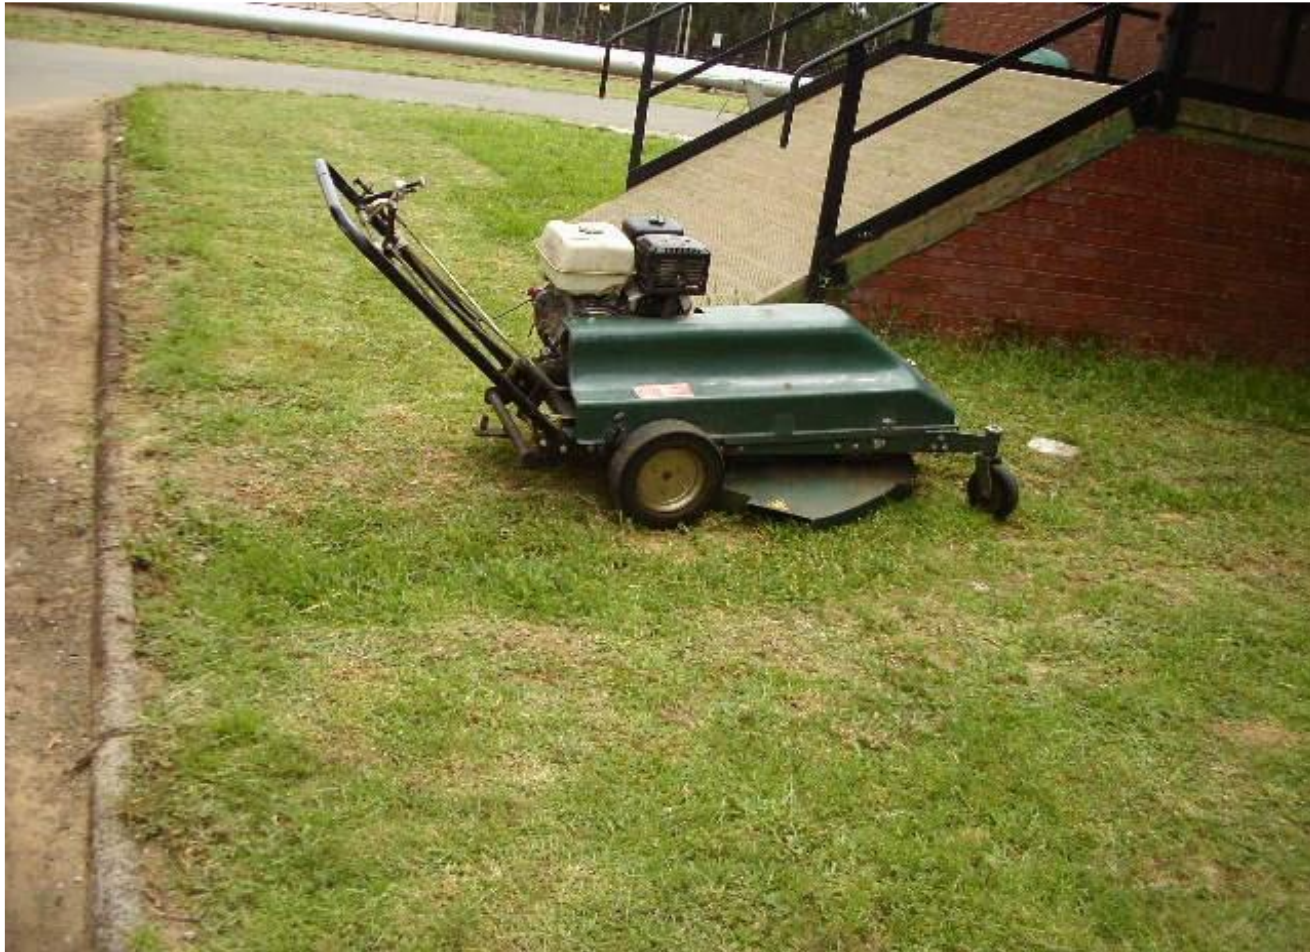
- Inadequate adherence to TRIC (task risk identification checklist) by IP - area inspection not adequately performed, the metal signage plate not identified as a potential hazard or a potential projectile.

- Service provider employees that are involved with cutting of the grass on Natref site must always ensure that areas are properly inspected, all potential hazards are identified and mitigated before commencing with grass cutting.
- 2. Service provider supervisor must perform adequate supervision to ensure adherence to procedures and instructions.
