# Safety Bulletin

## Contractor amputation of fingertip

Location Name: On forecourt

Location Address: Durban

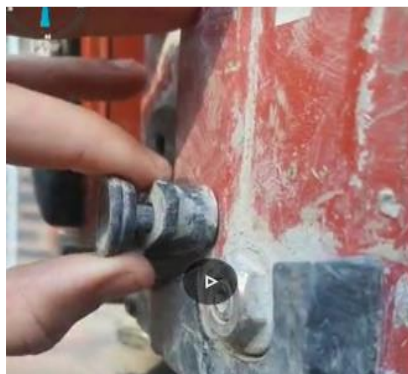
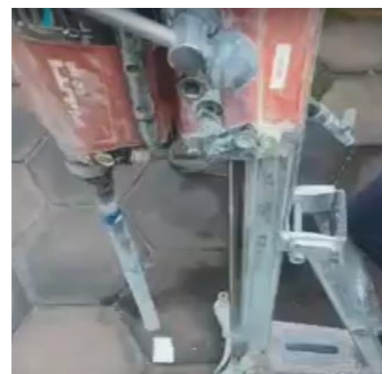
On the 14/06/2023, a contractor, working on the forecourt of a service station in Durban, was busy with core drilling, when they lost control of the drill they were using. The coring machine fell onto the contractors left hand severing the tip of the middle finger.

- The barrel of the drilling machine was engaged with the drilling device.
- The device was attached to the stand.
- A safety device on the stand is available to secure the unit in place when not actively coring.
- The barrel landed on the employees left middle finger whilst he was measuring the depth of the hole.
- The risk of the barrel in an elevated position was not sufficiently mitigated in the JLA (job loss analysis).

- Always follow processes and procedures.
- Always conduct a pre-job brief for any task.
- Ensure you are always focused on the task at hand.
- Conduct an LPSA (loss prevention self assessment) before, during and after a task.
- Keep clear of line of fire.
- Ensure planned maintenance of equipment is adhered to.
- Ensure JLA's address all critical risks of the task.
- When amending JLA's, train all relevant staff on the changes.
- Ensure correct PPE is worn and in good condition.
