# **Sasol - Instrument artisan grinder incident. 25 March 2024**

**Description of Incident:** While cutting a unistrut with an angle grinder (115 mm), the senior instrument artisan sustained a laceration to the left hand from the angle grinder.

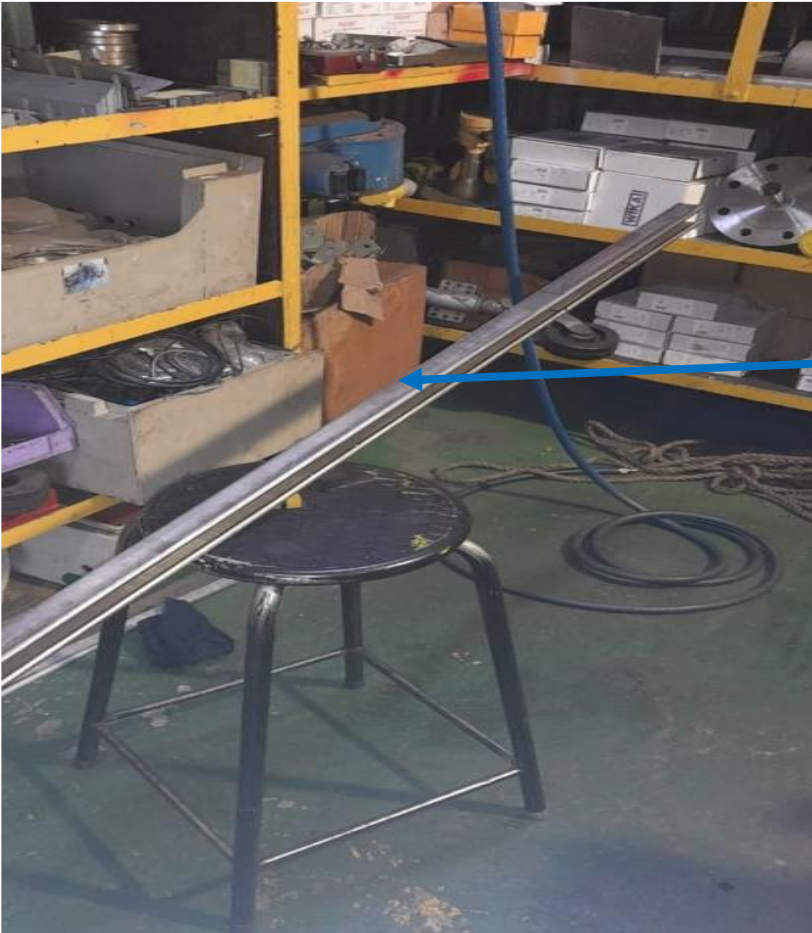
The Unistrut that the instrument artisan was cutting with a grinder (the unistrut was found on the chair after the incident occurred)

The senior instrument artisan did not secure the unistrut before cutting as per the SHE requirements for hand and pneumatic tools work instruction. The senior instrument artisan stated that he felt that the unistrut was sufficiently secured on the floor as it was a flat surface and due the length of the unistrut.

- The senior instrument artisan was cutting the Unistrut in a crouched position facing towards the power supply, which caused the electrical cord to be in the direct line of fire. There was also no play on the electrical cord.
- The senior instrument artisan used a crisscross motion while cutting with the angle grinder. The position of the senior instrument artisan's left hand was directly in the line of fire.

Management should identify the requirements for the competency declaration for the utilisation of the grinders and incorporate these requirements into the training matrix.

- Management should ensure PPE requirements as per task risk assessment are available, used and inspected to ensure that this control is effective.
- When conducting task risk assessments ensure that the correct documentation is used and referenced to provide the most effective / detailed preventative and mitigating controls.
- Management should ensure when making reference to a procedure in a task risk assessment that the procedure is still valid.
