On Thursday the 24 March, at approximately 11:45 it was reported that a bobcat Operator was removing rubble and while reversing from section 8 of the site, his foot got caught in between the bobcat bucket and the machine.

ROOT CAUSES

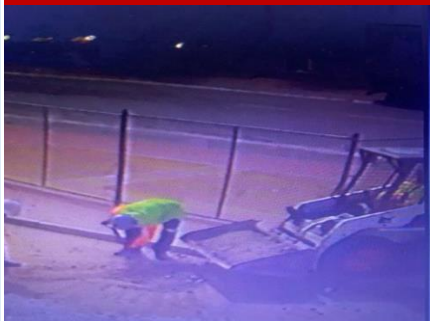
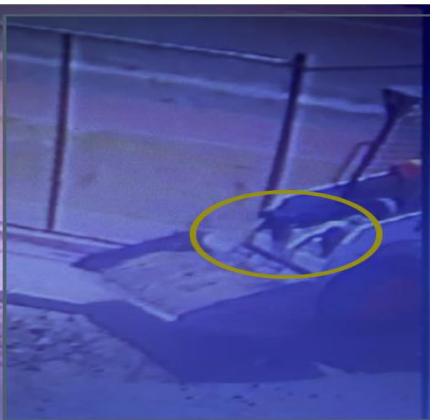
- Inadequate safety intervention during project execution.
- Inadequate Job Safety analysis specifically on potential hazard in operating skid steer as per stated in operating manual and warning sign..
- IP had placed his left foot on the left pedal and his right foot protruded over the cabin access step.

Hazards of placing limbs outside the Bobcat cabin must be included on Risk assessment or Safe Working procedure for operation of Bobcat.

Initiate awareness on Stop Work Authority , Comply and Intervene programme, share with all the Contractors on Contractor Management meeting.

Ensure that Job Hazards Analysis identify the risk of injury from limb caught in between for all machinery

Ensure that Bobcat operator does not sit in the operation cabin when it is not in operation with legs stretched out of the machine.
