# Incident Learning: What happened?

- Incident Summary

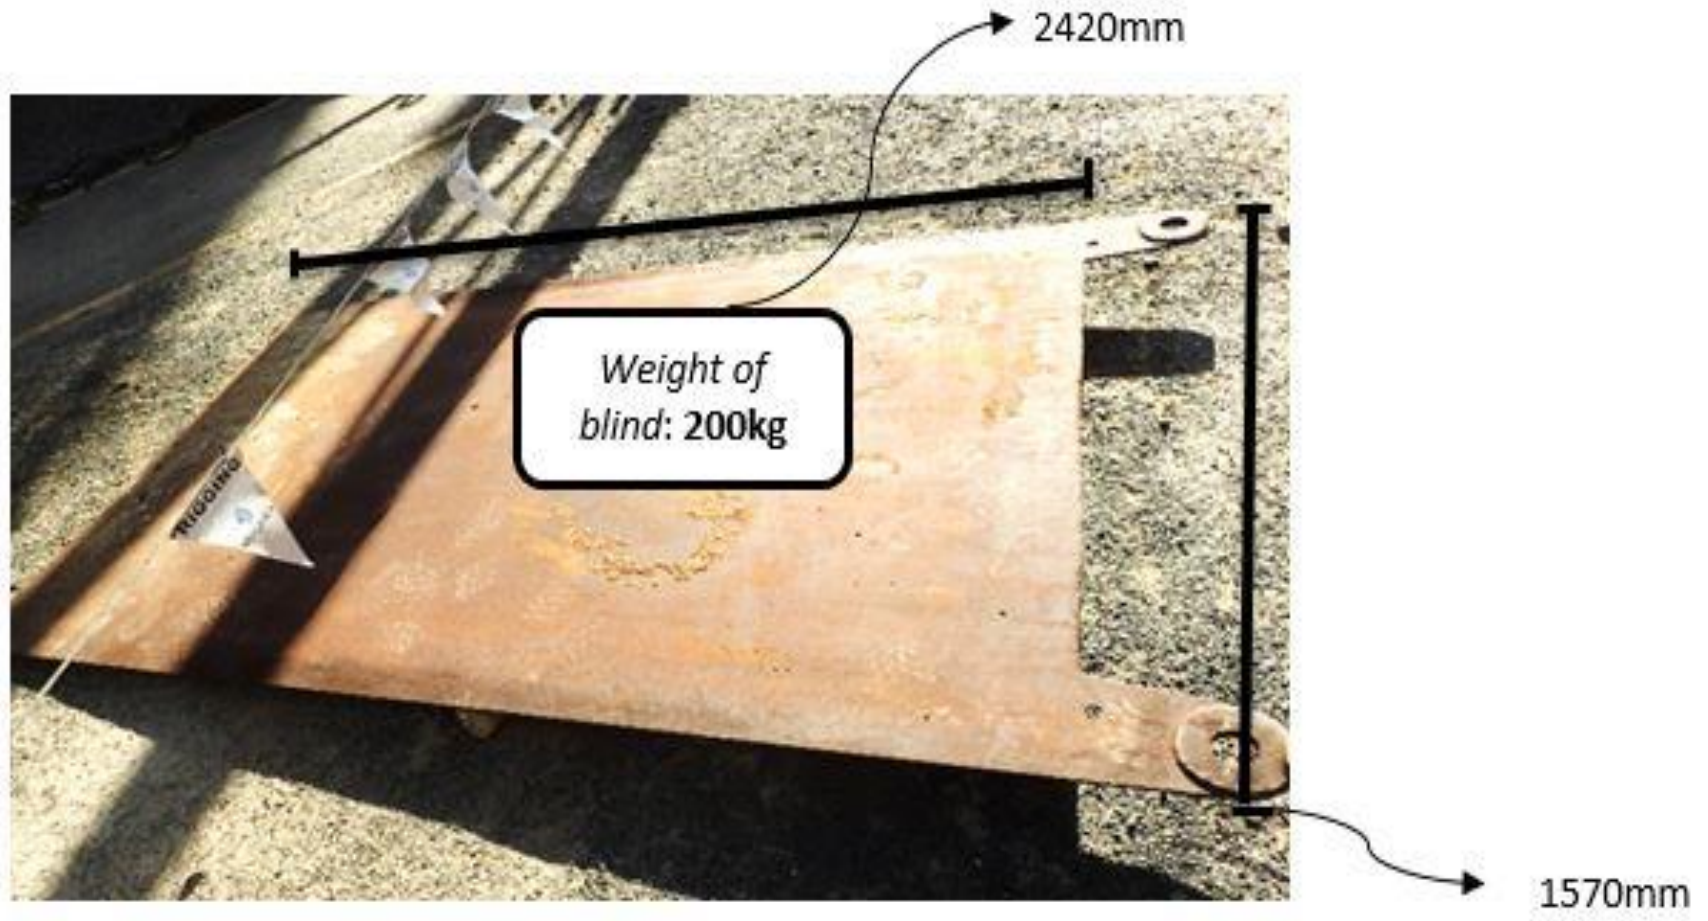
On the 14th August 2018, two employees were **manually lifting** a blind that was leaning in an upright (vertical) position against a structure. The employees **decided** to lower the blind to the ground in preparation for rigging. The intention was to move the blind from a vertical position to a horizontal position with one side of the blind lying flat on the ground. When the blind was close to the ground it **slipped** out of the injured person's hand and struck him against his left outer foot. It was confirmed that the employee had un-displaced fracture of the 5th metatarsal bone.

- Job Safety Environmental Analysis (JSEA) should be task specific and any changes on the method should be signed off by the respective supervisor.
- Ensure adequate supervision in place prior to commencement of high risks tasks.
- Raise awareness on expectations required i.e. how to handle equipment and tools with a weight limit below 500kg and not over live equipment and plant
