## ***Learning from Incidents***

# **Mobile Test Pit Caught Fire during Truck meter Calibration Leading to Lost Time Injury (LTI)**

10 January 2023

Depot, Mpumalanga

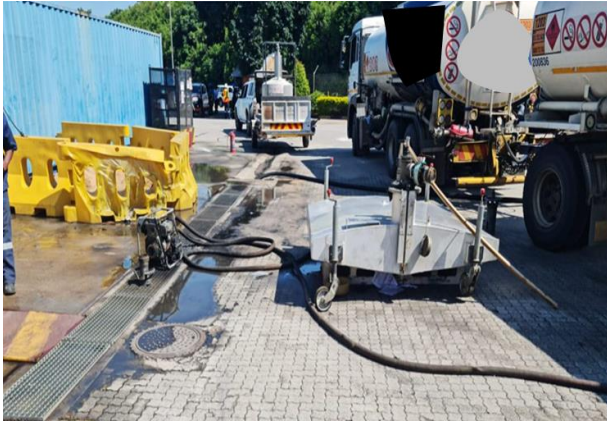
**Picture 1:** Meter Calibration rig after the fire still connected to the truck

- At approximately 14:40 on 10<sup>th</sup> February 2023 a fire broke out on the generator during truck meter calibration which resulted in an Assistant burning both arms.
- There was a blockage (airlock) in the pipe. The assistant opened the breather of the generator while it was running which led to the fuel (Petrol) spraying on the hot surface of the generator resulting in a fire.
- The assistant suffered visible burns on both arms.
- The team managed to put out the fire using Engen fire dry powder extinguishers & water hydrants and the site was made safe.

- 1) Issue Non-Conformance Report ( NCR) to the Contractor for not following Engen PPE requirements
- 2) Share Lessons Learnt with wider organization with Similar operations .
- 3) Ensure all Contractors have an approved safety file to ensure competency requirements are met.

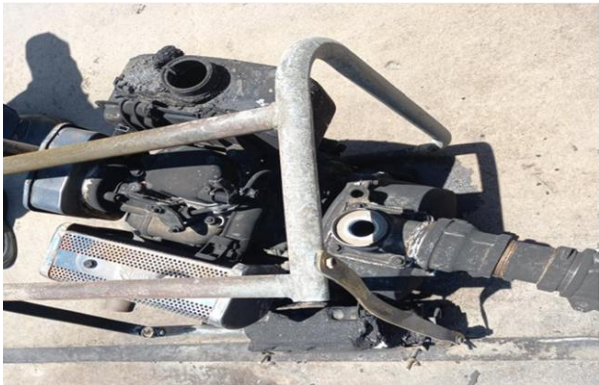
**Picture 2:** Burnt Generator used during meter

- 1) The Assistant opened the breather while generator was running .
- 2) Inadequate procedure for meter calibration of the truck.
- 3) No enforcement of PTW safe systems of work procedure.
- 4) Lack of Contractor Management/Supervision .
- 5) Lack of Management of Change (MOC) which lead to inadequate identification of hazards and safety measures.
- 6) Non-compliance to PPE requirements
