# Incident Learning: What happened?

## MEDICAL TREATMENT CASE

### BRIEF DESCRIPTION OF THE INCIDENT

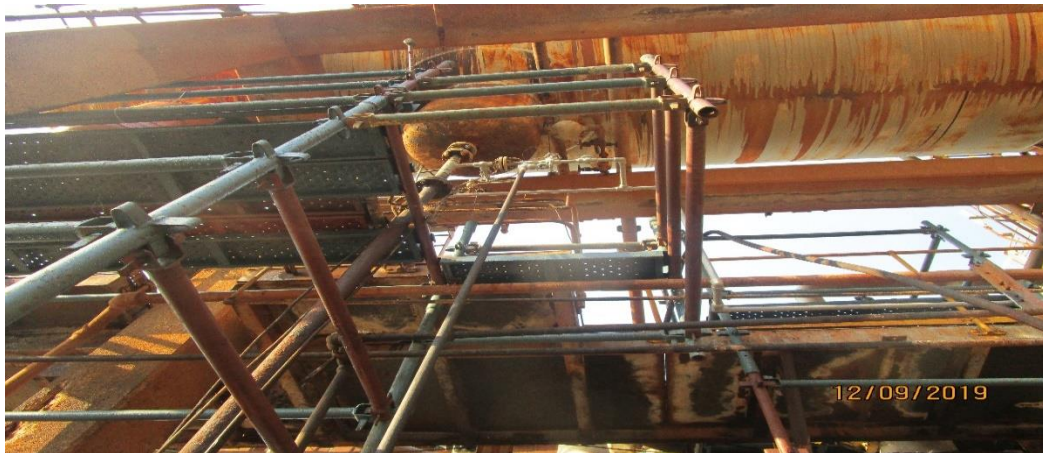
A business partner (contractor) was tasked to spread a flange in the De-Asphalting (PDA) unit at South 3 in order to remove a block valve.

The employee was tasked to remove the block valve for replacement. After the flange was broken for removal of the valve, a few minutes later there was a release of residual product onto the employee which resulted in a cold Burn on the neck area (Similar to a dry ice burn).

1. Ensure that the system is depressurised and made safe before the workers can start working.
2. Ensure lines/equipment is checked prior to breaking flanges, by means of connecting a steam hose/N2 hose and purging system to ensure no pluggages.
