# Incident Learning: LOSS TIME INJURY

On the 20 November 2021 at approximately 09h15, the injured party (IP) sustained a contusion to the bridge of his nose whilst investigating a potential leak on neighbouring equipment located in berth 7 (Island View).

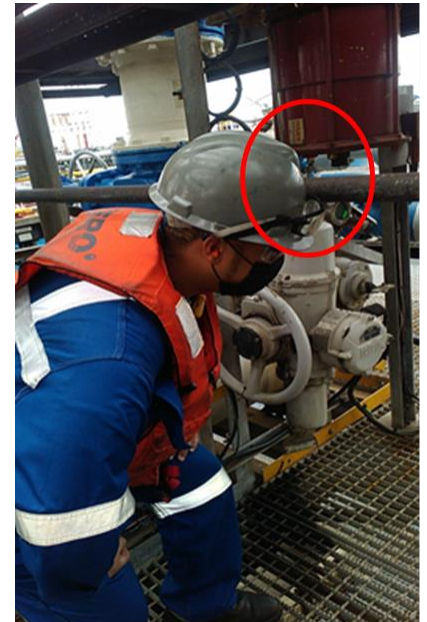
- The scaffolding platform support pole was not marked nor demarcated to show the low level. The scaffolding platform is estimated to be around 1.3m to 1.4m high.

- Inadequate communication between different organisations. The low-lying scaffold platform support pole was not demarcated nor was there any signage to indicate the height or to be mindful of the overhead pole.

- Ensure all employees are aware of their surroundings. Take note of workplace hazards and highlight any concern to supervisor.
- Ensure warning signage are clearly displayed to create awareness for all.
