# Incident Learning: Medical Treatment

# Incident Learning: First Aid Case 1

# Incident Learning: First Aid Case 2

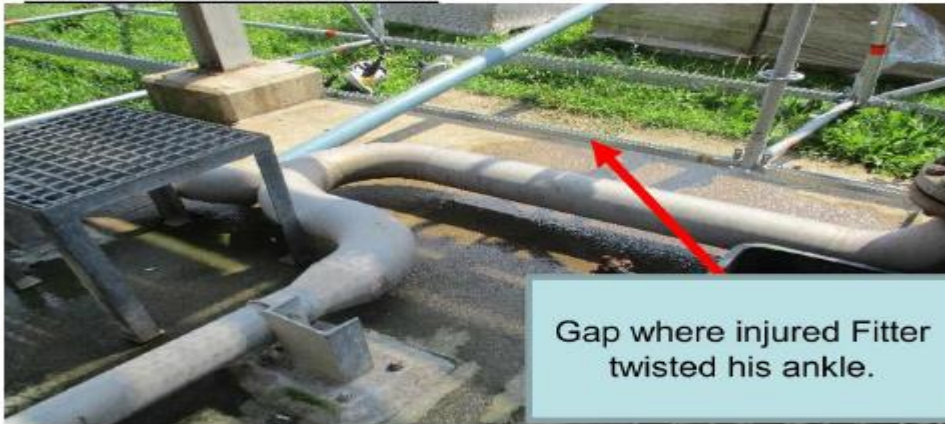
### 3. SKETCH/PHOTOGRAPH:

1. Mechanical Fitters were stripping and removing filters on the boiler feed water utility system. A fitter had removed the covers and then decided to place them on the grass area adjacent to where he was working. As he stepped of the concrete plinth onto a lower concrete step, his ankle twisted on the uneven surface.
2. The injured person was taken to the clinic for medical attention, where he received treatment for a soft tissue injury. Hew returned to work the next day with a slight limp and slight swelling. He has since recovered fully.

- Mechanical fitter stepped between the concrete step and the scaffolding.

- Uneven surfaces had not been identified.
- Employee not aware of his surroundings.

- Uneven surfaces to be identified and mitigated accordingly. The LMRA discussion to involve entire team and signed as proof of communication.
- Employee to be made aware of there surrounding via the LMRA/RAMS and Toolbox talk discussions.

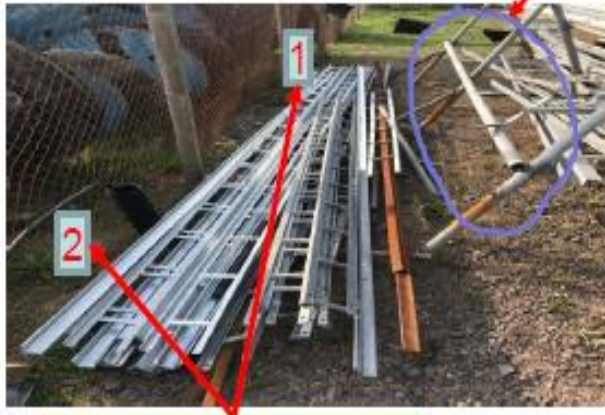
### 3. SKETCH/PHOTOGRAPH:

1. Two contractors were offloading cable trays from a vehicle and loading them onto an A-frame storage rack. When the last tray was placed on the storage rack, the shelf collapsed and falling material caused the 2<sup>nd</sup> shelf to collapse under the additional load. The workers were caught in the line of fire from the falling material and sustained bruises to their shins.
2. They were taken to the clinic for medical attention, where they were treated for bruises and lacerations. They have since recovered fully and are working as normal.

Employees were standing at each end as they loaded cable rack

- Load was not evenly distributed between two shelves.
- A-Frame was rusted at weld points compromising integrity of shelving
- Employees were inadvertently placed in the line of fire when shelf collapsed as there was no room to move out of the drop zone &
- Indirectly linked to space constraints and how items were stored
- A-Frame rack was overloaded with materials resulting in supporting arms breaking off.
- A-Frame rack was not designed to support heavy weight – no SWL

- In the interim all angle iron and cable racking will be stored at floor level, within a designated area which has been allocated .
- A-Frames will be reviewed and will not be used in the interim.

- Appointment of an adequately trained stacking and storage supervisor to monitor all loading and offloading activities in non-process areas.
- Layout of laydown area to be reviewed and all excess/ unused materials to be removed in order to create more storage space.

- Inspection of all storage shelves to ensure they are not overloaded, safe stacked and adequate to withstand weight of materials.

- Robust inspection system of all equipment that is exposed to weather also considering wear and tear over time.
- Risk recognition i.e. integrity of the support brackets; LMRA that was reviewed did not highlight this risk which was deemed routine
- Visible field supervision in execution of all tasks to visually assess weight when stacking material.
- Prior to offloading mechanical items first identify location of final resting place and determine if suitable for offloaded items
