# LFI: Trip & Fall @ Central Control Room

# IOD **LTI** – 31 December 2023

- Central Control Room @ 20H45 -

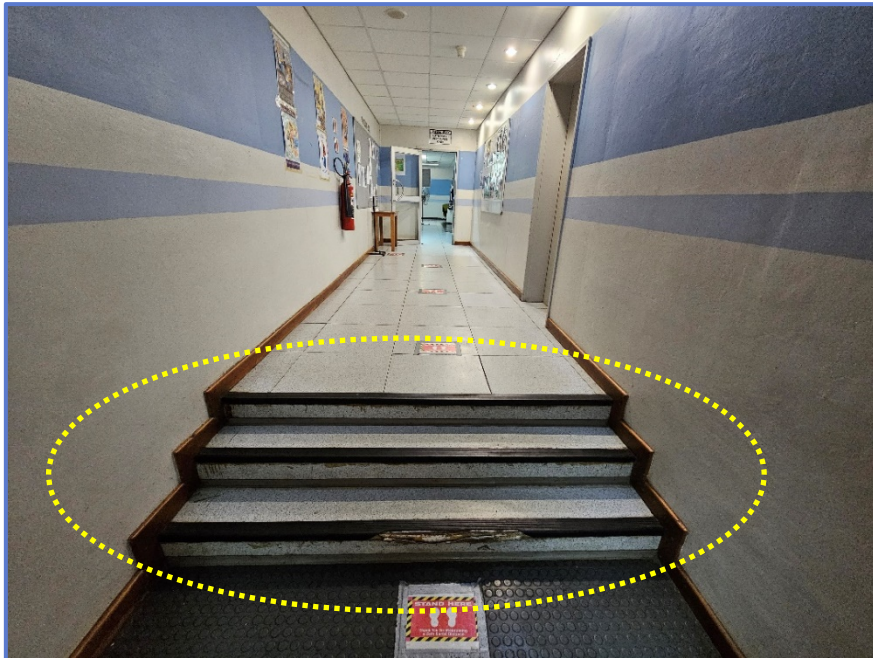
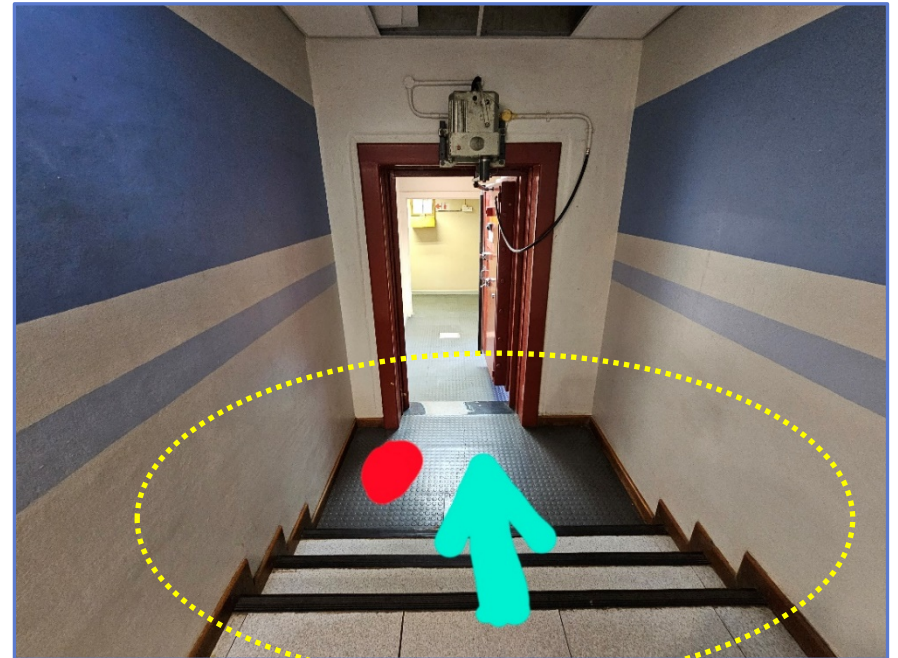
- o Colleague walking towards exit of CCR.
- o At staircase at the end of the corridor, the employee mis-stepped and fell.
- o Fire Dept stabilised and recovered patient to Medical Station with ambulance.
- o Sprain to left ankle, booked off by Occupational Medical Practitioner for 2 shift working days.

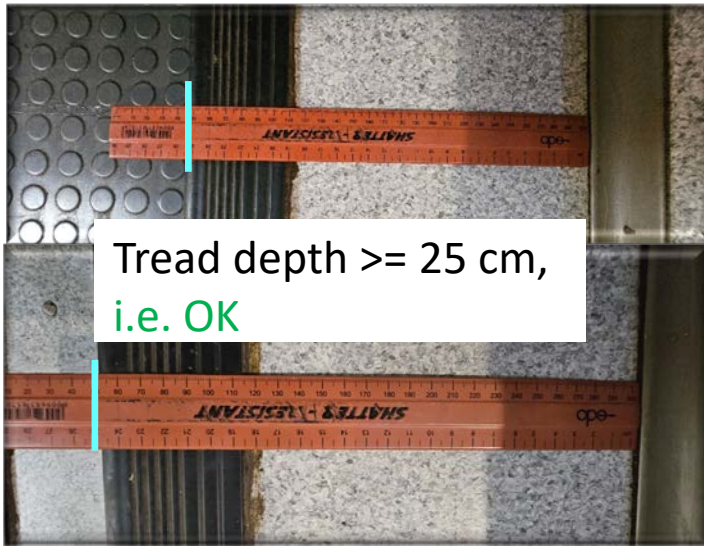
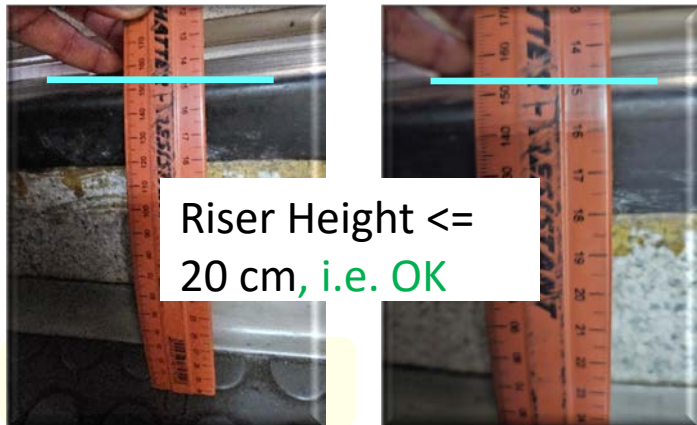
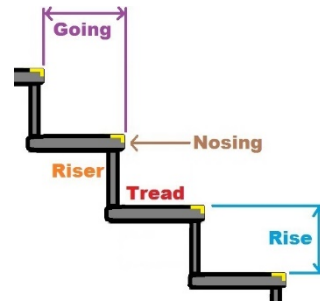
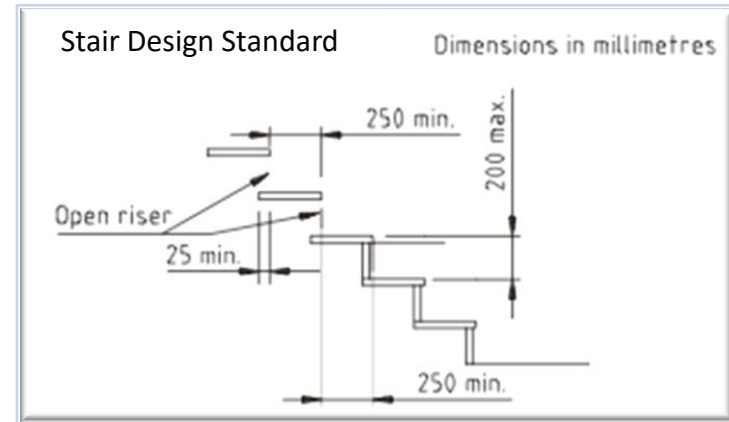
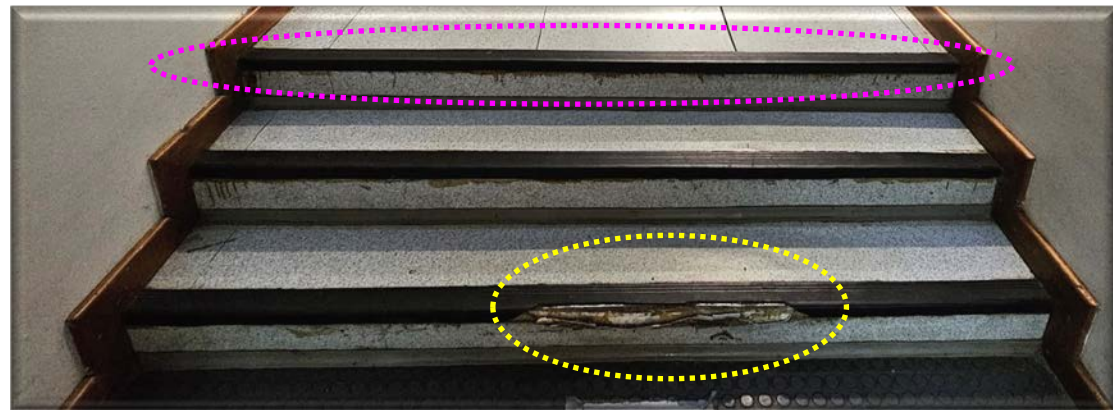
- o Staircase design per SANS 10400 standard?

Rubber nosings tight and intact everywhere - but at step 2, the outer part of the nosing edge has broken off – which could have been a causal factor for this incident.

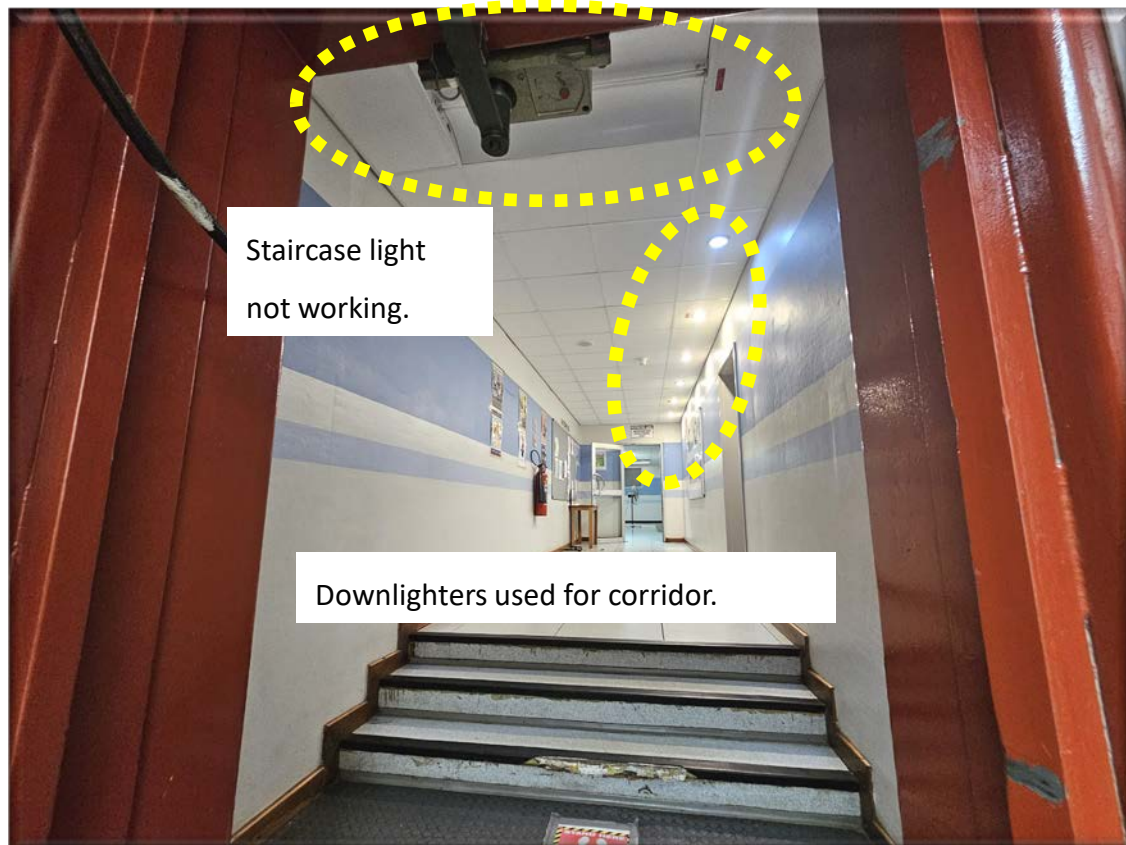
- o Lighting: illuminance for staircases inside offices per SANS 10114-1 requires minimum 150 lux.
- o **Lux at staircase = 37 average.**
- o Illuminance below required SANS standard of 150 min and 100 min at tread.
- o Inadequate illuminance is a causal factor.
- o *Near Miss for light not working was not reported – thus hazard not identified, and risk not recognised.*

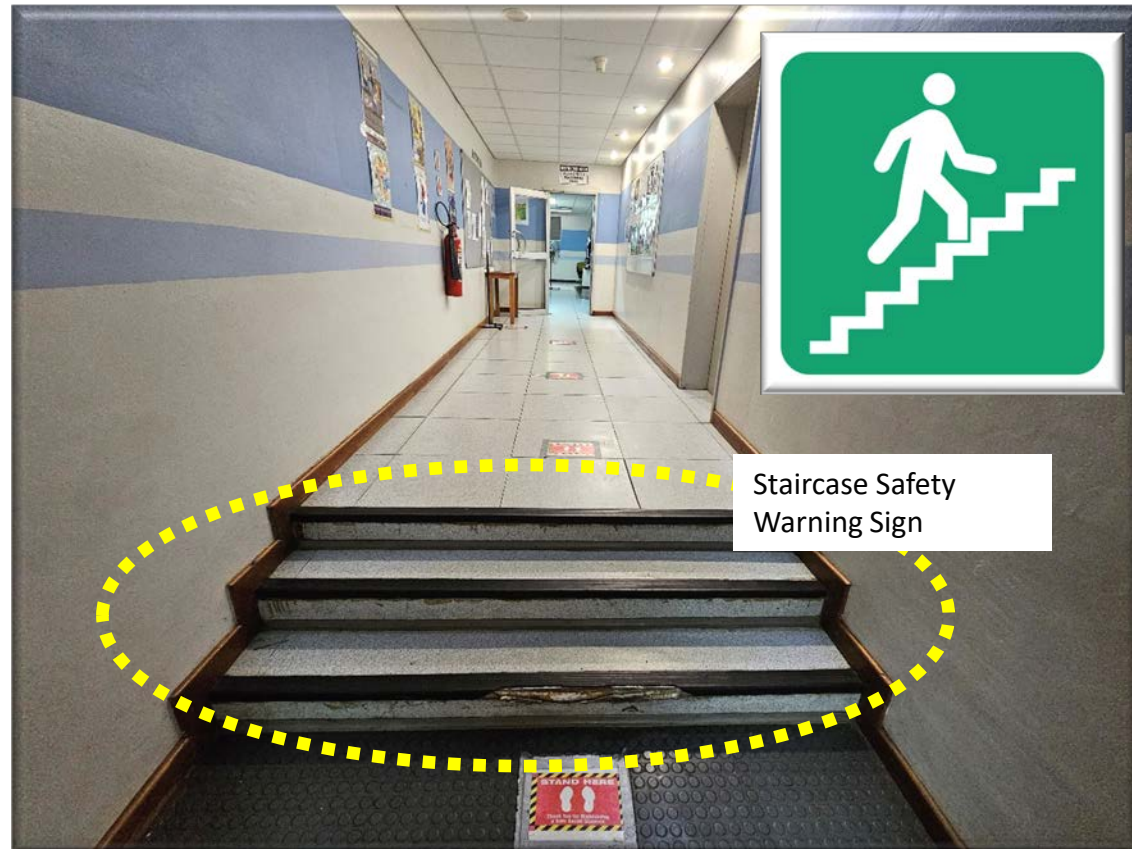
- o Safety Signs: there is **no safety warning sign installed** either above the staircase, on the floor, or on the wall of the corridor.
- o Safety warning signs identifies a hazard and warns thereof in a proactive manner – thus preventing human error.
- o *Absence of safety warning sign not reported as non-conforming Near Miss – thus hazard not identified, & risk not recognised.*

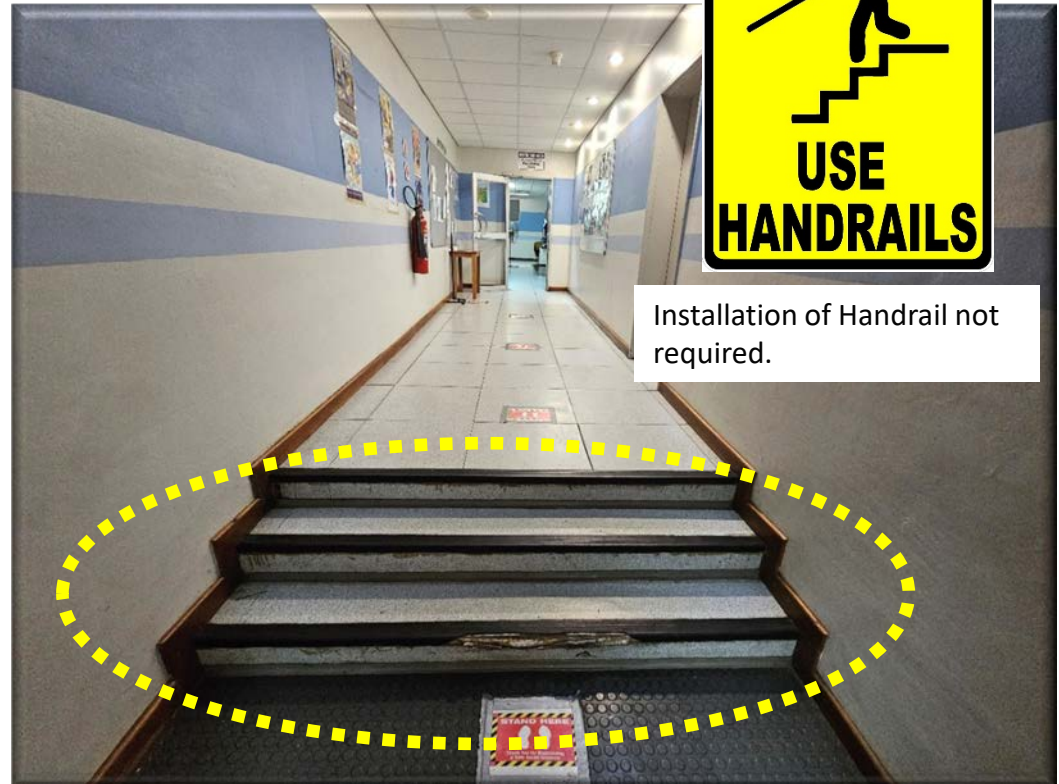
- o Handrail Requirement: there is no handrail installed along the wall at the staircase.
- o SANS 10400 does not require handrail installation for staircases of 3 steps or less.
- o Also, no previous injuries at this staircase – i.e. no repeat incidents.
- o Handrail installation is not necessary at this staircase – risk based.
