# LFI: **Staircase Trip & Fall** @ Water Treatment Plant

# IOD LTI – 24 April 2023

- Water Treatment Plant - Sandfilter @ 12H00 -

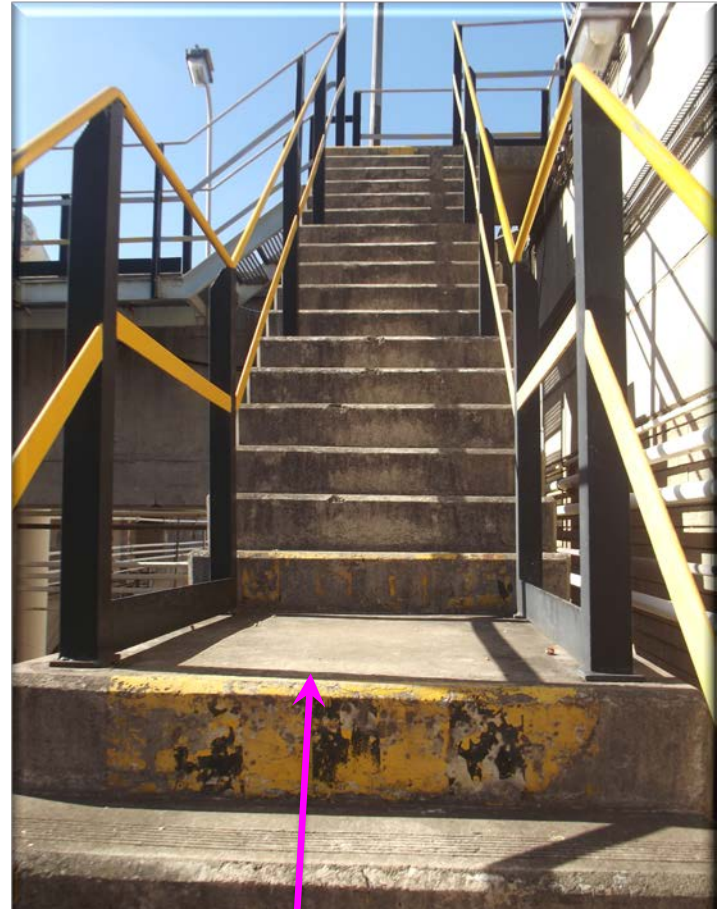
Staircase with 33 steps at Flocculation Channels

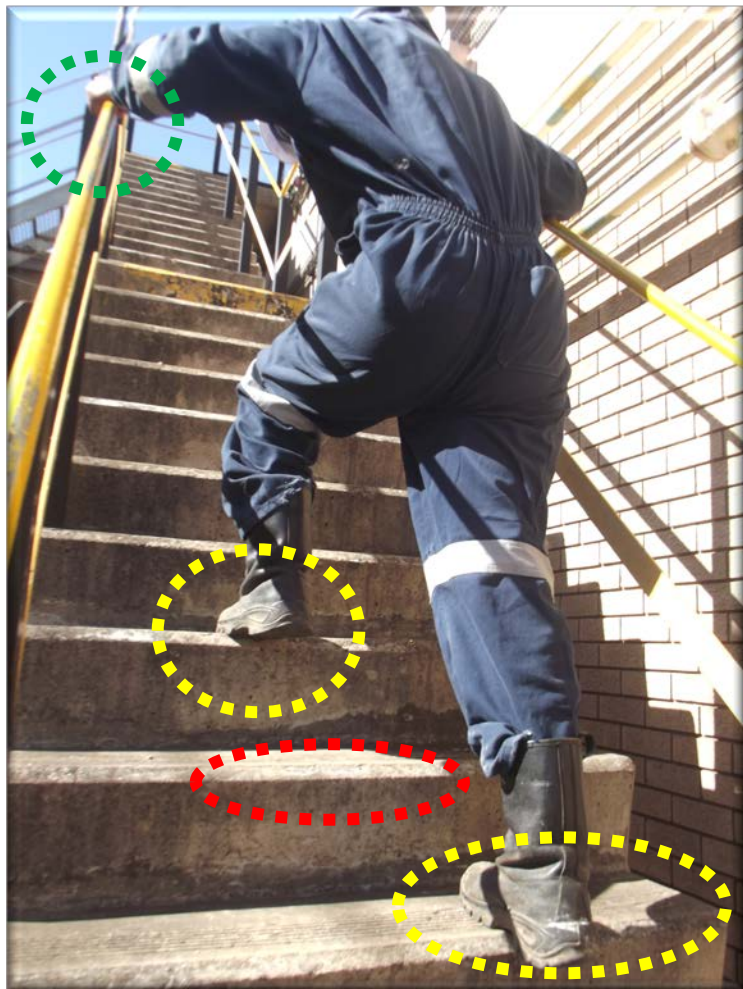
Flawed Method / Haste / Routine Activity without Thought

- o Flawed Method of Ascending Staircase: 2 steps at a time – overexposure of physical capability. *Contributing Factor: 33 Steps on 2-tiered staircase, and frequent use because of temporary mixing operation on top of flocculation channels.*

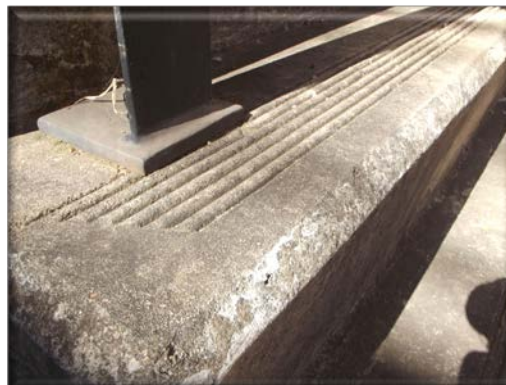
Stair Design per Standard

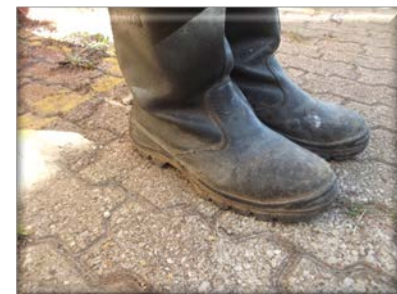
Boots in Safe Condition

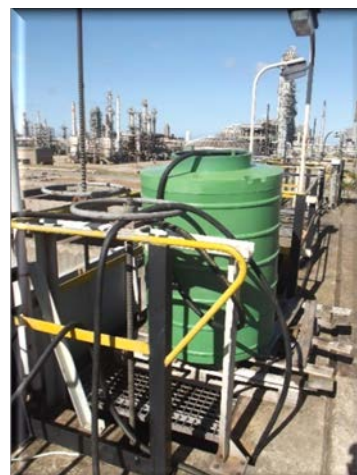
Temp Mixing Tank / MOCA in place.

- o **Manual operation** of the automatic operated polyacrylamide dosing system because of delay in mechanical pump replacement necessitating a temporary MOC.
- o Human Factors not adequately considered in MOC design, i.e. Placement position of valve for controlling water addition placed at ground level (33 stairs) – should be next to temporary mixing tank.

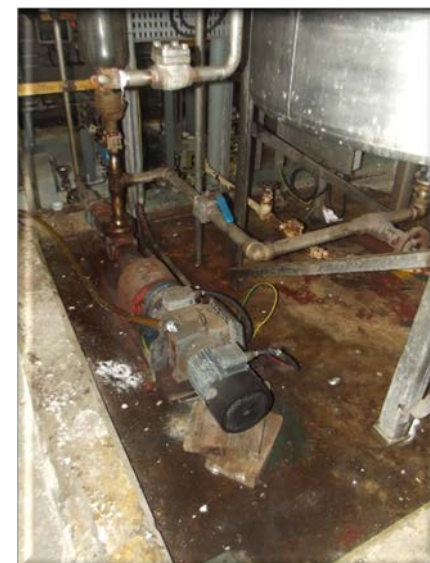
Faulty Pump per MOCA

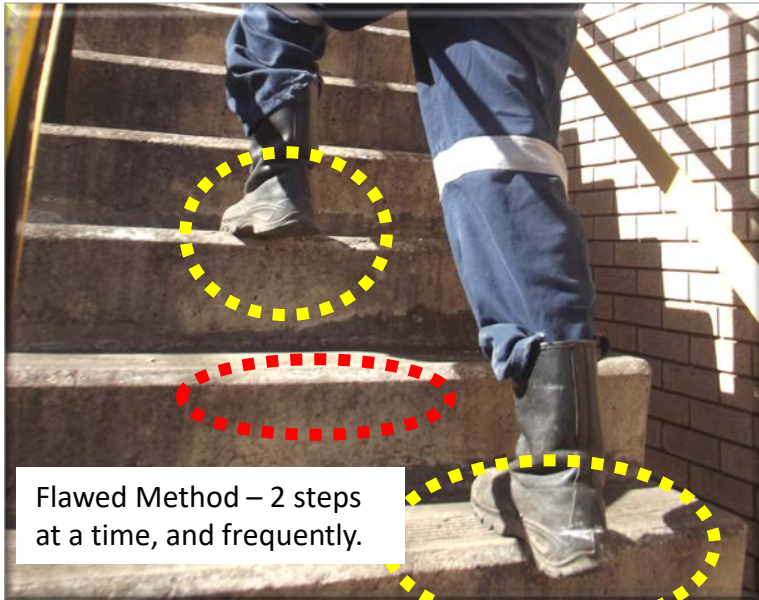
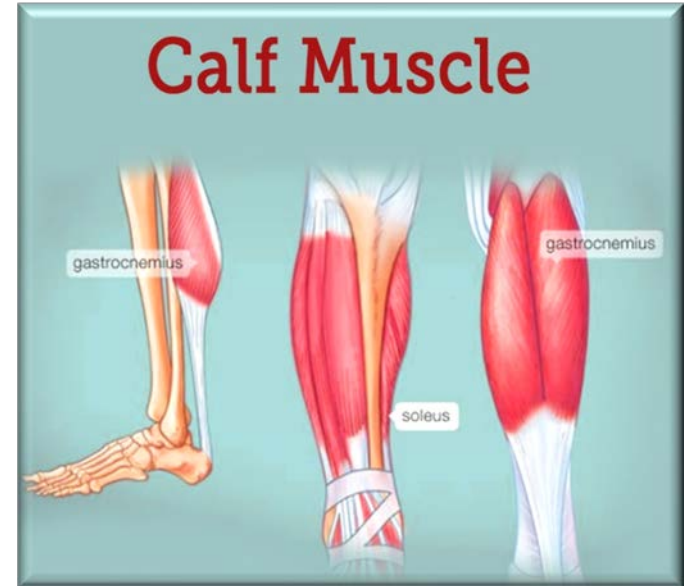
**Calf Strain:** The calf is made up of 2 muscles called the gastrocnemius and the soleus. Overstretching or tearing either of these 2 calf muscles is known as a calf strain.

Walking Up and Down a staircase:

**Methodology is 1 step at a time** because the design of the staircase does not prevent calf strain if you leap 2 steps at a time..

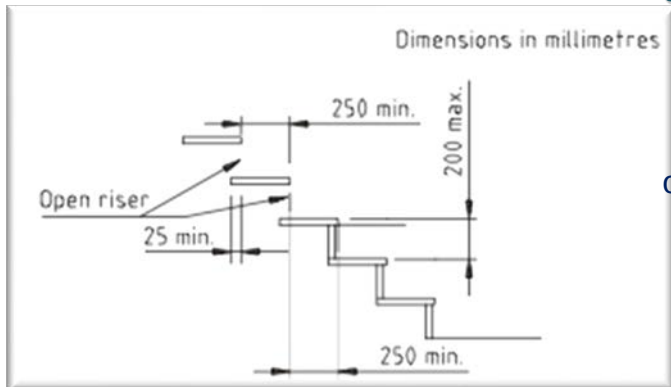
Stair Design per Standard
