SAPIA Sasol – Learning Exposure to Hot Product

Sasol - Exposure to hot product

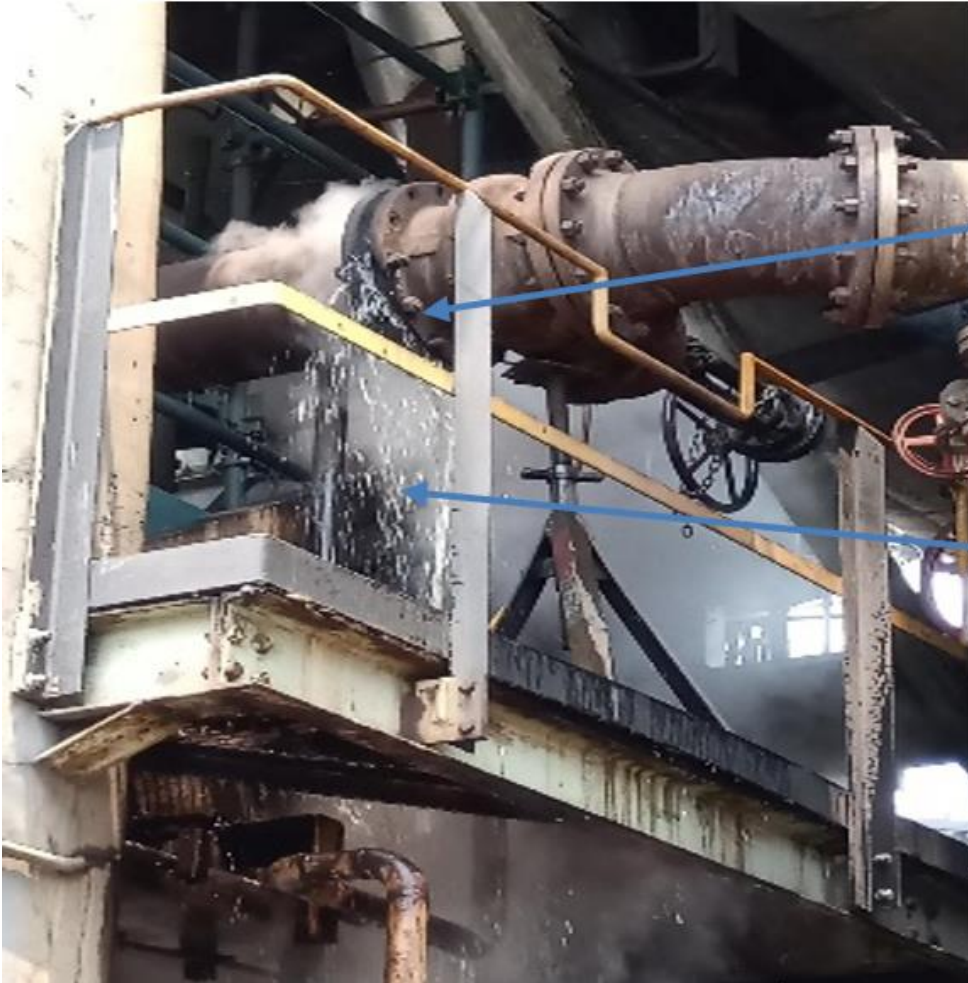
Sasol - Photo

Continuous release of stripped gas liquor and associated vapours after removal of figure 8.

The area where the injured service provider mechanical fitter was standing when he was exposed to stripped gas liquor and associated vapours.
