**Consequences : LTI**

**Brief description of Event:**

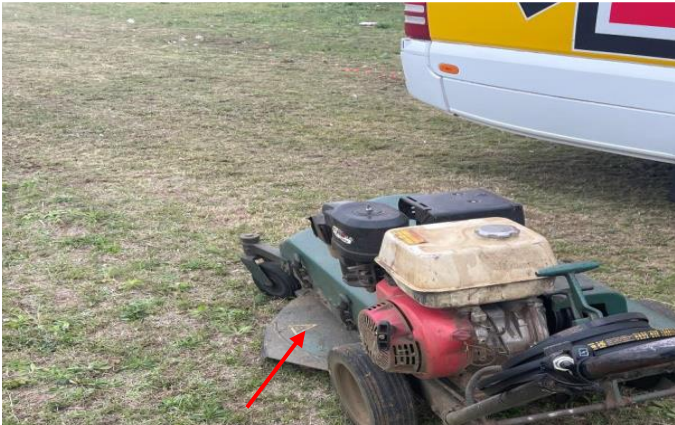
Mower used during the incident

Outlet/chutes face at an angle towards the back of the machine and not directly away from the operator

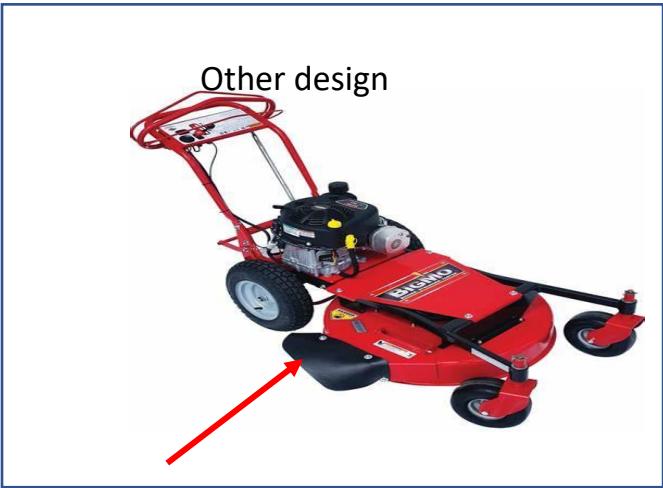
Outlet/chutes face away from the operator

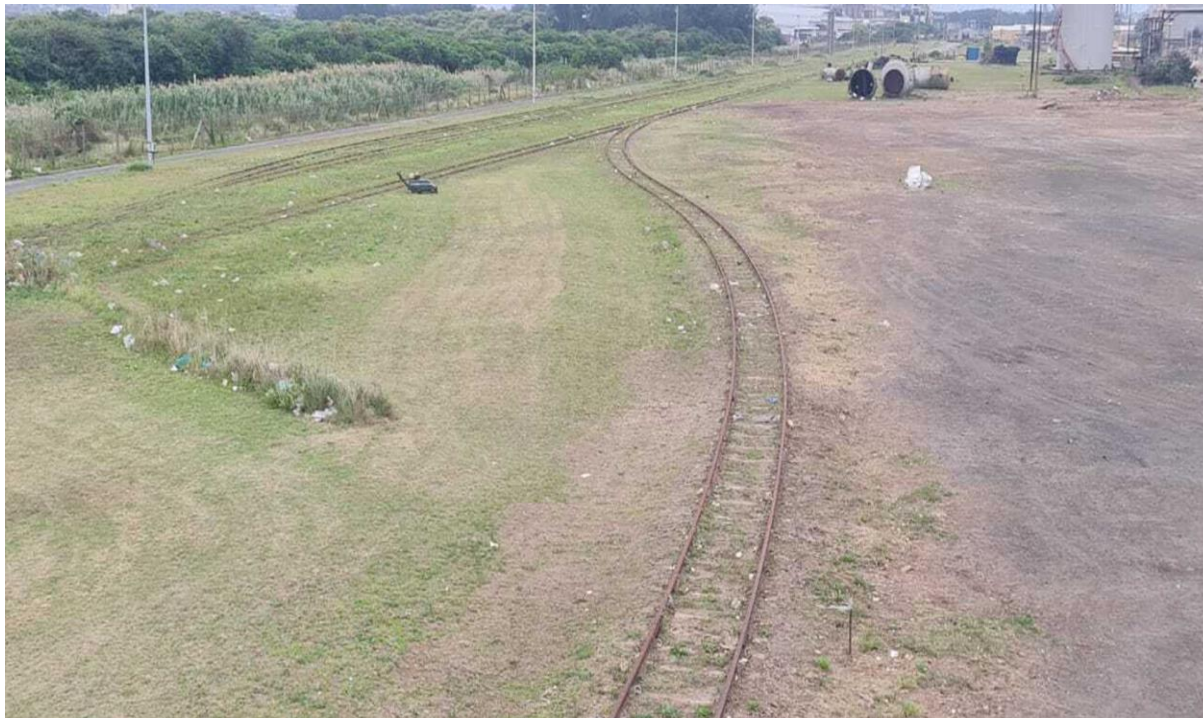
- He may have lifted the machine to remove stuck object exposed foot/upper body.
- Due to uneven surface – machine could have tilted, and running blade may have strike an operator

- PTW pack quality,
- Work supervision,
- Risk recognition & mitigation and
- Management of change
