(TIER 2) PRACTICAL EMERGENCY EXERCISE

“Port of Durban Oil Spill Equipment Deployment at Island View”

To : Distribution list
From : Sapref Emergency Services
Date : 17 February 2023
Subject : *Executive Summary* – Island View Tier 2 Oil Spill Equipment deployment exercise

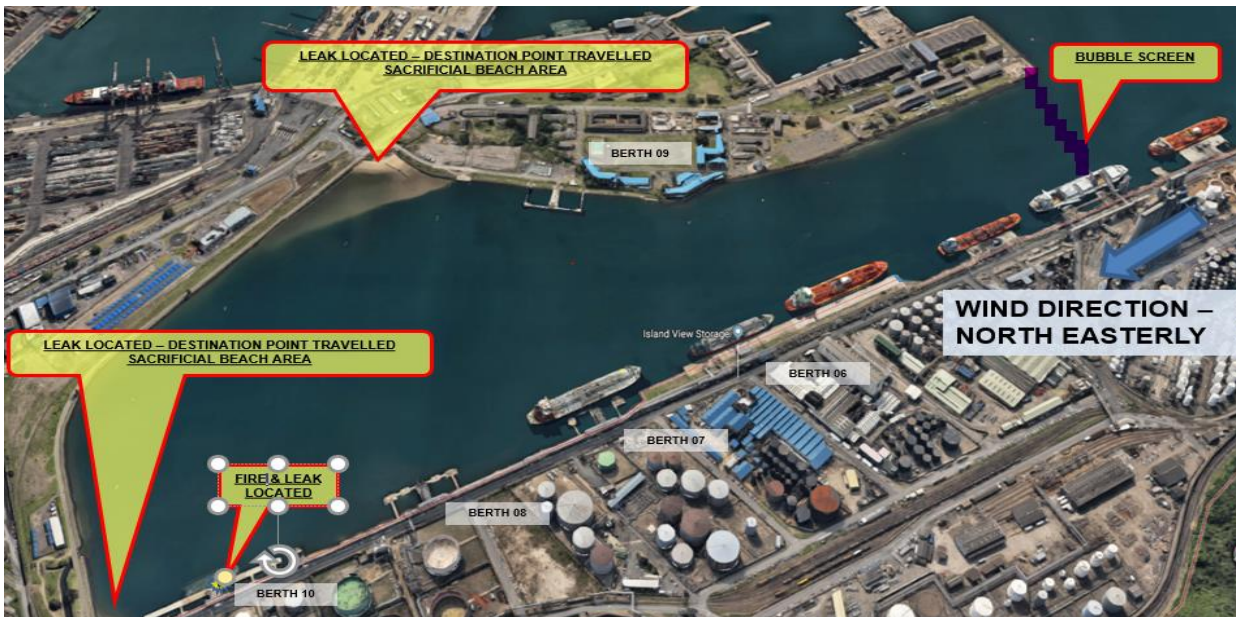
Pictogram Satellite View on the day North Easterly Winds:

6. Spilltech's management of the incident with other stakeholders went well, adverse weather conditions with strong currents below grade under water was encountered, the teams attempted to set up primary containment on the seaside, 35 minutes into the drill from deployment of equipment onto the seaside of the quay side for initial containment it was found not to be effective due to heavy winds and the team allowed the product (MFO /BFO) to land on the identified sacrificial beach areas presented onto pictogram above...
