# Safety Alert

## Enterprise Fatality: Forklift Mechanic Fatality

Location: PASAR Copper Department, Glencore

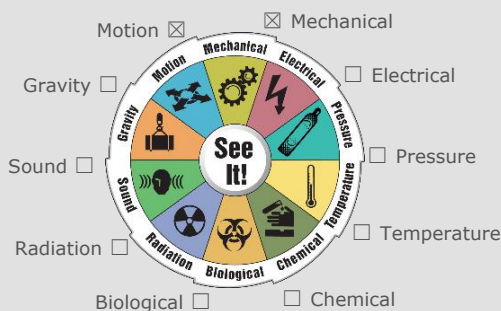
An incident occurred at around 6:42 AM on 30 July 2022 at the Copper departments Mobile Pool Parking area. A Ravago Mechanic was investigating an oil leak, observed on the rear right cylinder of a Ravago Rental Forklift, and was fatally injured.

Initial investigation findings indicate that the Forklift Operator was instructed to turn the wheels by the Mechanic. In between the instruction and action, the mechanic positioned his head between the wheel and the counterweight, resulting in the fatal injury.
