**South Africa NOV RBA - Service Champion Injured By Falling Object (Solar Panel from canopy roof)**

### SOUTH AFRICA NOV CO RBA - SERVICE CHAMPION INJURED BY FALLING OBJECT (SOLAR PANEL)

JULY 2024

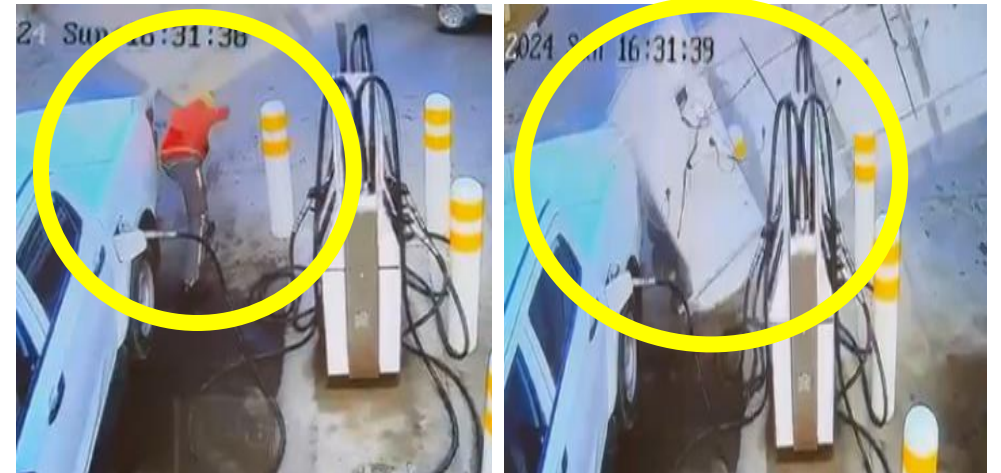
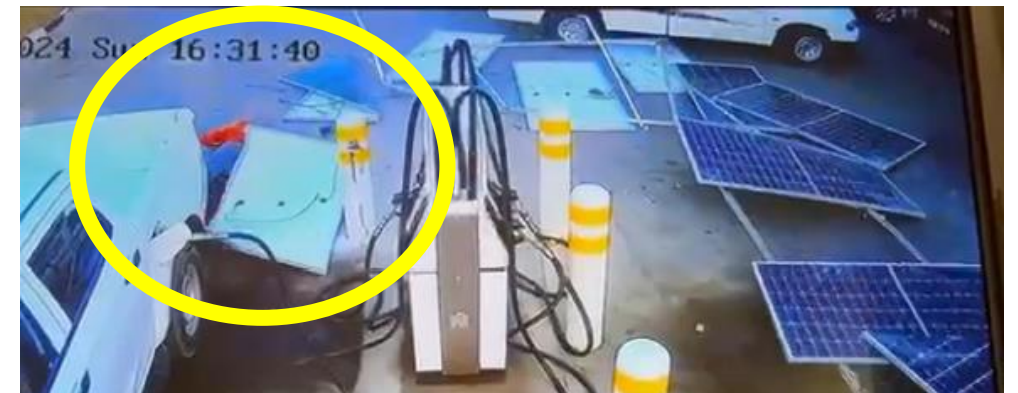
- On the 07<sup>th</sup> of July 2024, at approximately 16:37 PM, during extremely strong windy conditions, solar panels on the canopy roof of the Sedibeng Service Station in the South African city of Qwa Qwa came loose and one of the rows fell.
- The solar panels fell onto the forecourt where the Service Champion was refuelling a customer's vehicle. Fortunately, the panel only slightly injured him in the leg as it hit the back of the bakkie/vehicle first.
- The injuries were treated in hospital by suturing the wound. In addition to the injuries of the Service champion,, the customer's vehicle was also slightly damaged.

- Maintenance Program - Market to develop a maintenance strategy with supplier for solar panel for adequate health checks.
- Winds in this location were more than 142km/h leading this row of solar panels to get "Dislodged from the roof"
- The solar panel installation were deployed by an approved supplier and covered other sites in the last 2 years.

- Work with supplier for making safe other sites and providing the additional barriers for similar risk sites (With high wind speed risks)
- Service Champion Big Rules "I promise to stay forecourt safe". High wind speed to be factored in the risk at sites.
- ERP readiness at sites and its importance during such incidents.
- Intervene when you spot an unsafe condition or act. Report proactively.
