# Incident Learning: What happened?

## Medical Treatment Case

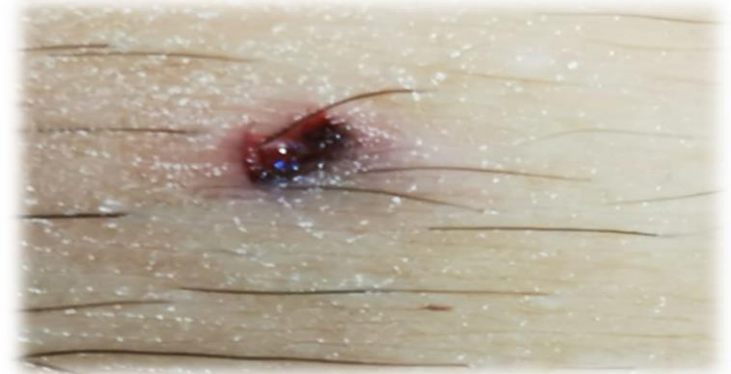
Piece of metal dislodged from either:

1. Head 2. Tip 3. Bolt

*Not clear where piece of metal dislodged from, awaiting final investigation*

- Develop a procedure /SOP that clearly identifies the different scenarios of unbolting rusted bolts.
- Use the Pre Job briefing process to clearly outline the agreed method to be used and the clear communication process to follow if agreed methodology is no longer feasible to execute
- Develop a procedure to prevent the distribution of poorly maintained equipment (Chisel head was mushroomed) at collection from stores.
