# LFI: Road Curb Trip & Fall @ Voorbaai Tank Farm

# IOD **LTI** – 19 January 2024

- Voorbaai Tank Farm @ 16H30 -

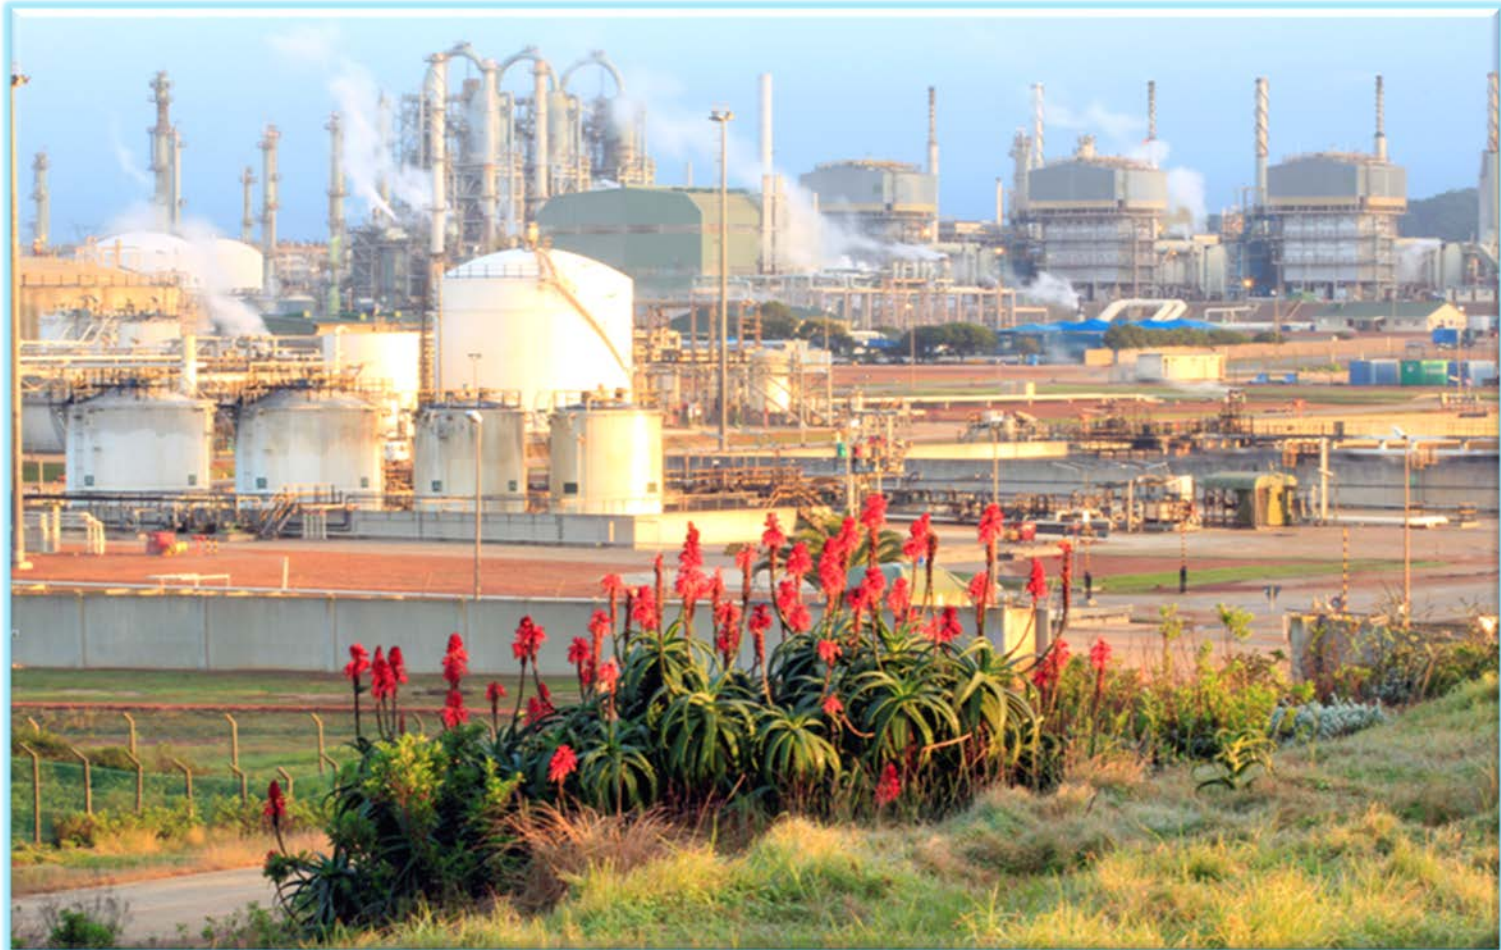
- o Security Officer patrolling the perimeter fence in anti-clockwise direction from the gate office.
- o *Route crosses the road to pass through to the maintenance workshops.*
- o Safety Hazard – required to safely negotiate the curb to check the workshop building.
- o *Right foot tripped against top edge of the road curb.*
- o Security Officer fell down towards the left and cushioned fall with left hand.
- o *Left Hand muscles torn. Injured wrist. No fracture. Booked off by OMP. Injury > 13 days – thus more serious than normal LTI.*
