## Title: BVO Head Injury

Reference: ALERT- branch-zone or business-year-order number (ex: ALERT-RC-RBE-2017-001) Date: 29 July 2022

Country: South Africa

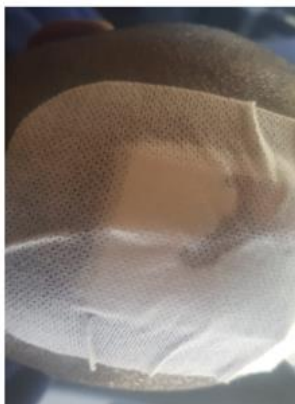
BVO was injured while he was in the vehicle cab. According to the information received, the BVO stood up and attempted to reach for documents which were on top of the dashboard on the passenger's side. While he was extending his body towards to the driver's side, he accidentally bumped the back of his head against the orange box which secured on the ceiling inside the cab. The BVO was cut on the back of his head. Driver received medical treatment by the site clinic. Skin staples were used to close the scalp wound. He commenced with normal work duty as per the doctor's medical assessment report

For this vehicle, the orange box was mounted on the ceiling of the cab, and that is what contributed to the incident.

- *For all vehicles fitter with orange document box holders (weather metal or plastic), it is recommended that the boxes be relocated to the center of the cab between the driver and the passenger side in line with the recommendations of the SANS standards.*
- *For all orange document holders with sharp edges, after relocation, it is further recommended that edge protection be in place to avoid contact with persons in the cab*
- *Furthermore, it is also recommended that consideration be given to the replacement of such boxes with the alternatives available in the market (such as PVC type bags)*
