# PetroSA LFI: Non-Availability of FireWater on Demand

# PetroSA LFI: Pump Bearing Failure (Linked Prelim)

## Technical Findings: Stripping of Pump Around Pump

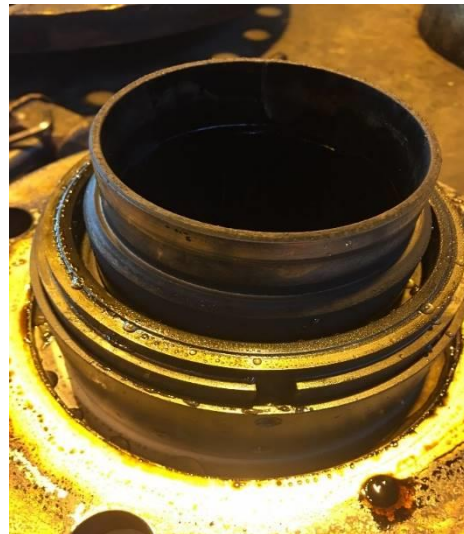
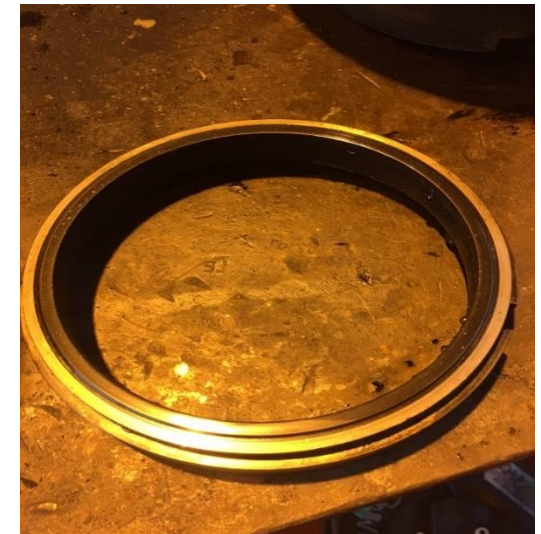
- Definite indications of heat transfer to the seal coming from the overheated & failed bearing.
- No specific damage to the inboard seal detected
- Outboard seal radically worn with signs of overheating.... this seal has possibly been installed for approx. 2 years.

The mechanical seal suffered no catastrophic failure or damage but cannot be re-installed as is. Standard reconditioning is required to bring the seal back to its operating spec.

Carbonization  
formation due  
to heat

- Cooling water supply and return lines not commissioned, leading to overheating of bearing and causing premature failure of the bearing and pump. The excessive heat from the bearing lead to overheating of the oil causing smoke/fumes and then activating the fire alarm.
