LFI: Tube failure on an air-cooler on the Naphtha Hydrotreater Unit

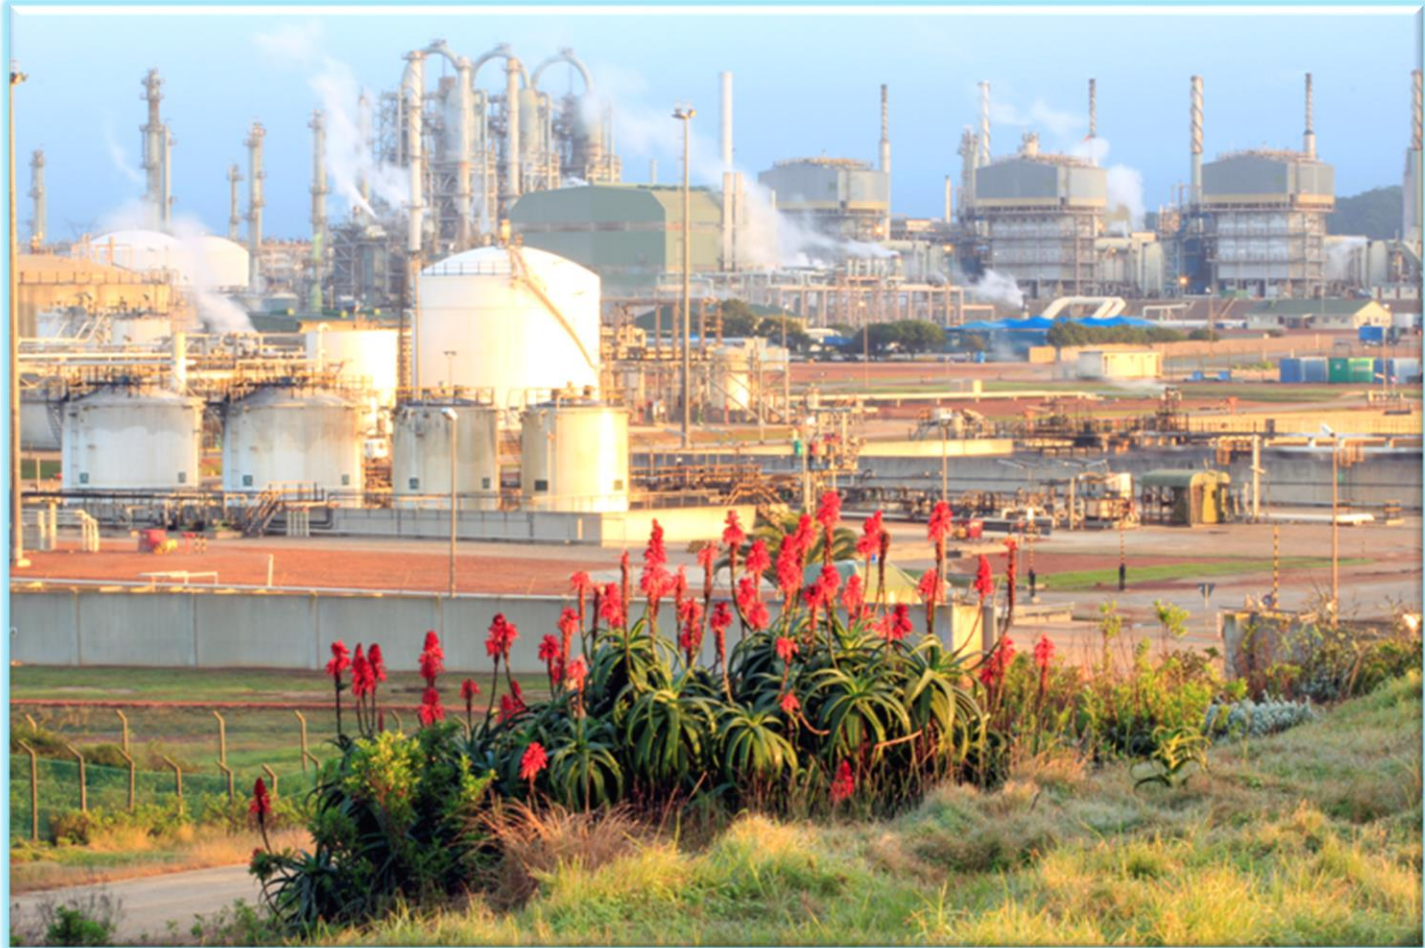
On 17th October 2019 one tube of an air cooler on the Naphtha hydrotreater was observed to be leaking hydrocarbon and recycle hydrogen. In response, the unit was taken offline and depressurized.
