# What happened?

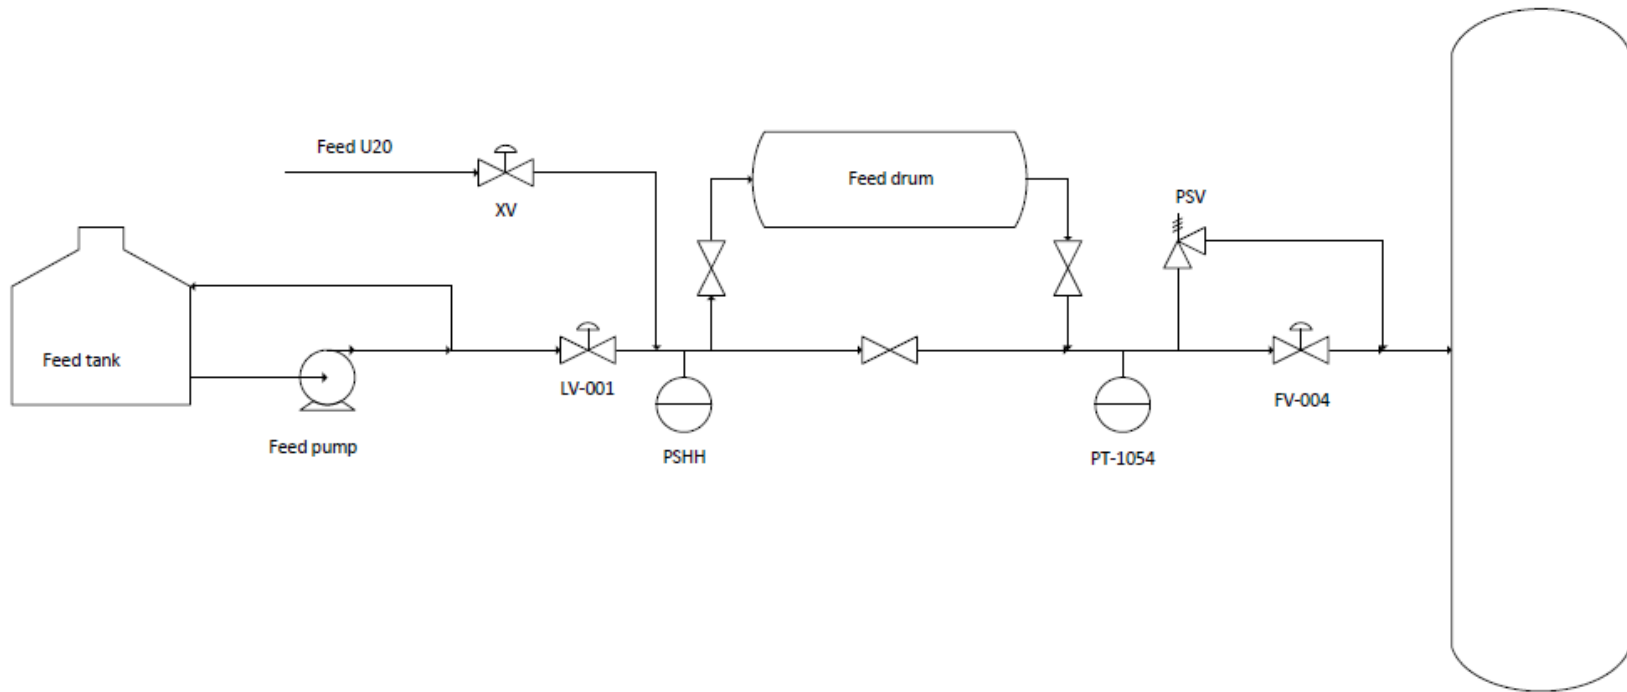
# Process flow

- Stabilised Light Oil (SLO) unit lost feed from Tank Farm due to the feed pump that tripped.
- The secondary pump at Tank Farm, was started.
- The feed to the unit was restored, but at a higher pressure and flow relative to normal operations.
- Approximately 20 minutes later SLO was released from the feedline when the 1" stub broke off from the reducer where the pressure transmitter is connected. (15 ton of SLO was released)
- The SLO sprayed into the pipe rack and across the road 5 into another unit.
- Emergency Services responded when the alarm was activated.

- Spec breaks in pipeline not without pressure protection, credit for pressure protection on feed drum
- Inadequate pressure control in unit, control the incoming feed pressure manual with a level control valve
- PSV sizing and installation, gaseous service PSV installed in liquid service, place of installation
- End of job documentation not available after expansion project
- Trips to active at all times, high pressure trip was never commissioned during installation
- Procedure to provide line of sight when feed fall away not available
- Communication channels to long
- Risk studies to be done with upstream & downstream parties involved
