# Incident Findings

## MEK Fire Incident (29 April 2025)

9 May 2025

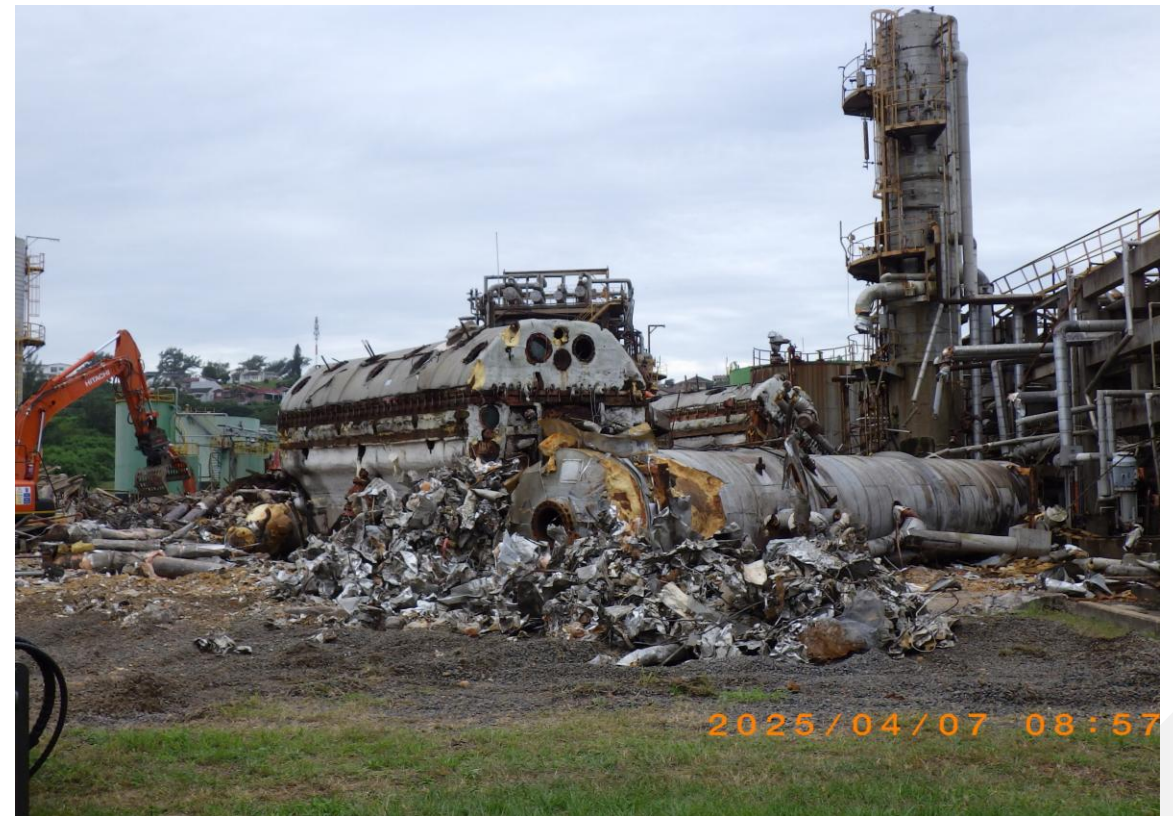
1. Sight glasses were open for several years
2. Under pre-demo prep : Equipment was visually inspected from the outside – no signs of solvent present and no smells on all 3 vessels

*Note: Equipment was not listed on the Exceptions list due to gas test on the openings which raised no concerns*

3. Prior to handover to Jet (as part of the handover documents) - Gas test was done on all open sight glasses (confirmed LEL free on outer drum)
4. Handover document ensured precaution that unit is not HC-free – only cold-cutting
